Ute Park Fire

Damage Assessment and Burned Area Emergency Rehabilitation Plan

SWCA ENVIRONMENTAL CONSULTANTS

AUGUST 2018

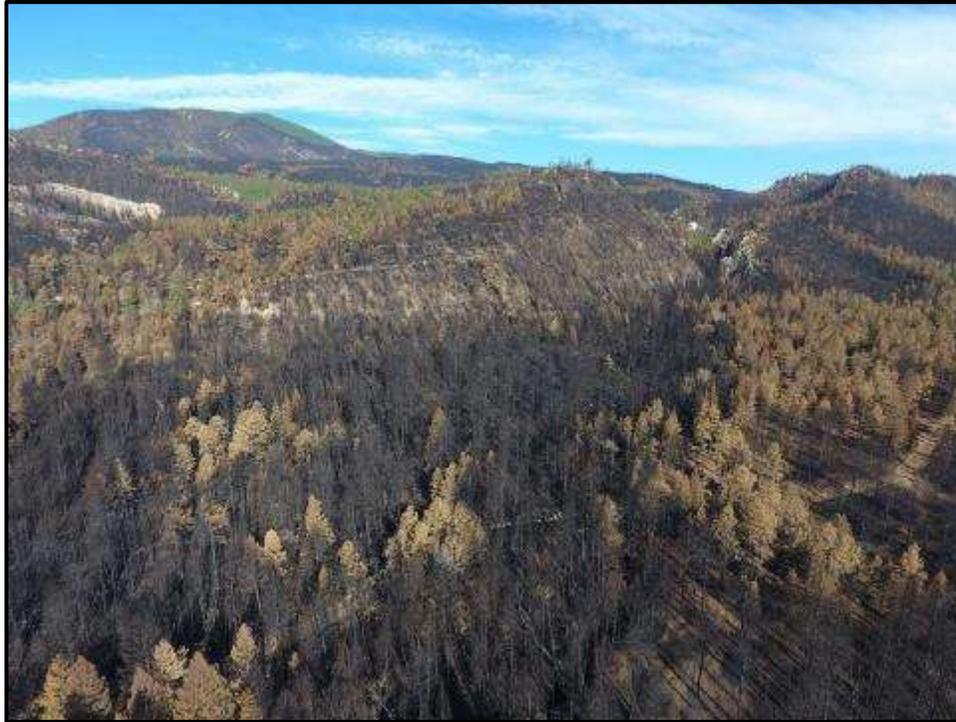
Figure 1.1. Aerial photograph taken during drone reconnaissance showing small patches of moderate and low-severity fire effects on canopy, adjacent to high-severity patches.

The 36,740-acre Ute Park Fire damaged and disrupted watershed function on mostly private lands, and to a limited extent may have even destroyed watershed function on a smaller portion of that area. However, because the Ute Park Fire was a running crown fire and moved rapidly across the landscape (30,000 acres in first 3 days), the Team found that watershed condition had been not impacted as severely as initially anticipated. Although this fire burned with high severity through the overstory vegetation, removing a majority of the forested overstory canopy and protective litter and duff layer, the rapid rate of spread resulted in minimal residence time on the soil surface. Therefore, the soils are relatively intact with fine organics still remaining, both on the surface and in the soil profile, and a viable seed bank of native plants likely still exists. The removal of the protective cover in the overstory canopy above the soil surfaces puts this resource in high danger of being eroded if vegetation ground cover is not reestablished. Overall, the fire burned at a variety of severities with large areas unburned or burned at a low severity, adjacent to areas of significant mortality following stand replacing fire behavior (Figure 1.1).

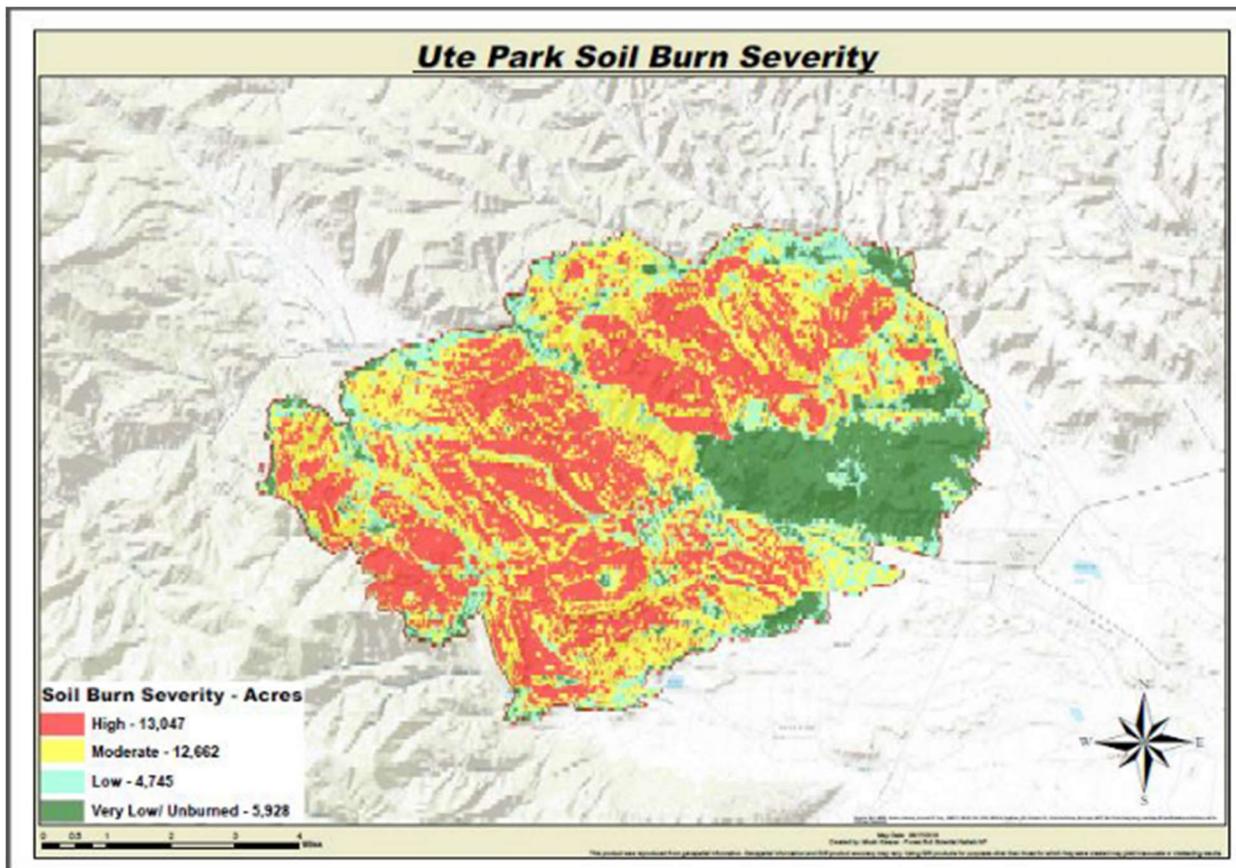
Figure 1.2. Soil burn severity map of the Ute Park Fire.

The primary driver of watershed condition post burn relates to the severity at which the soils burned. The soil burn severity map developed by the U.S. Forest Service is depicted in Figure 1.2 below.

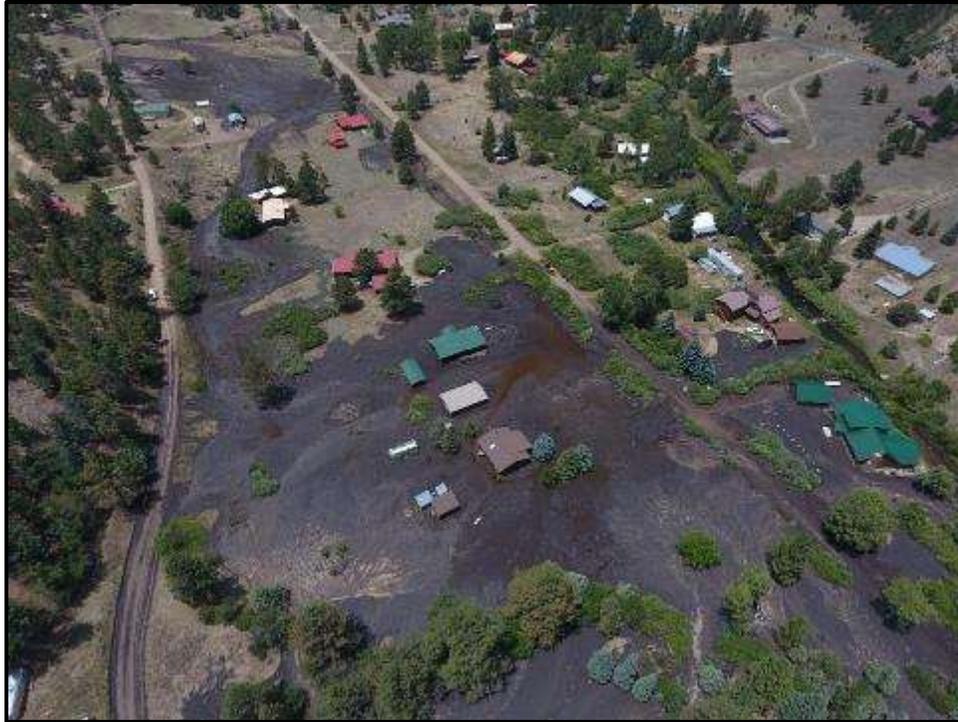
Figure 1.3. Debris flow generated from the Ute Park Fire that impacted Ute Park on July 13, 2018, following approximately 0.3 inch of rain directly on the burn scar upslope from Ute Park.

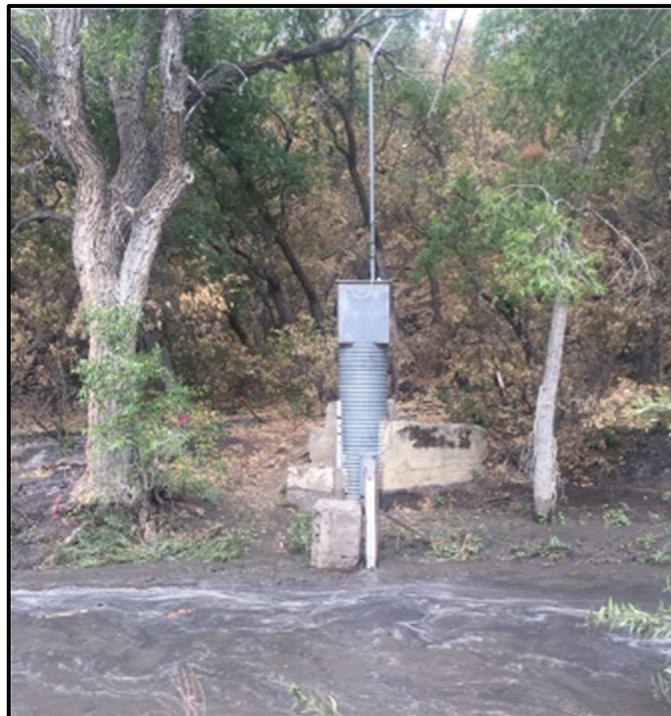
Figure 1.4. Sediment-laden stormflow impacting water quality following a convective storm event.

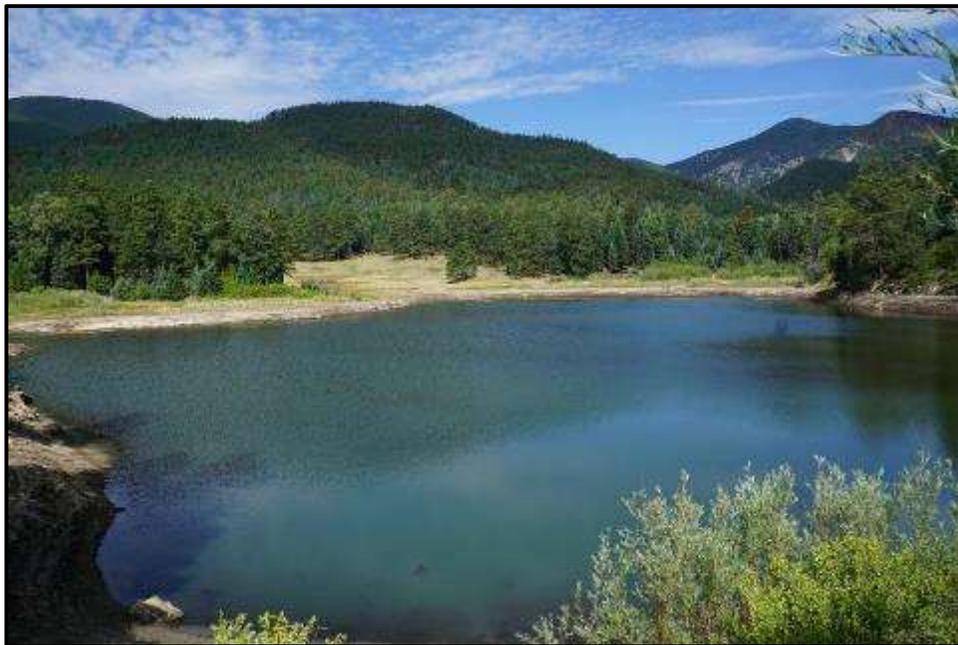
Figure 1.5. Cimarroncito Reservoir is a critical value at risk that has the potential to be impacted by the effects of the Ute Park Fire.

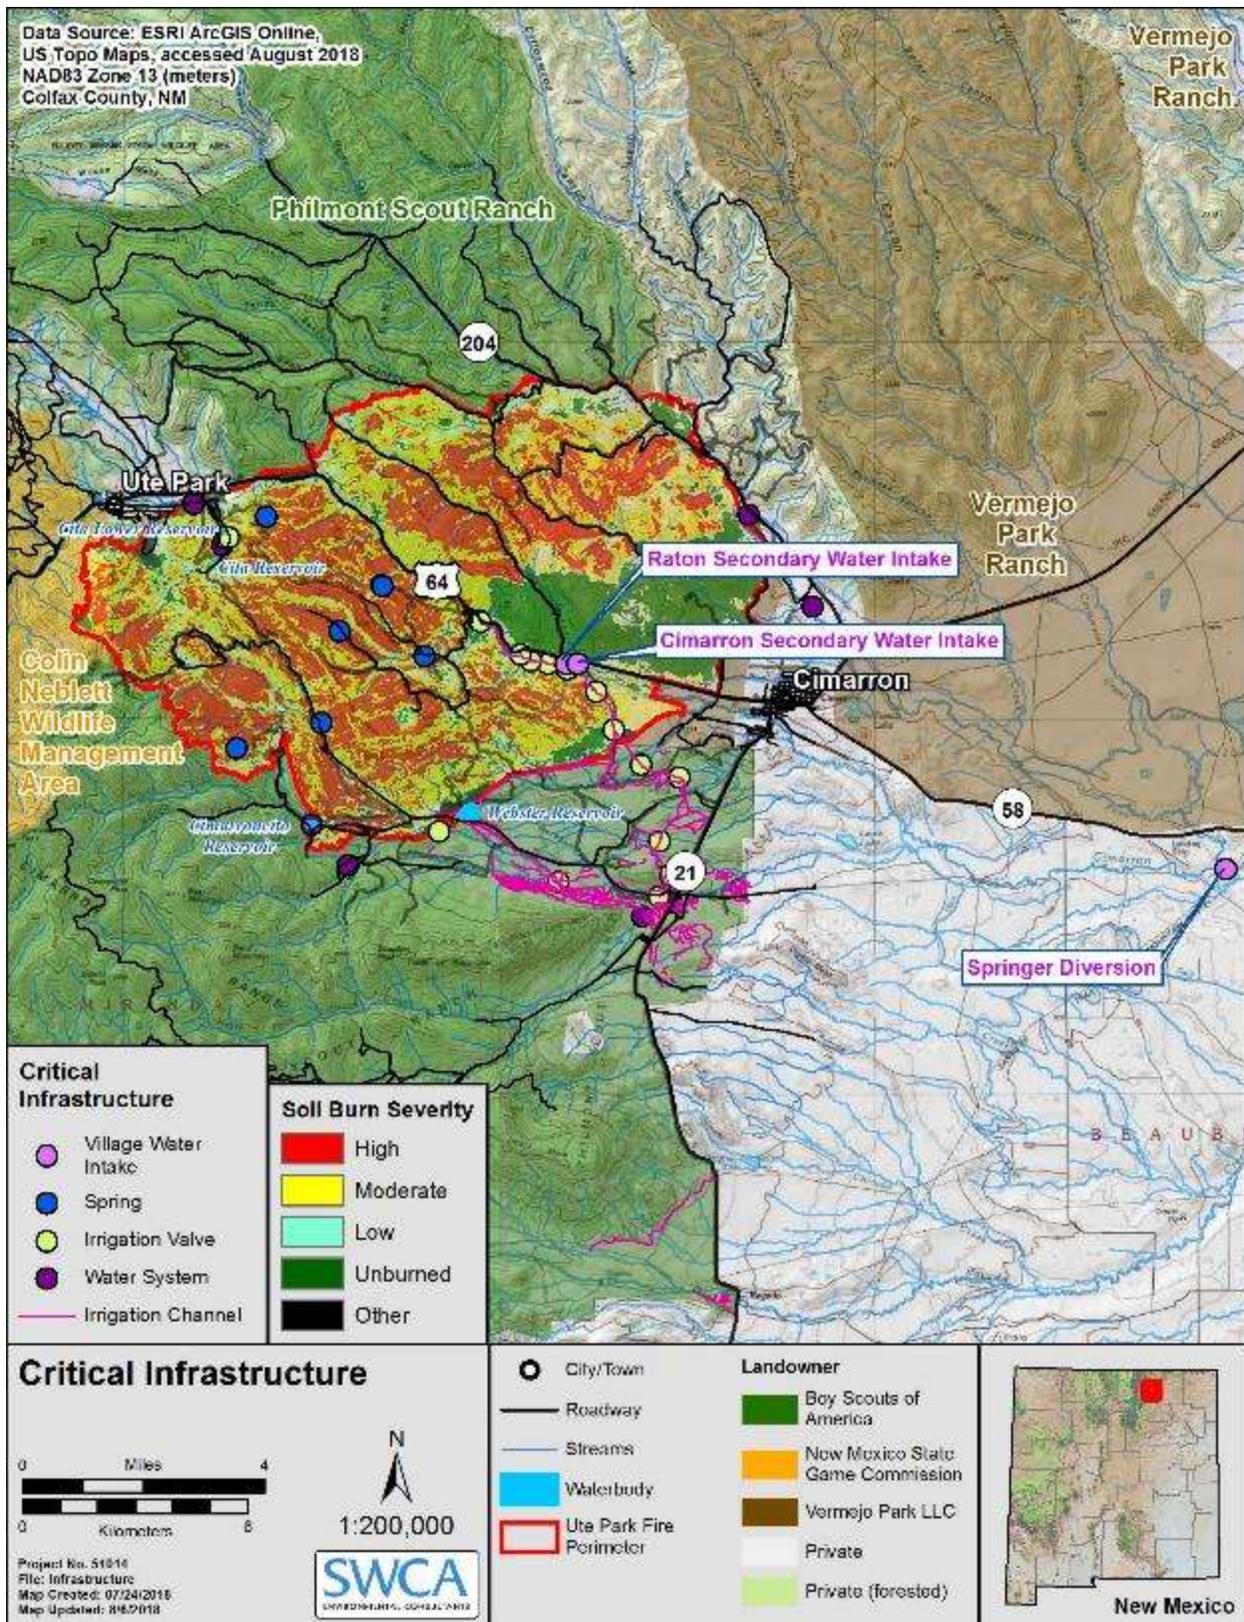
Figure 1.6. Map showing locations of the critical infrastructure that are at a high risk for impacts from the Ute Park wildfire.

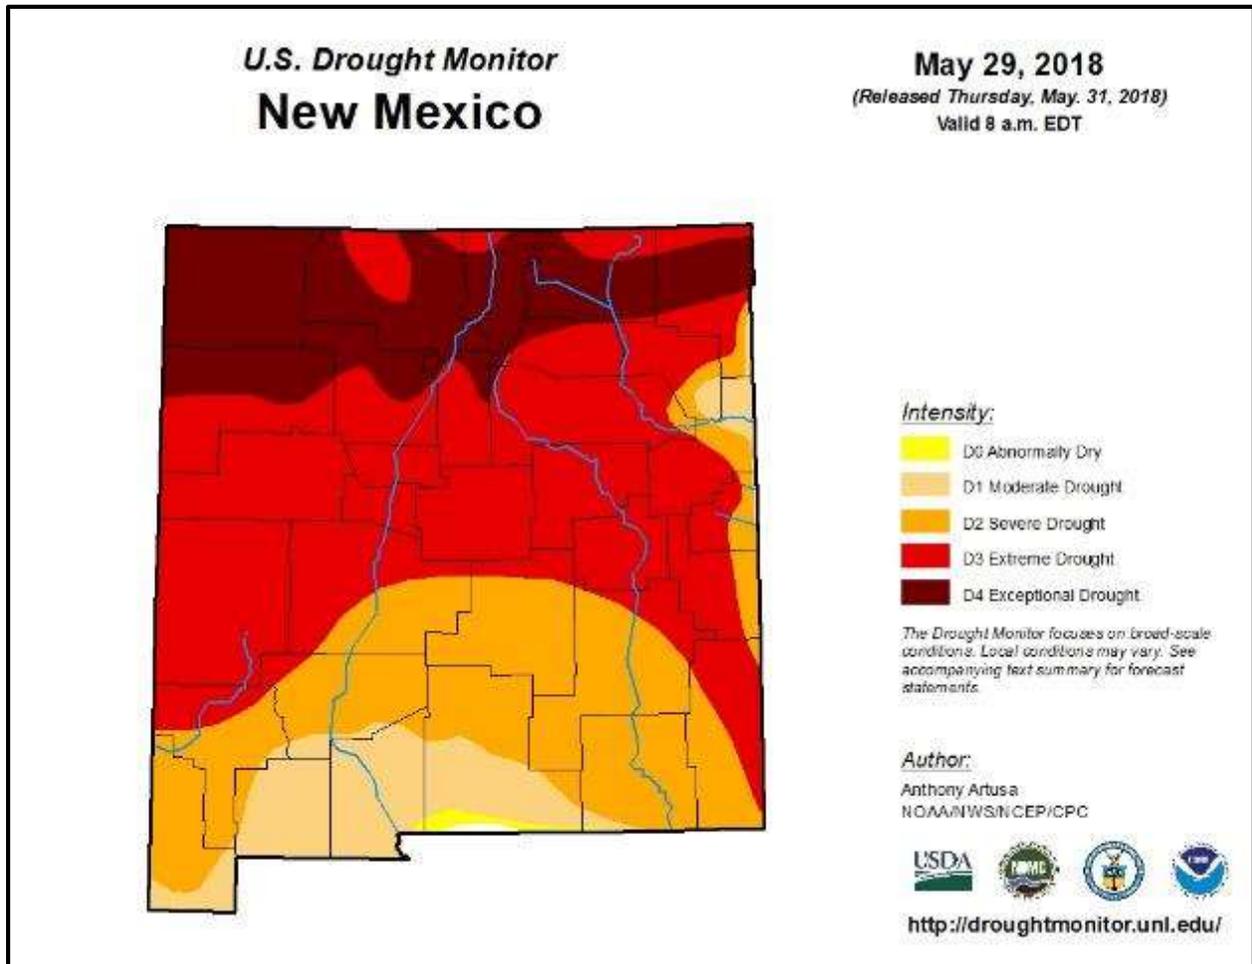
Figure 2.8. Drought map for New Mexico, week of May 29, 2018, showing exceptional drought for Colfax County and the Ute Park burn area.

The burn area had been experiencing exceptional drought during the week the Ute Park Fire ignited, as seen in Figure 2.8.

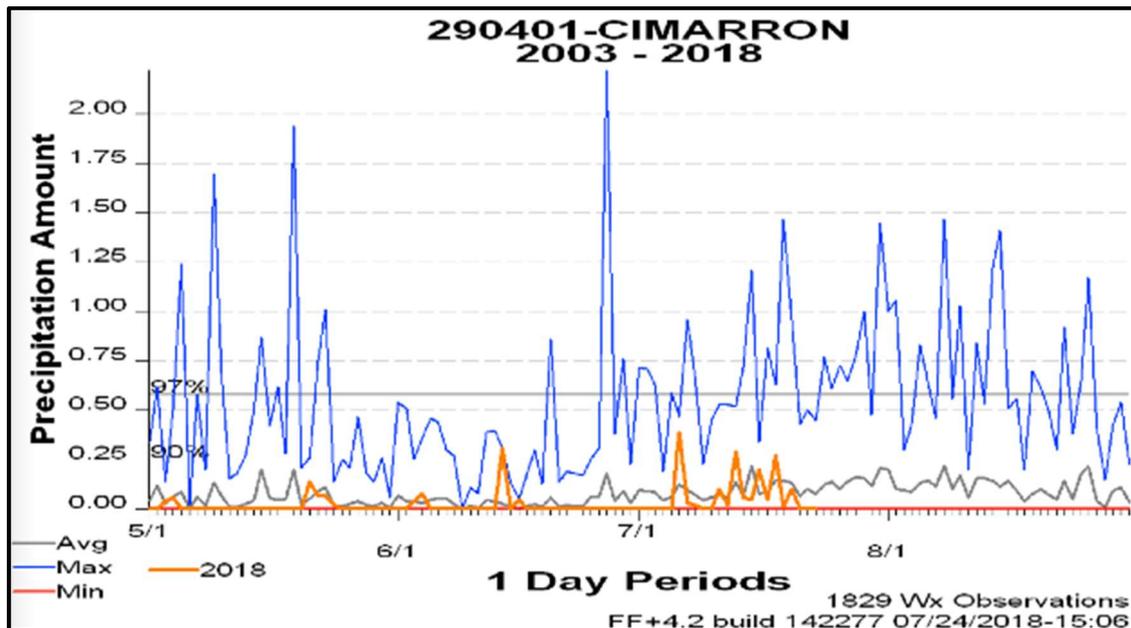
Figure 2.9. Cimarron RAW station precipitation data May 1 to present, relative to average, min and max data from 2003–2018. Graph shows that during the Ute Park Fire (May 31–June 17) precipitation amounts were well below average totals recorded over the last 15 years.

Figure 2.9 and Figure 2.10 show recorded precipitation and air temperatures for the area, beginning on May 1 through to July 2018, relative to average data recorded for the period 2003–2018.

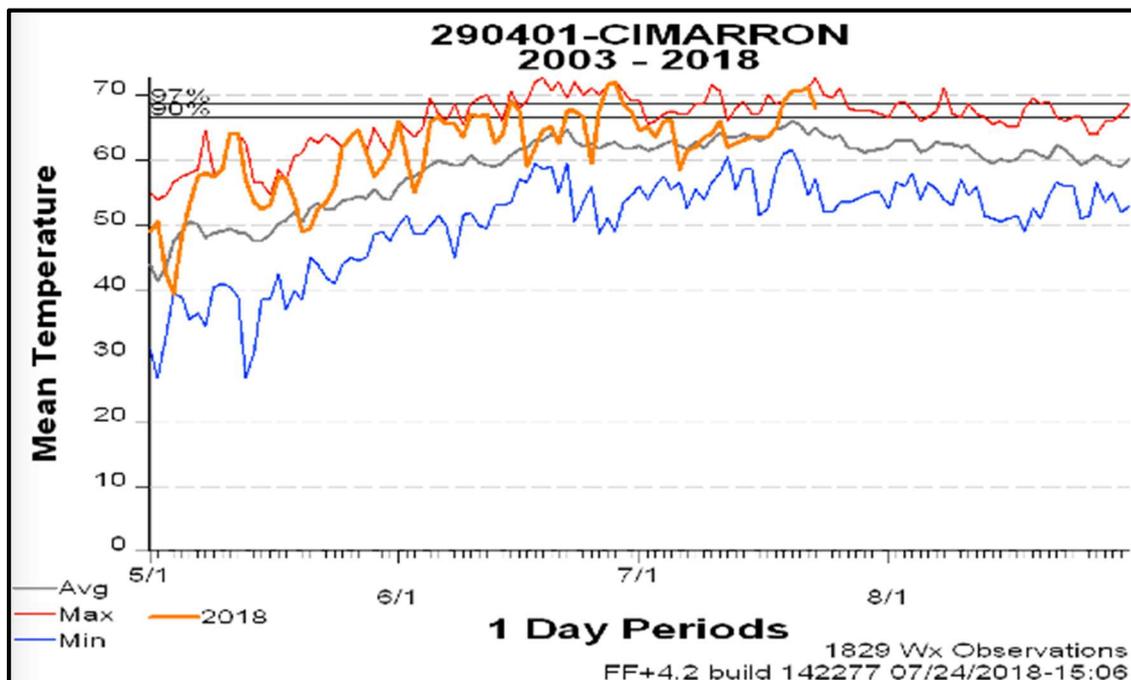
Figure 2.10. Cimarron RAW station mean temperature data May 1–present, relative to average, min and max data from 2003–2018. Graph shows that during the Ute Park Fire (May 31–June 17) air temperatures hovered close to maximum average temperatures recorded over the last 15 years.

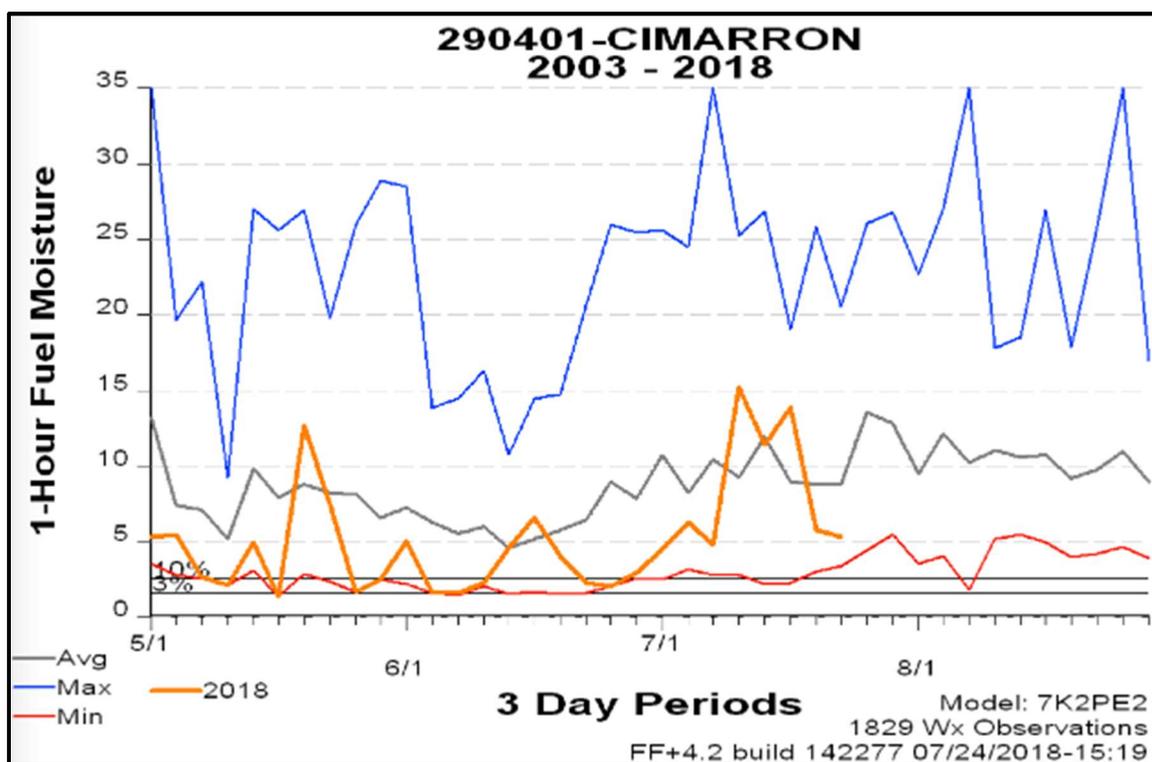
Figure 2.11. One-hour fuel moistures from period May 1, 2018, to current, relative to average, min and max levels (2003–2018). Graph shows the below-average fuel moistures (around the 90th and 97th percentile) in fine fuels in the region at the time the fire was ignited (May 31) through containment (June 17). These conditions are indicative of rapid spread rates.

Dead fuel moistures in the Ute Park area hovered around the 97th percentile during the period that the Ute Park Fire burned. Data for 1-hour (woody material less than ¼-inch diameter) and 1,000-hour (3- to 8-inch-diameter woody material) fuels are presented below (see Figure 2.11 and Figure 2.12) in order to demonstrate the extreme fuel conditions that contributed to intense fire behavior and severe fire effects observed on the fire.

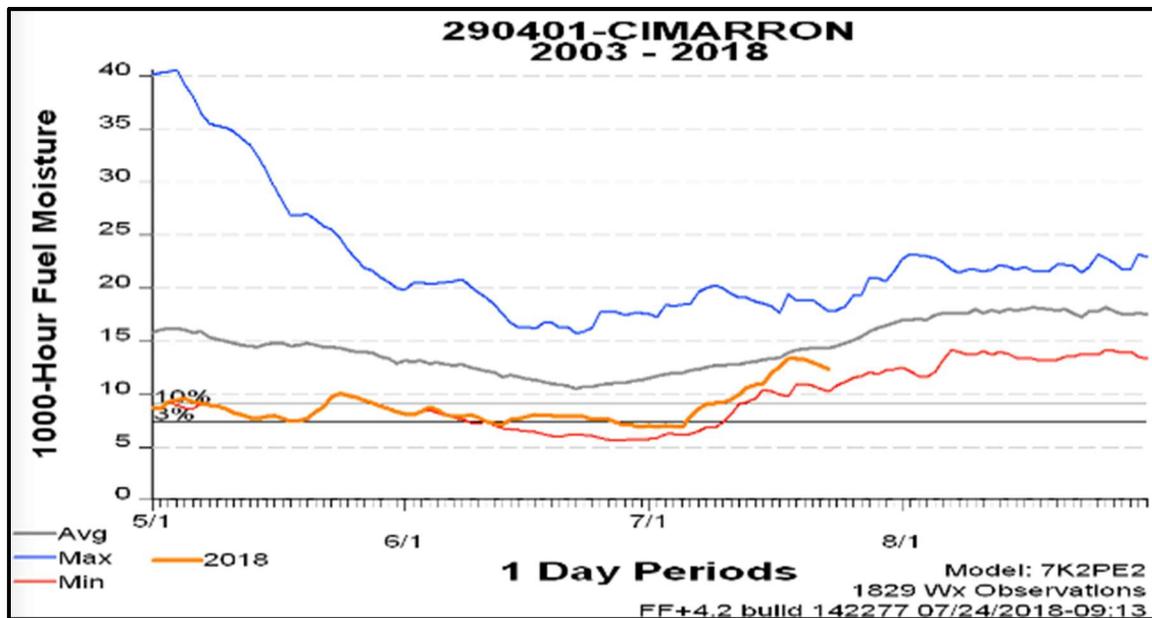
Figure 2.12. One thousand-hour fuel moistures from period May 1, 2018, to current, relative to average, min and max levels (2003–2018). Graph shows the extreme low fuel moistures (around the 97th percentile) in larger woody debris in the region at the time the fire was ignited (May 31) through containment (June 17). These conditions are indicative of high levels of fuel consumption and high fireline intensity.

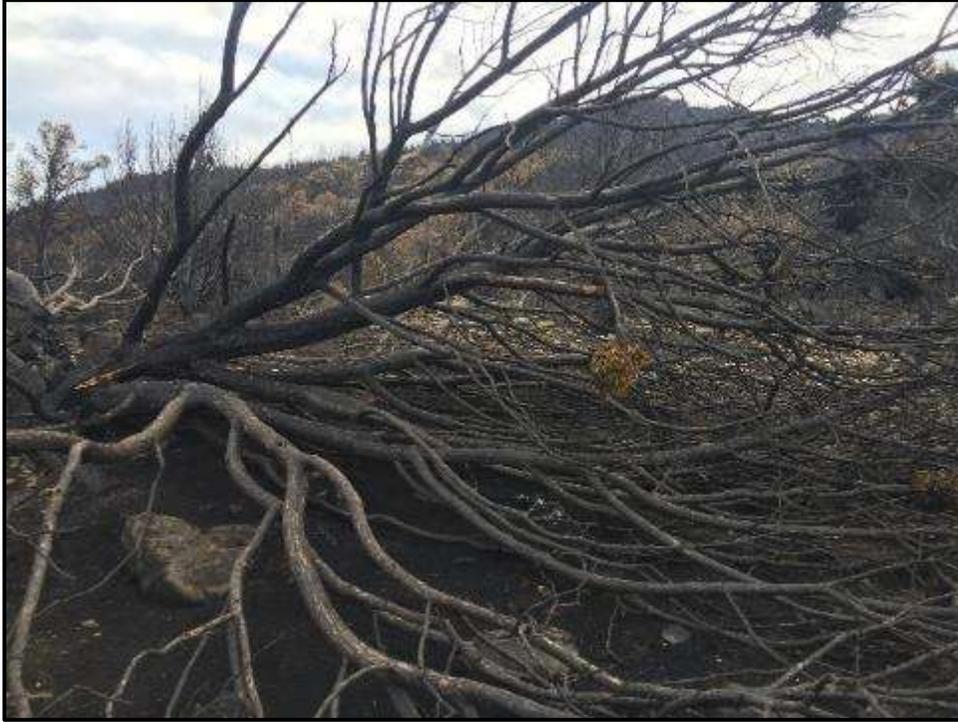
Figure 2.14. Dead Rocky Mountain juniper showing presence of dwarf mistletoe.

- Dwarf mistletoe (*Arceuthobium* spp.)- common statewide, attacks ponderosa pine, juniper species, Douglas-fir, pinyon pine (Figure 2.14).

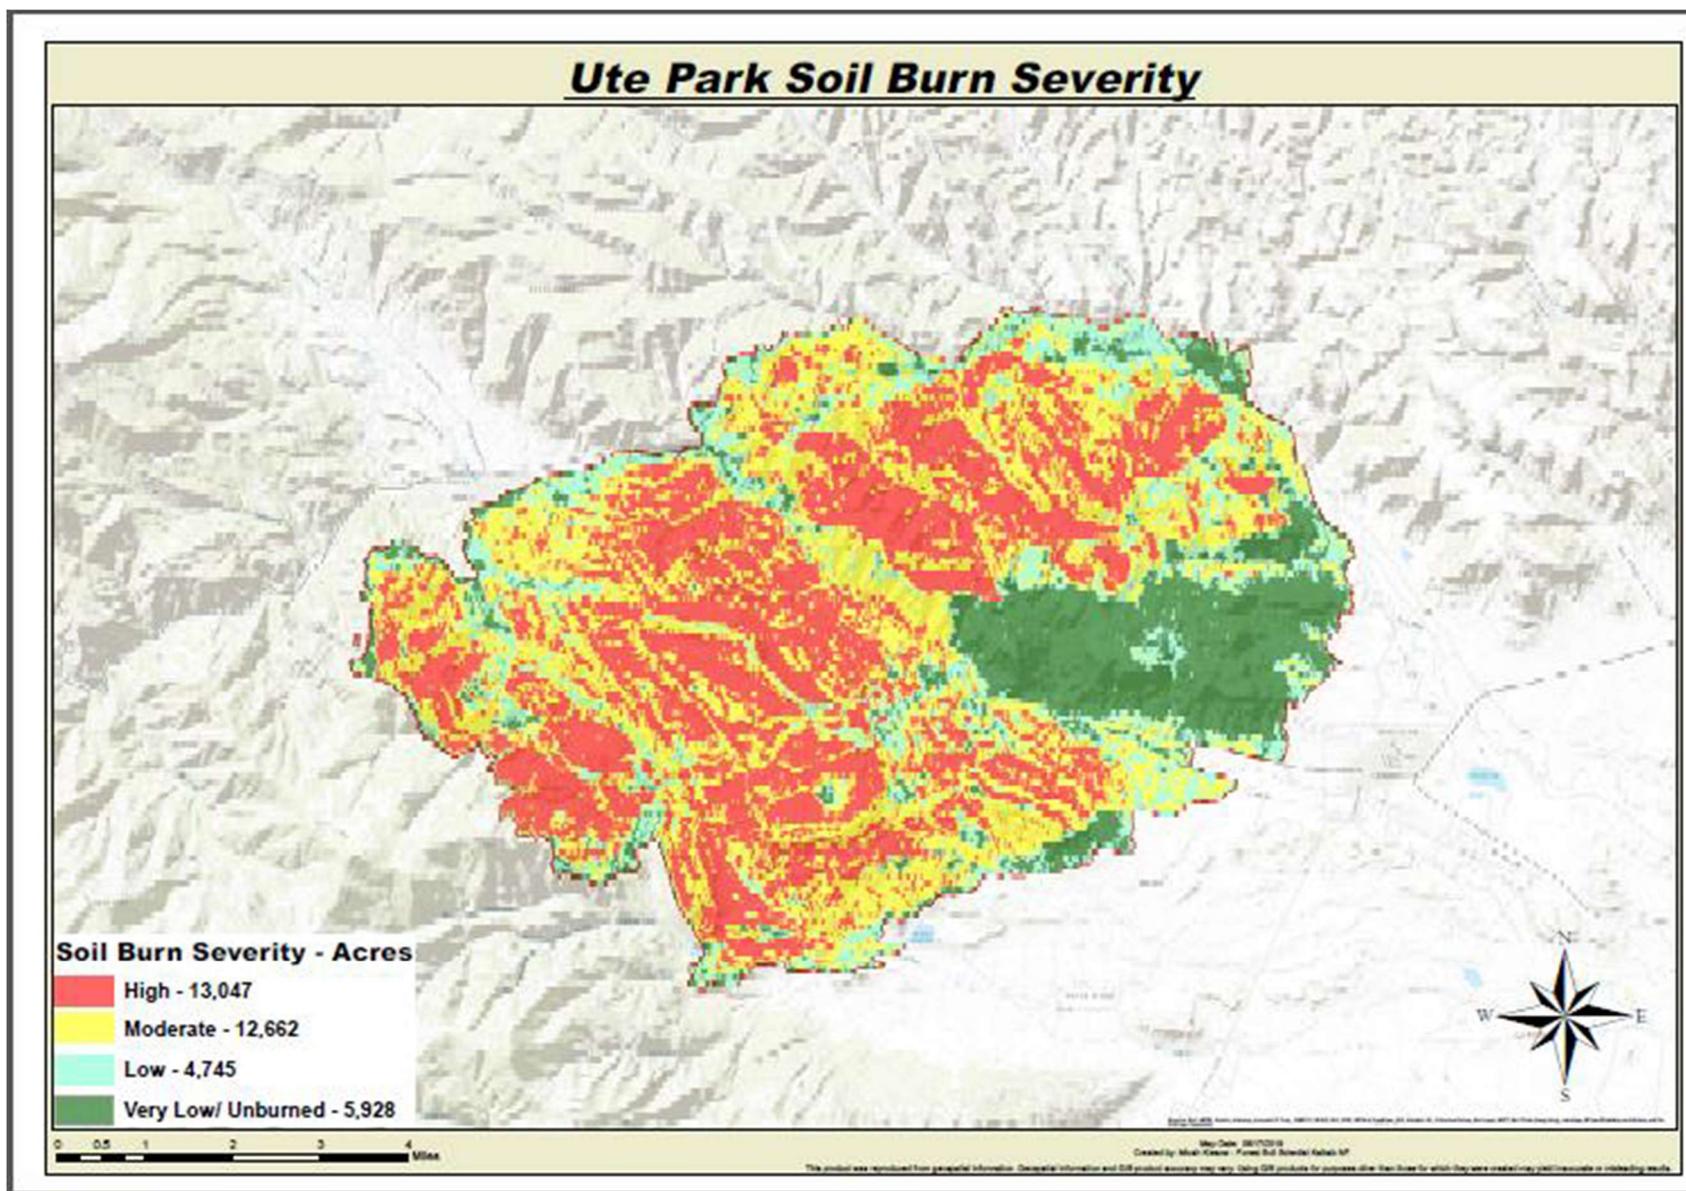
Figure 3.1. Soil burn severity map for the Ute Park Fire. Source: U.S. Forest Service (2018).

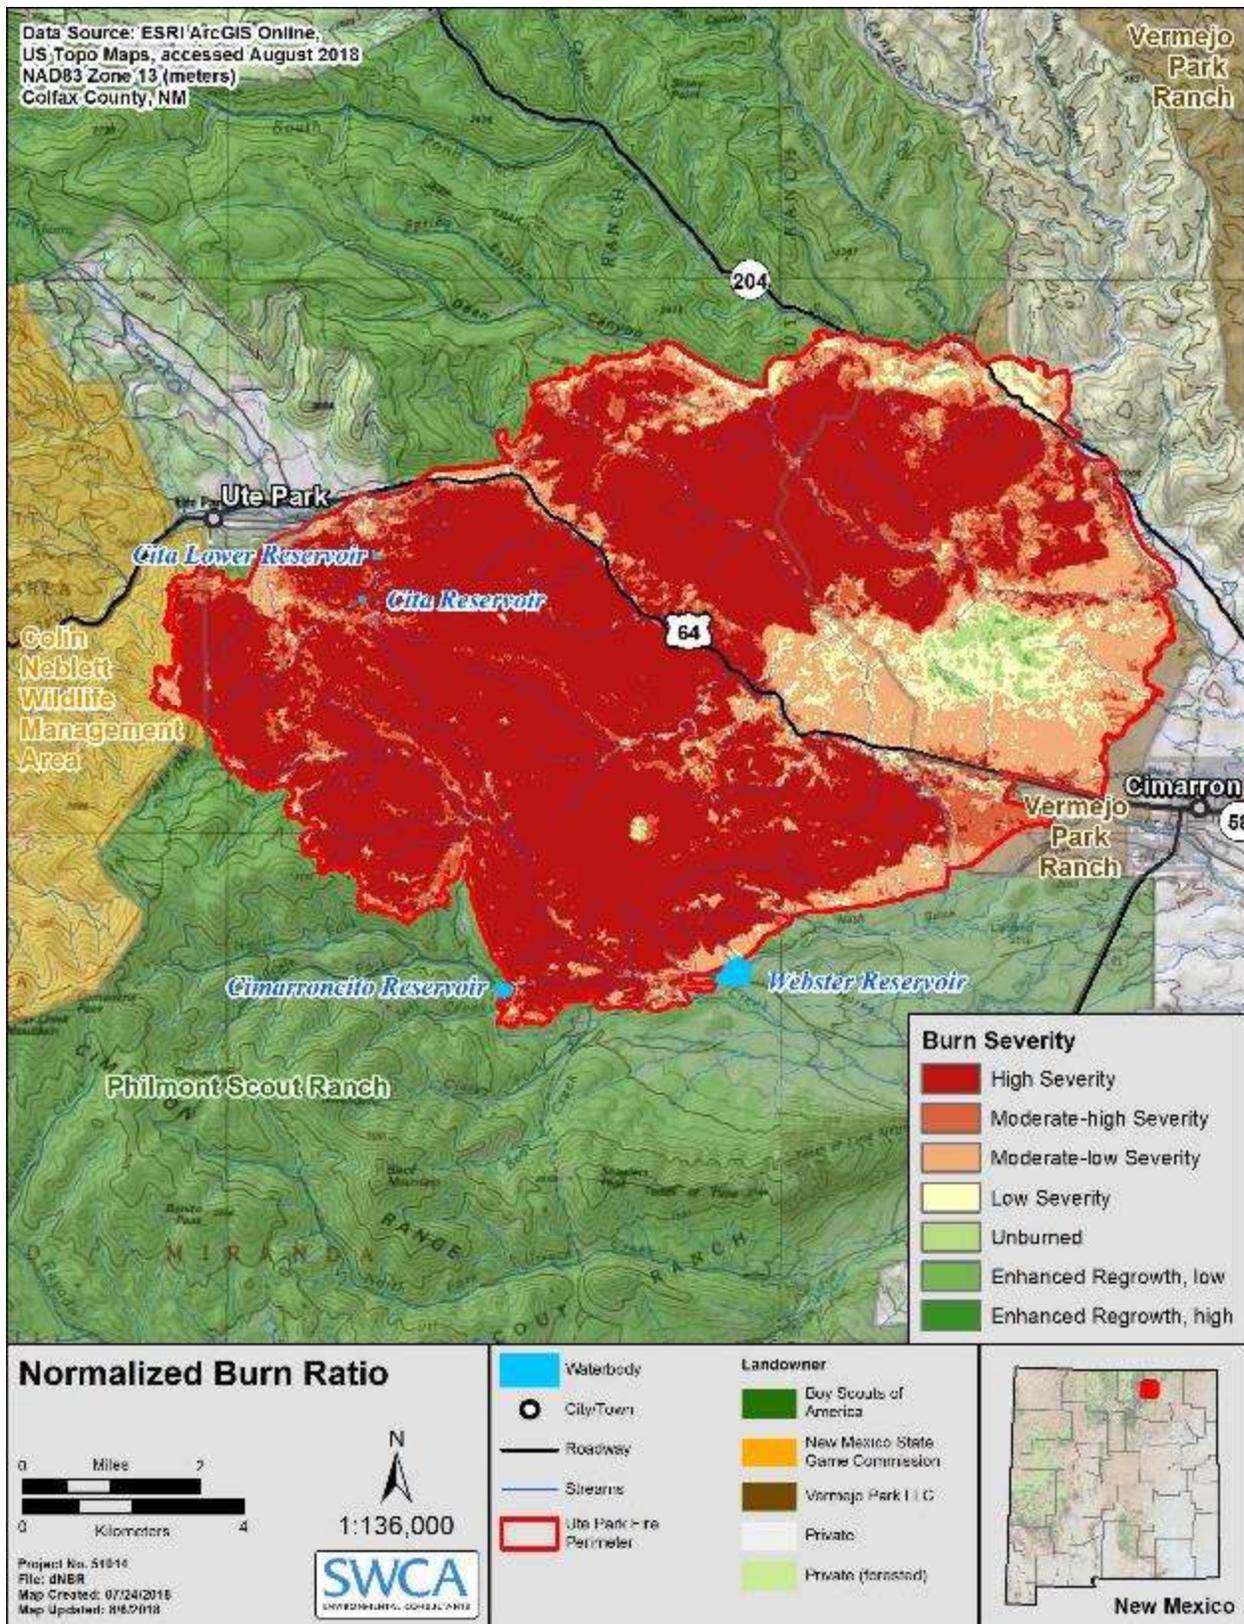
Figure 3.2. dNBR classification for the Ute Park Fire.

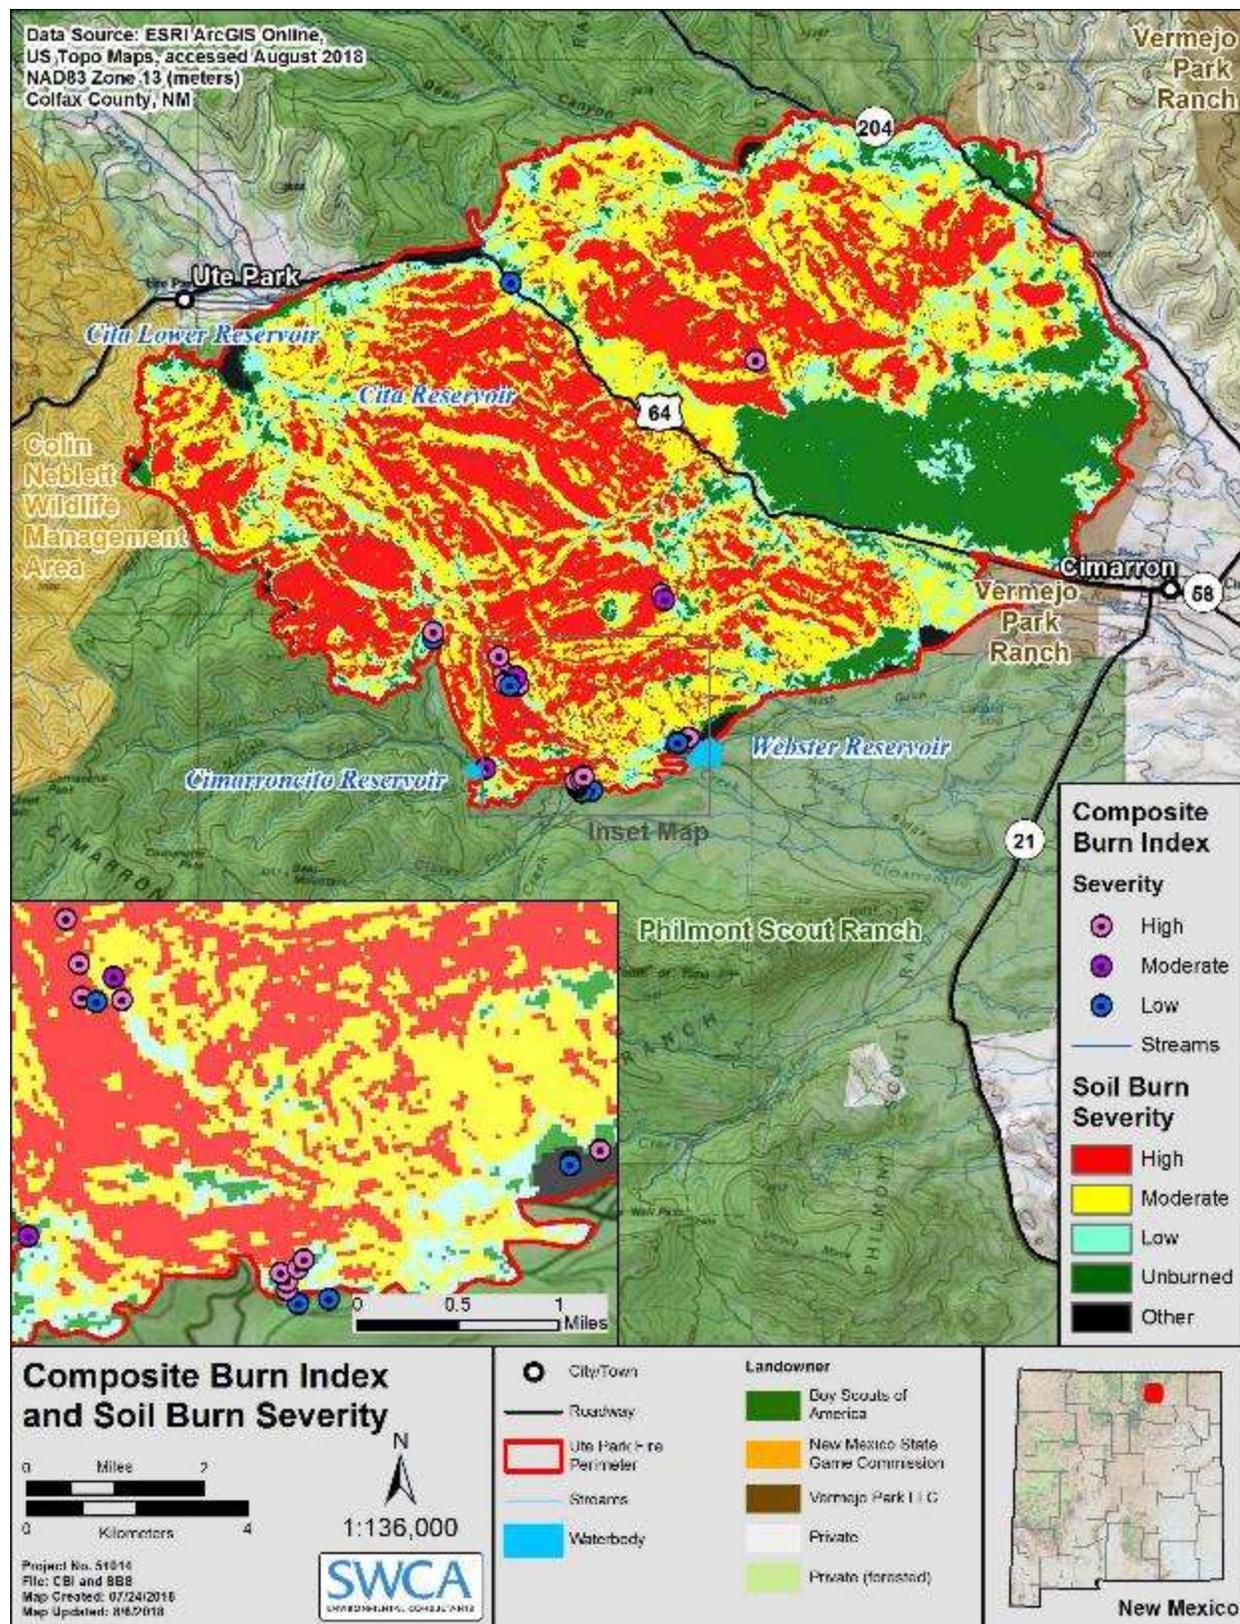
Figure 3.3. CBI scores collected in the field, overlaid on the soil burn severity layer.

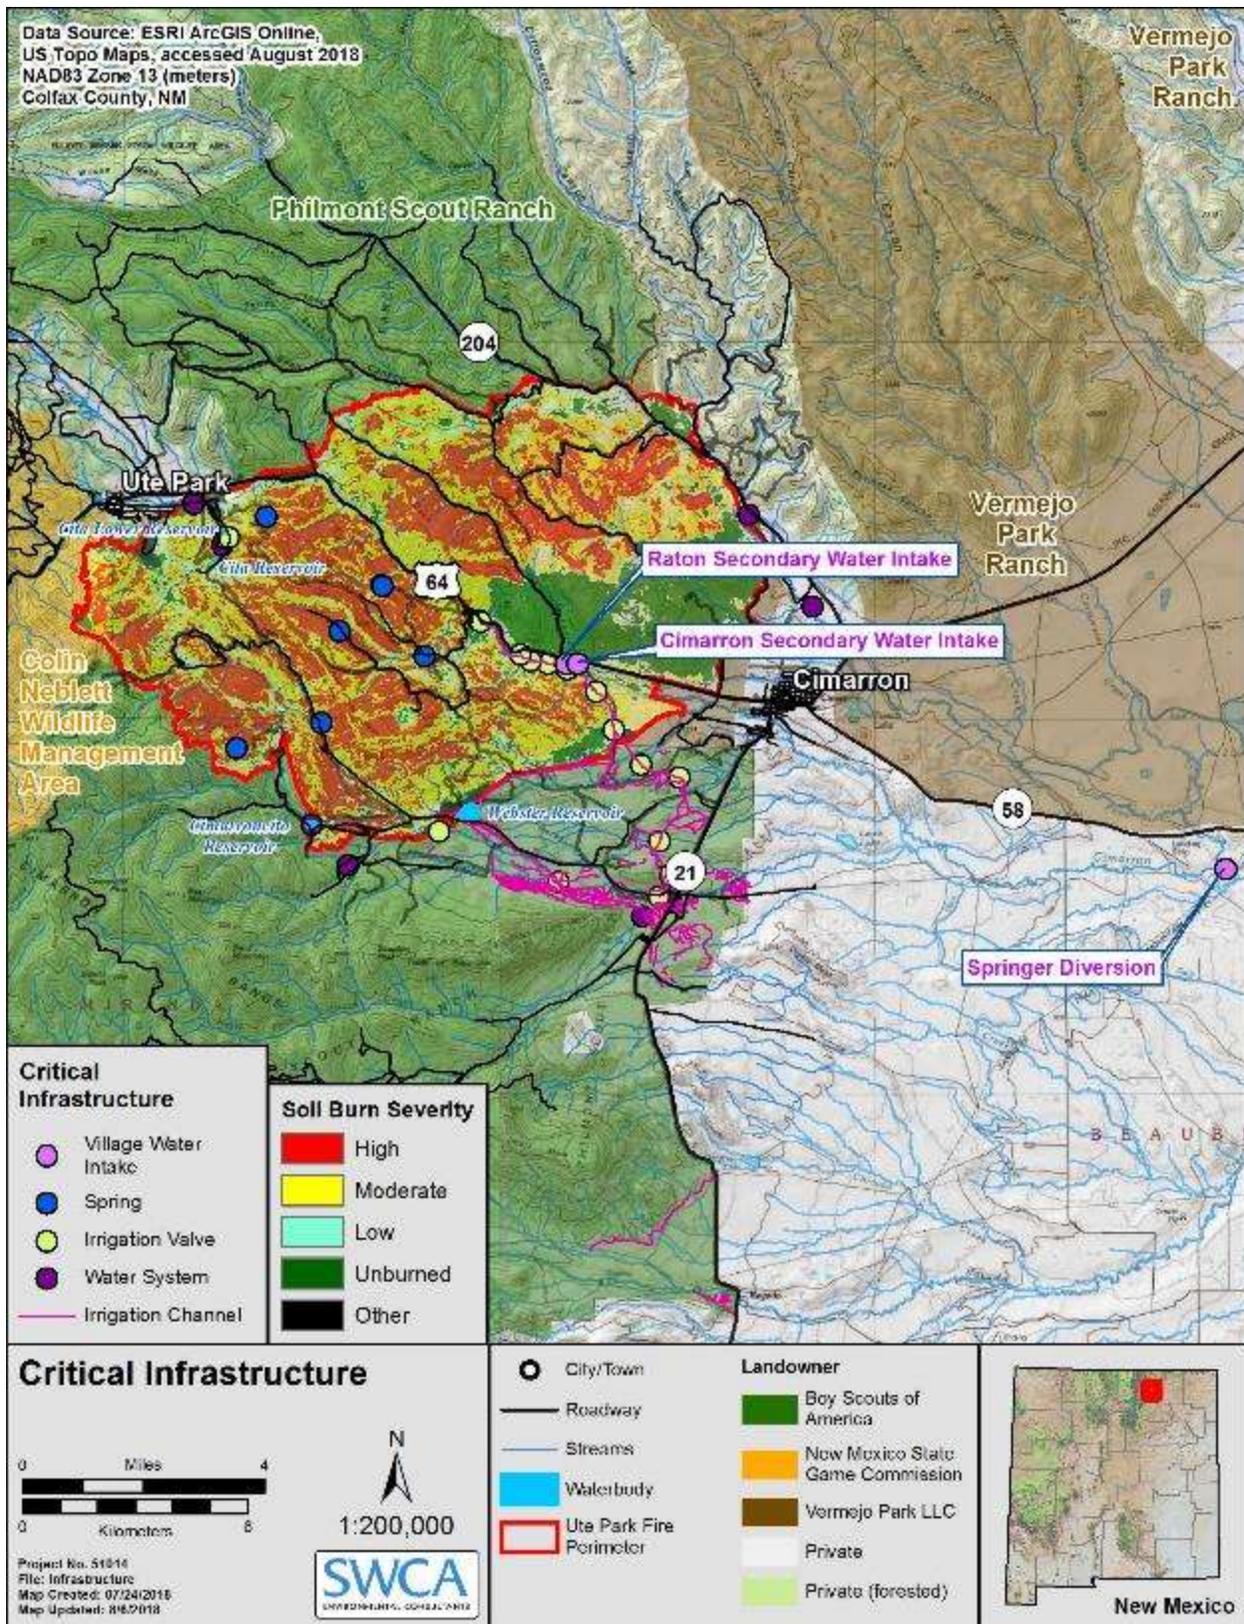
Figure 3.4. Water infrastructure impacted by the Ute Park Fire.

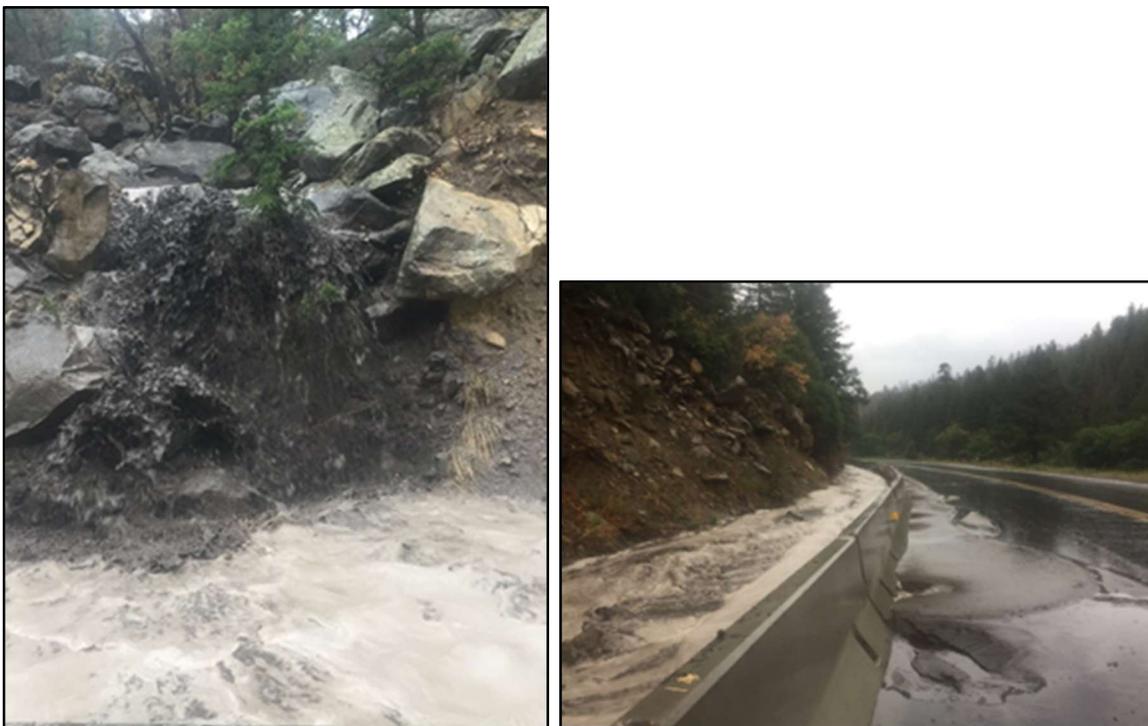
Figures 3.5. Left: view looking upstream at a gully on the east side of U.S. Highway 64. The gully originates at the high burn severity area in Midnight Mesa. Right: view looking downstream of the gully at the flow being routed by concrete wall barriers to a road culvert.

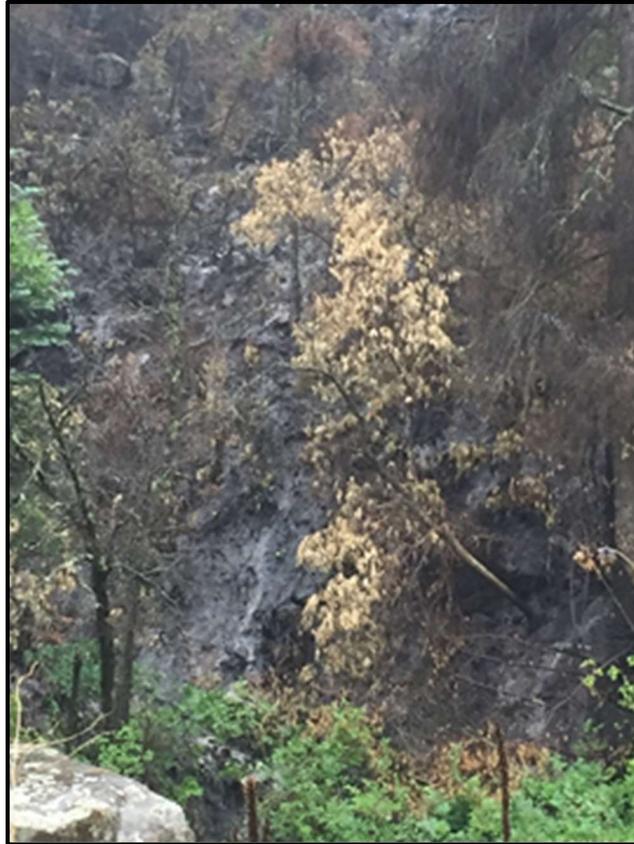
Figure 3.6. Photograph showing a dark curtain of ash sheet flow on a hillside on the west side of Cimarron Creek.

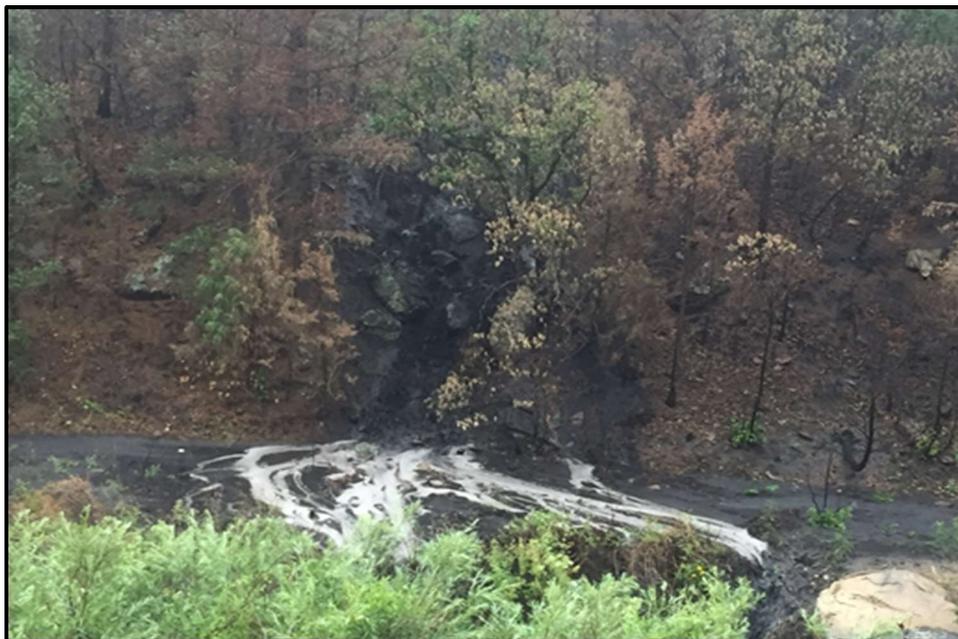
Figure 3.7. Photograph showing a gully on the west side of Cimarron Creek that originates from a high burn severity area on the above bench.

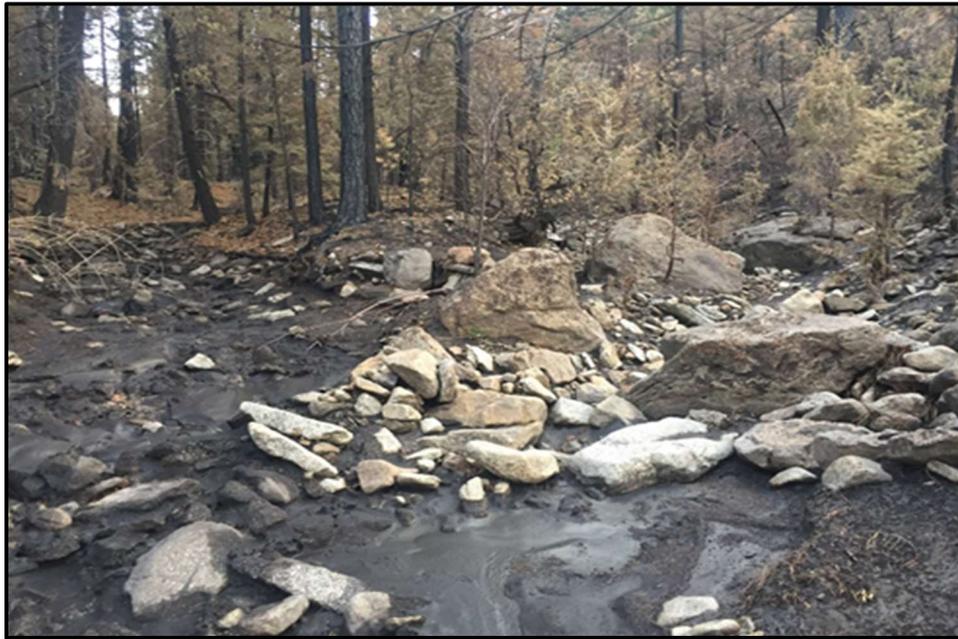
Figure 3.8. Looking upstream towards the confluence with Sawmill Gulch (left) and Ute Gulch (right).

On July 12 and 13, 2018, SWCA surveyed the very evident debris flow lines from this storm and included this data with the cross sectional and longitudinal channel surveys. In the high burn severity areas of Ute Gulch and Sawmill Gulch, significant bulk surface erosion had occurred transporting fine sediment and ash. Active debris flow from hillslope erosion was observed across the valley, with multiple flow lines running along old channel terraces and through the burned forest floor. Figure 3.8 through Figure 3.12 depict the sediment-laden flow and general conditions during our field efforts.
