Ute Park Fire

Damage Assessment and Burned Area Emergency Rehabilitation Plan

SWCA ENVIRONMENTAL CONSULTANTS

AUGUST 2018

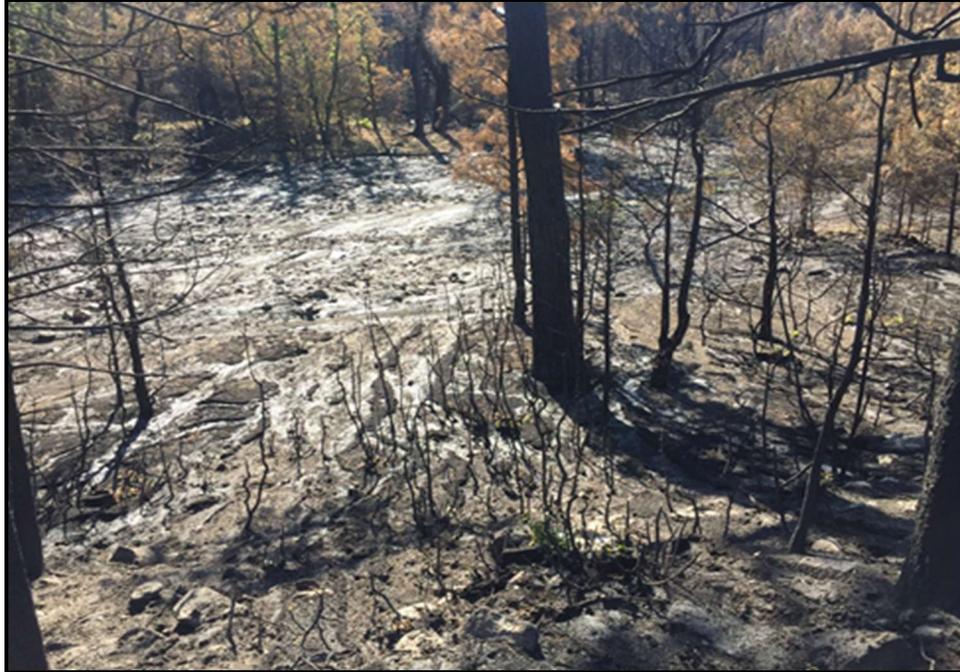
Figure 3.9. Looking at the valley floor on the west flank of Ute Gulch downstream of the confluence with Sawmill Gulch. The photograph shows the multiple flow paths and bulk surface erosion transported from the adjacent high burn severity hillslope.

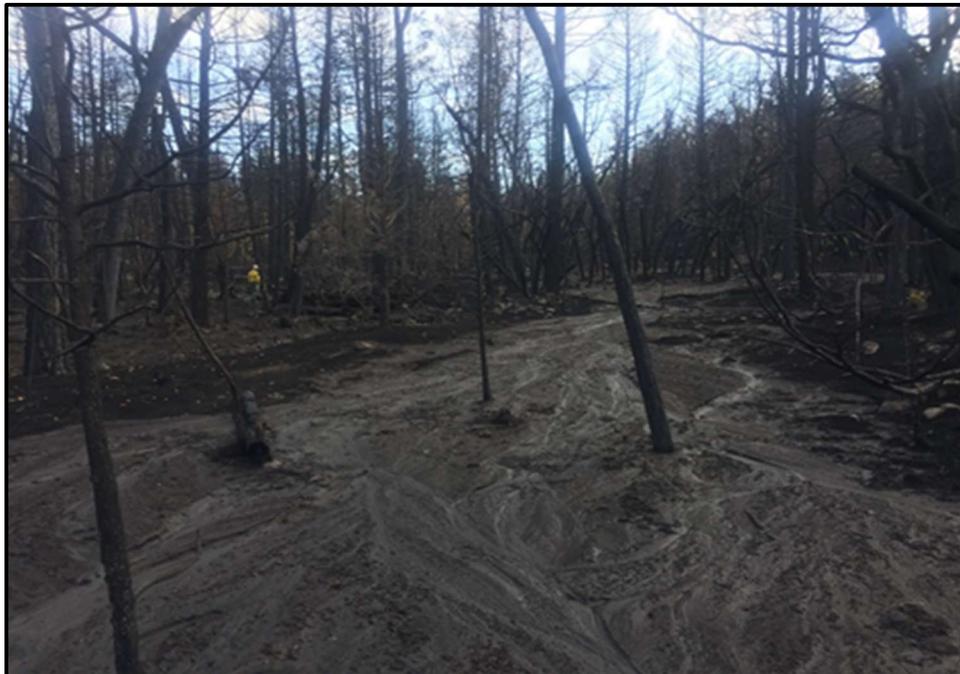
Figure 3.10. Looking at the debris flow across an old Ute Gulch terrace adjacent to the east flank of the valley just upstream of the confluence with Sawmill Gulch. Note that the worker in the yellow shirt is standing over the mainstem of Ute Gulch.

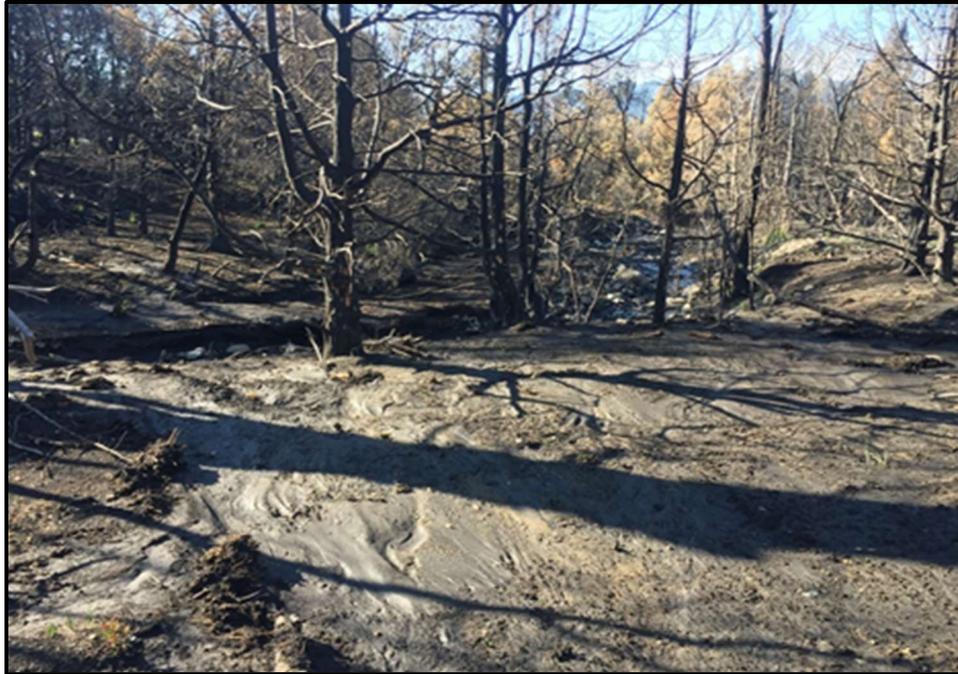
Figure 3.11. Another example of the debris from hillslope runoff transporting across the forest floor. The photograph was taken at a historic terrace bench on the west flank of the valley looking at the Ute Gulch channel.

On July 12 and 13, 2018, SWCA surveyed the very evident debris flow lines from this storm and included this data with the cross sectional and longitudinal channel surveys. In the high burn severity areas of Ute Gulch and Sawmill Gulch, significant bulk surface erosion had occurred transporting fine sediment and ash. Active debris flow from hillslope erosion was observed across the valley, with multiple flow lines running along old channel terraces and through the burned forest floor. Figure 3.8 through Figure 3.12 depict the sediment-laden flow and general conditions during our field efforts.

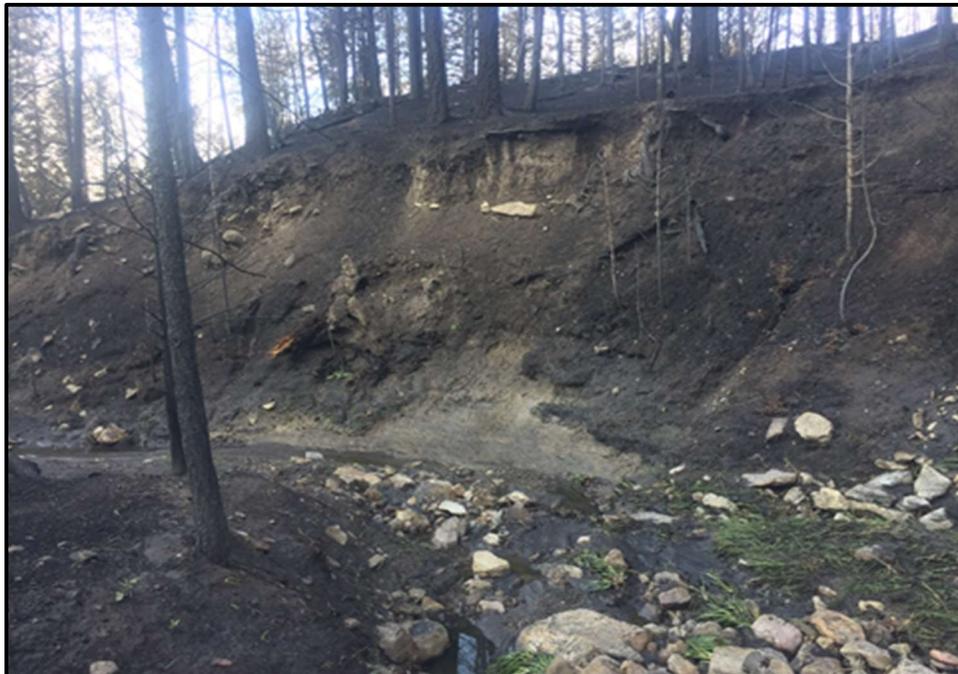
Figure 3.12. An evident flow line within the Ute Gulch channel located near Ute Springs camp caused from the 0.5-inch rain event that occurred the during field survey efforts.

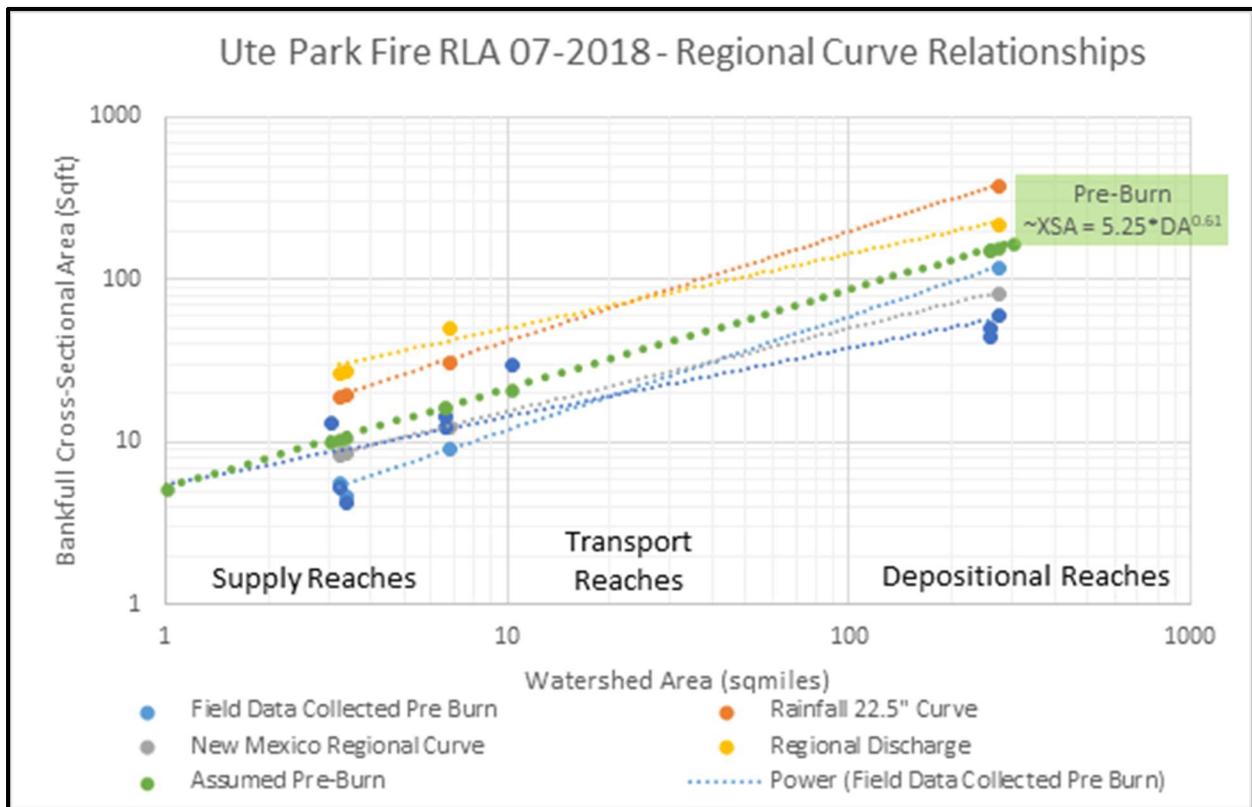
Figure 3.13. Ute Park Fire regional curve relating drainage area with bankfull cross-sectional area.

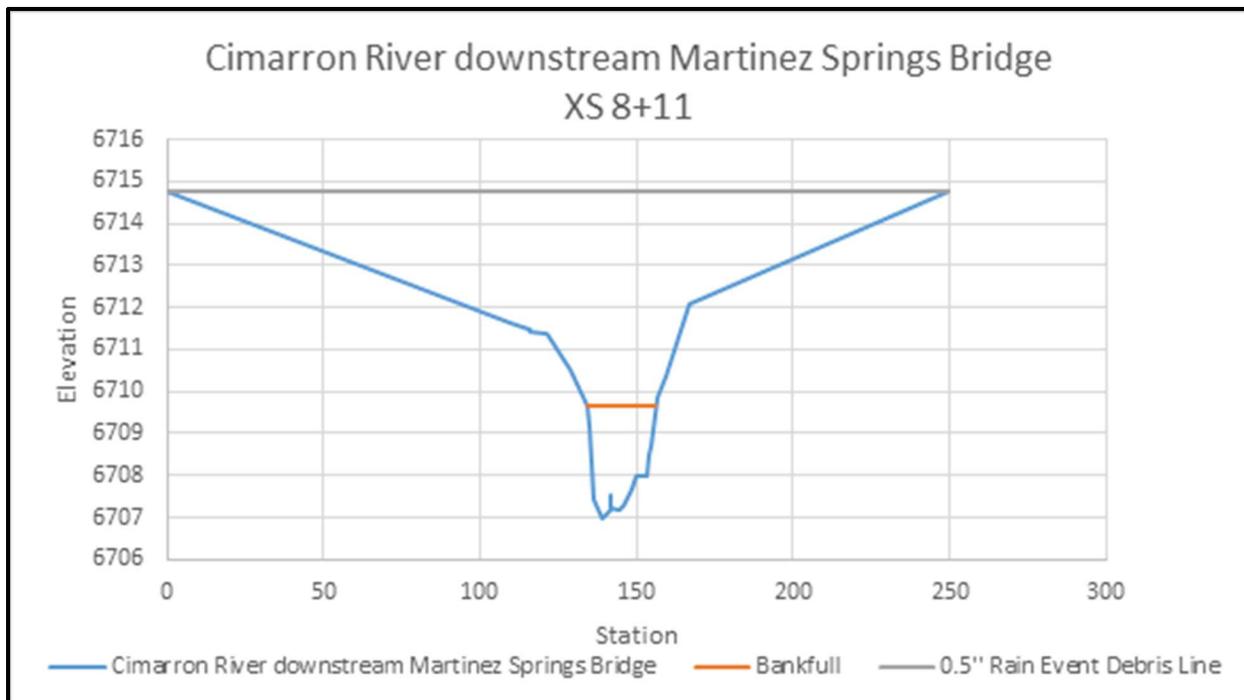
Figure 3.14. Shows a cross-section of the Cimarron River downstream of the Deer Lake alluvial fan and the burned Martinez Springs Bridge.

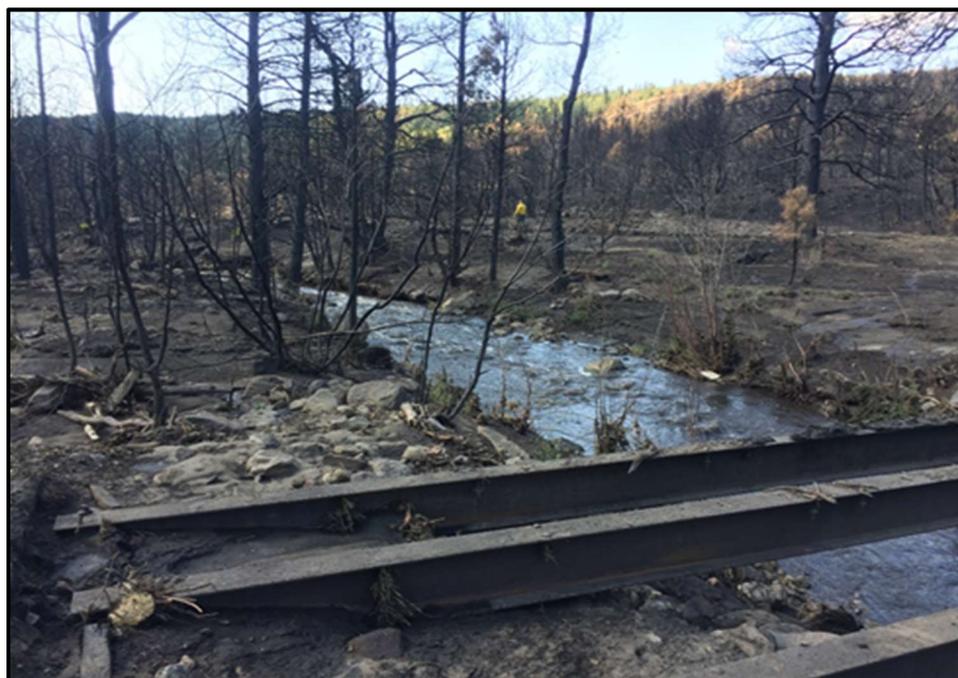
Figure 3.15. View looking south from the burned Martinez Springs bridge at the Cimarron River and the XS 8+11. Note the dark debris from the Cimarron River flows that spread across the floodplain during the July 12, 2018, event.

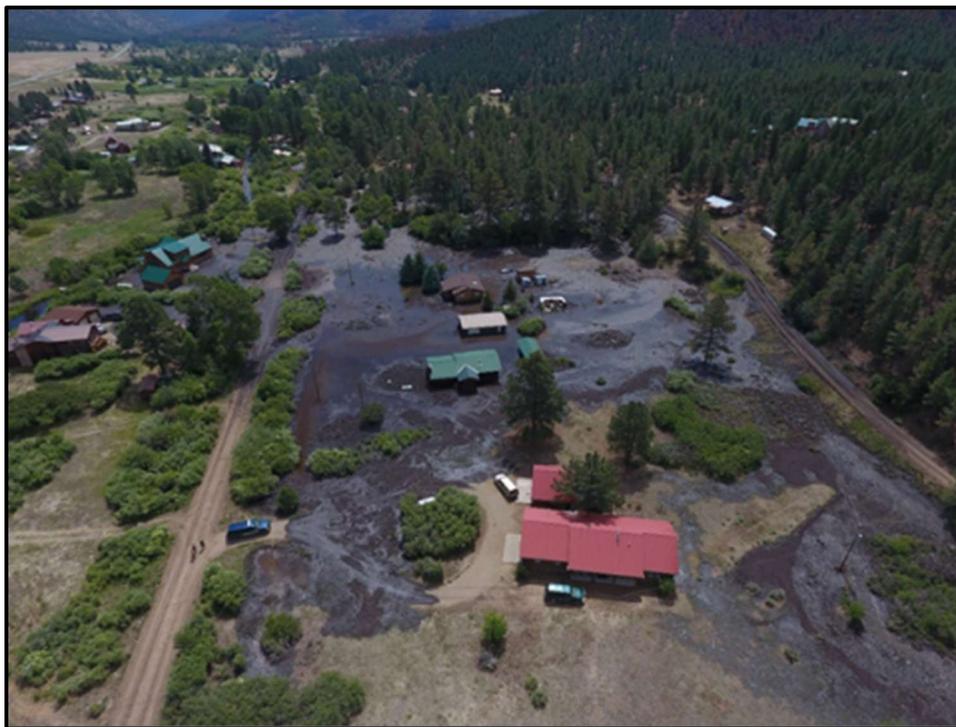
Figure 3.16. Aerial view of Ute Park area showing a post-flood debris flow after 0.3 inch of rain on July 13, 2018.

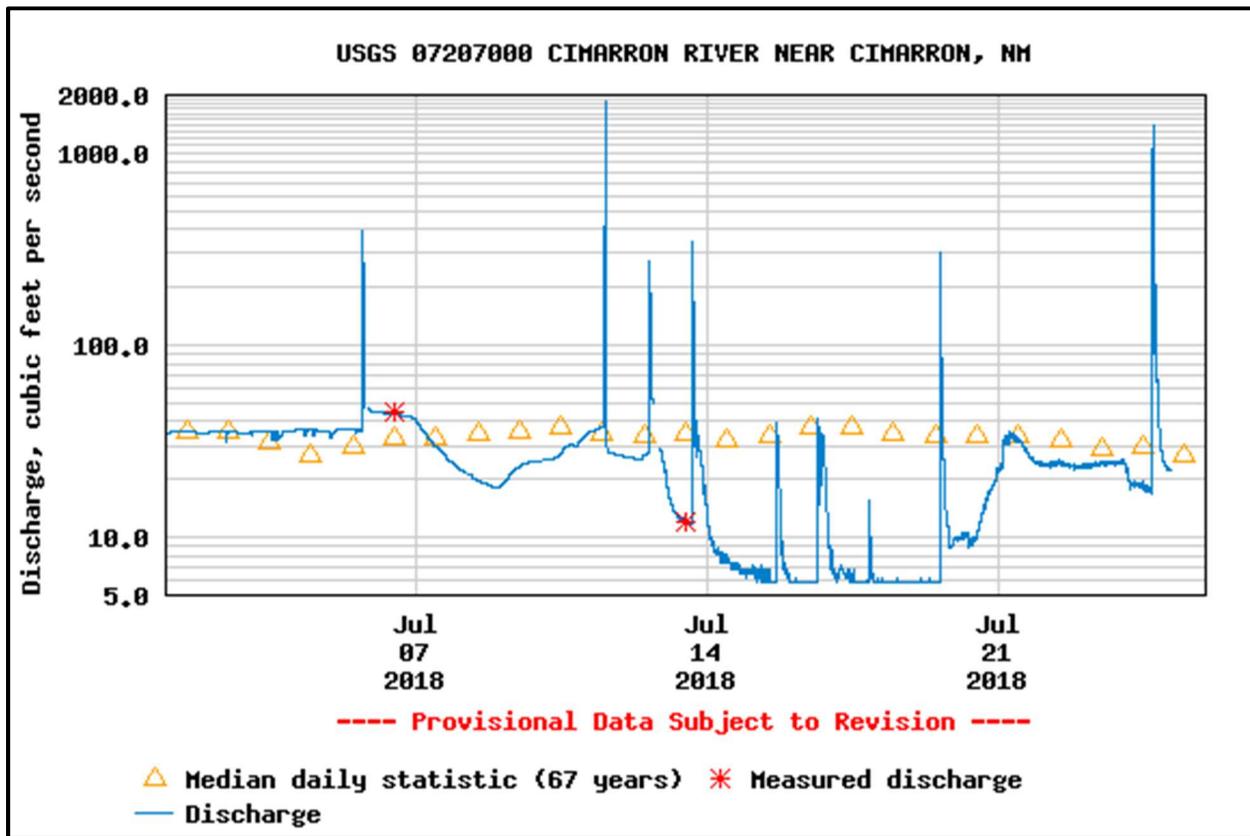
Figure 3.17. Instantaneous peak flow discharges that exceeded the pre-fire bankfull discharge six times during the month of July.

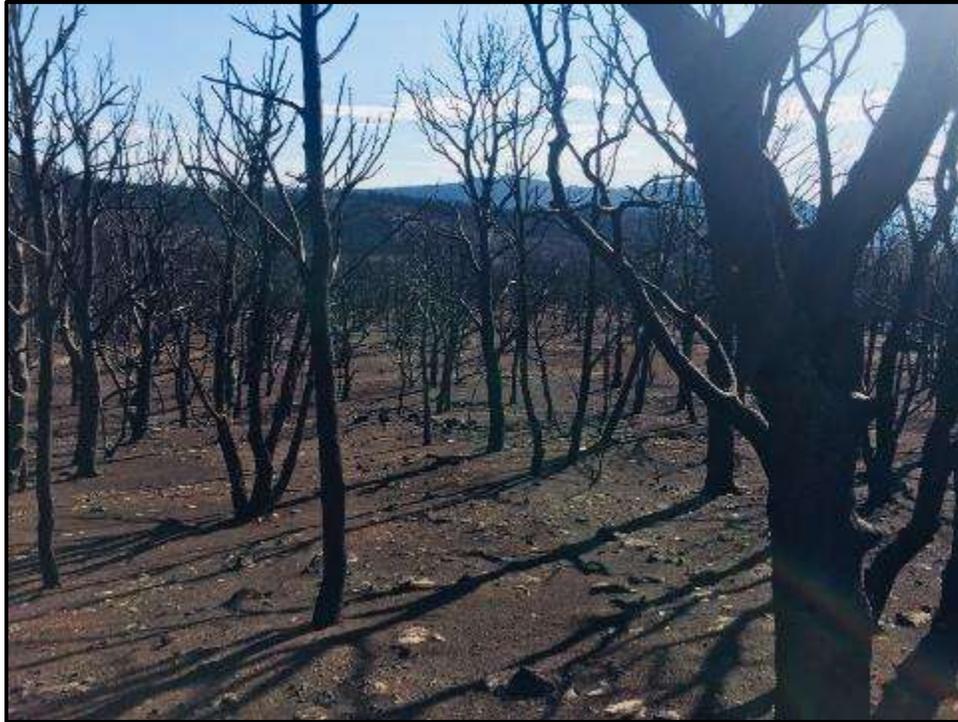
Figure 3.18. An example of the high burn severity forest floor.

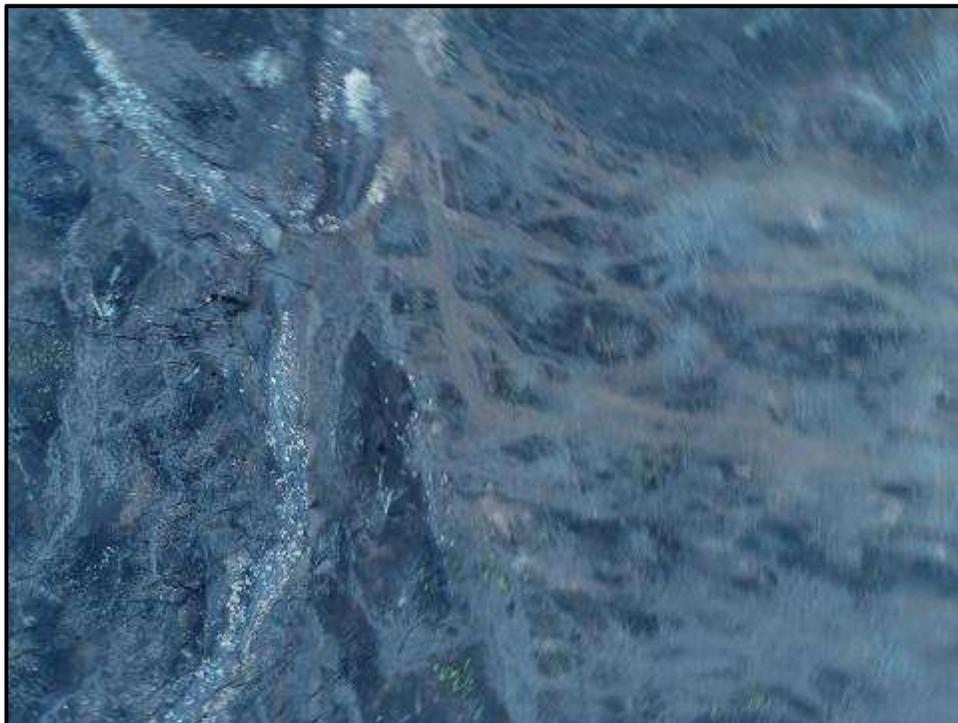
Figure 3.19. Aerial view of the hillslope sediment producing multiple debris flow paths transporting across the burn forest floor to the Ute Gulch channel. This aerial photograph was taken after the first significant precipitation event to occur post-fire.

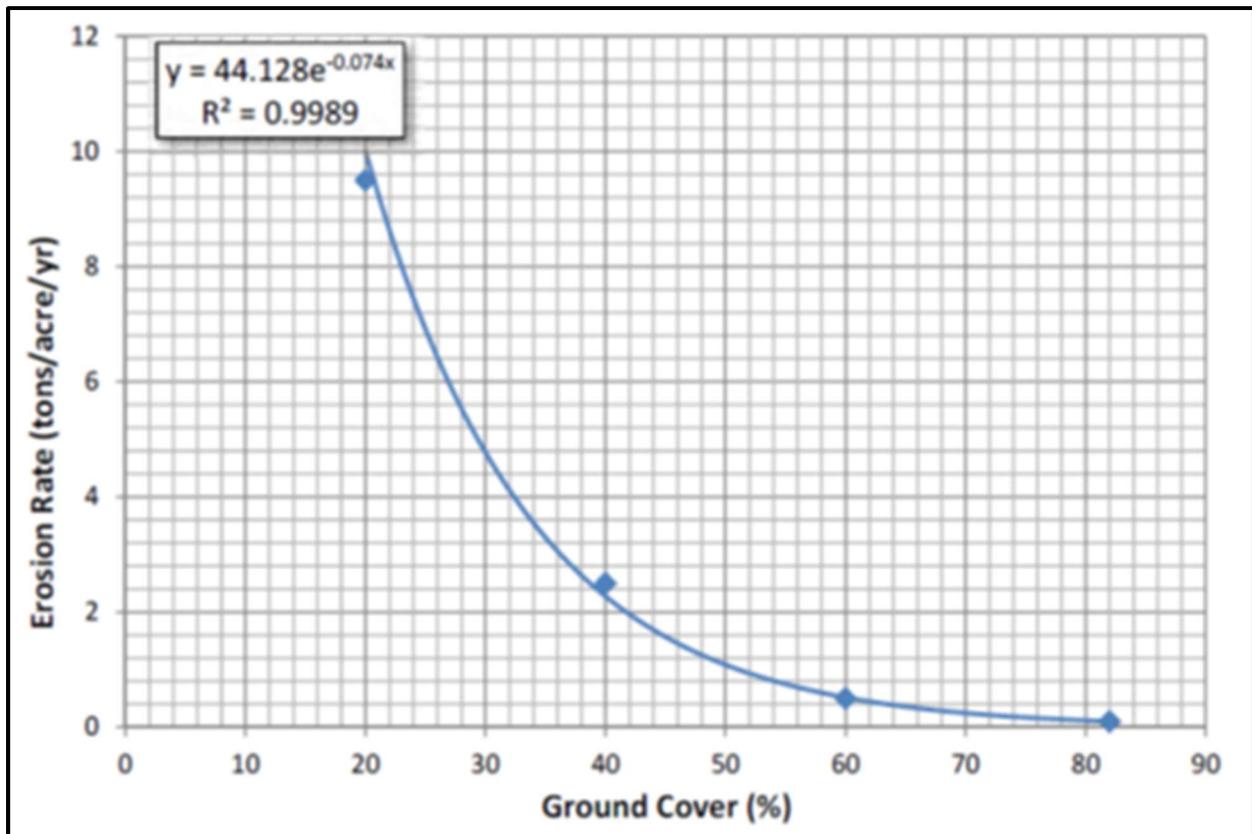
Figure 3.20. Surface Erosion sediment yields by ground cover density 20-40% slopes, as derived by Wildland Hydrology from Robichaud et al. (2009).

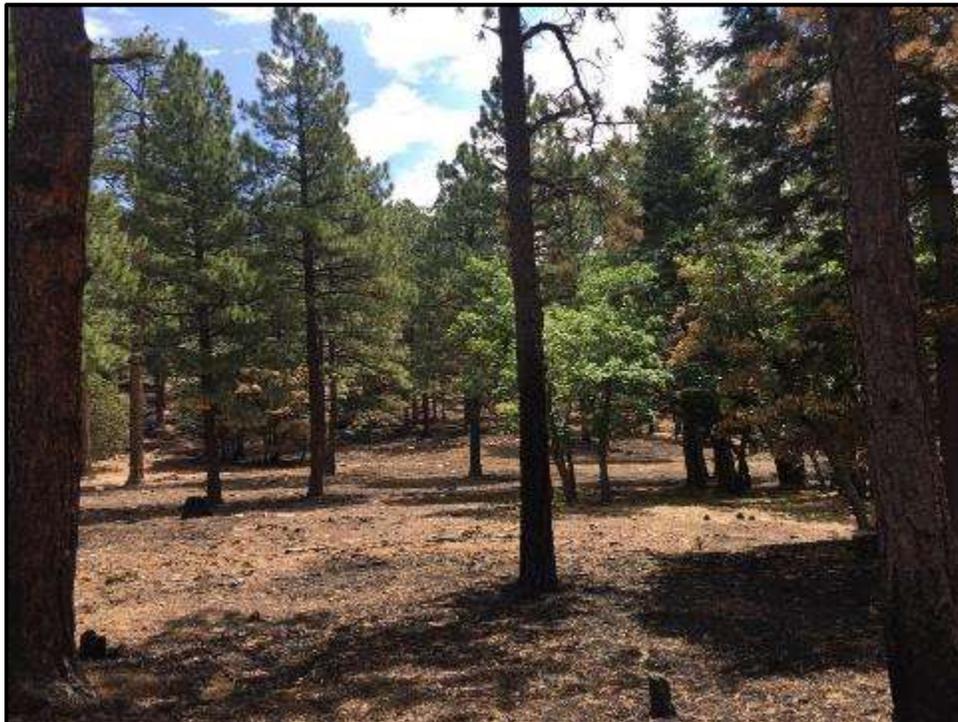
Figure 3.21. Typical structure of the forested vegetation that was common before the fire.

Eighteen scenarios were chosen based on the most prevalent soil type, burn severity, and hillslope characteristics. All vegetation type was modeled as forest (Figure 3.21). Soil Type was based on the Unified Soil Classification.

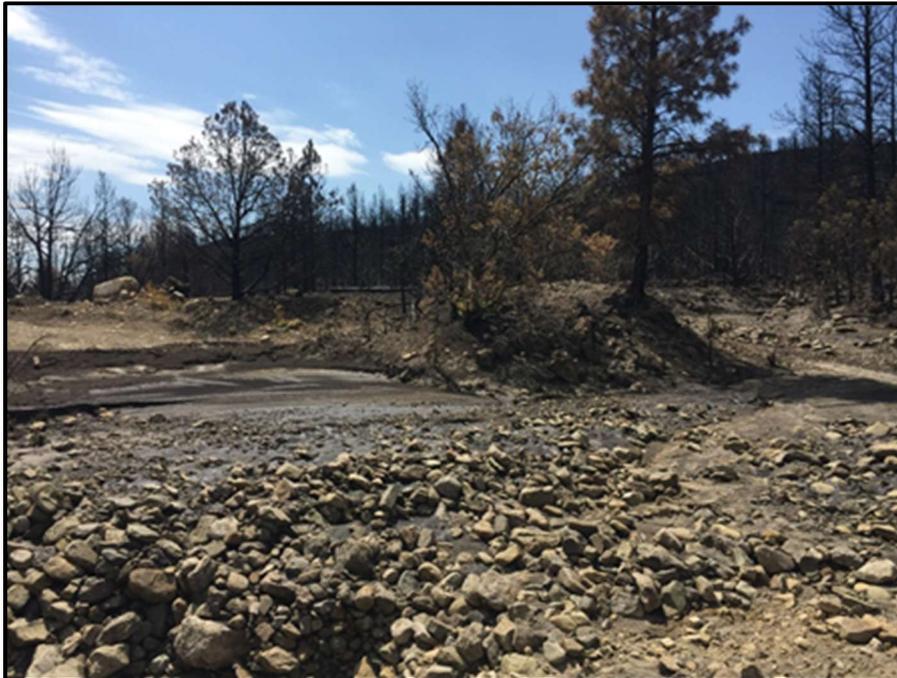
Figure 3.22. Photograph looking up at the Deer Lake Mesa gully and alluvial fan.

The stable stream types for actively building, alluvial fans are the braided, D3–D5 stream types. The braided channel types disperse flow by convergence/divergence bed feature processes and induce sediment deposition over the width and length of the fan (Figure 3.22 and Figure 3.23).

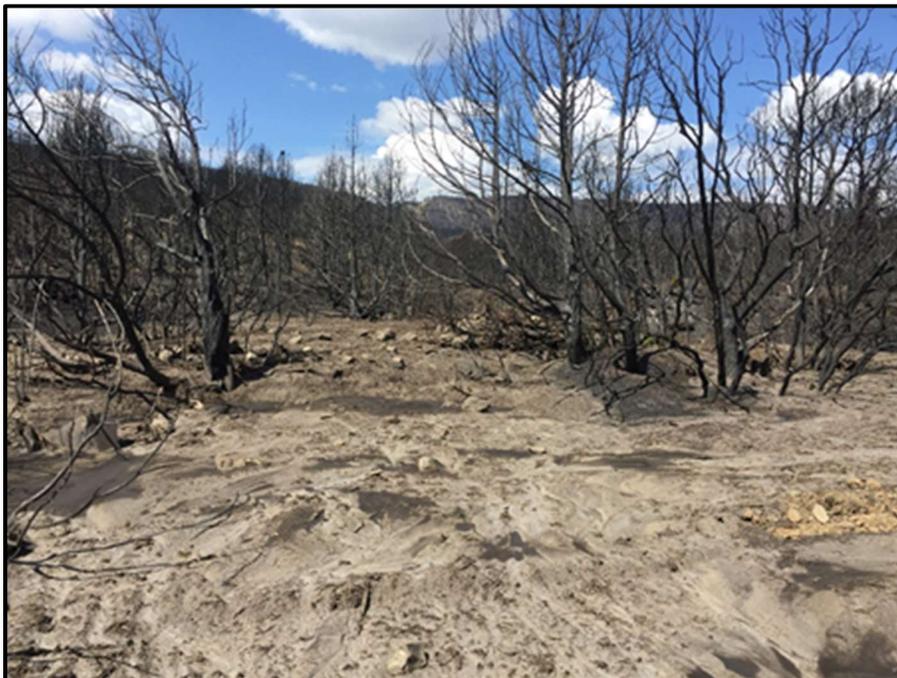
Figure 3.23. Photograph looking west across the delta of the Deer Lake Mesa alluvial fan.

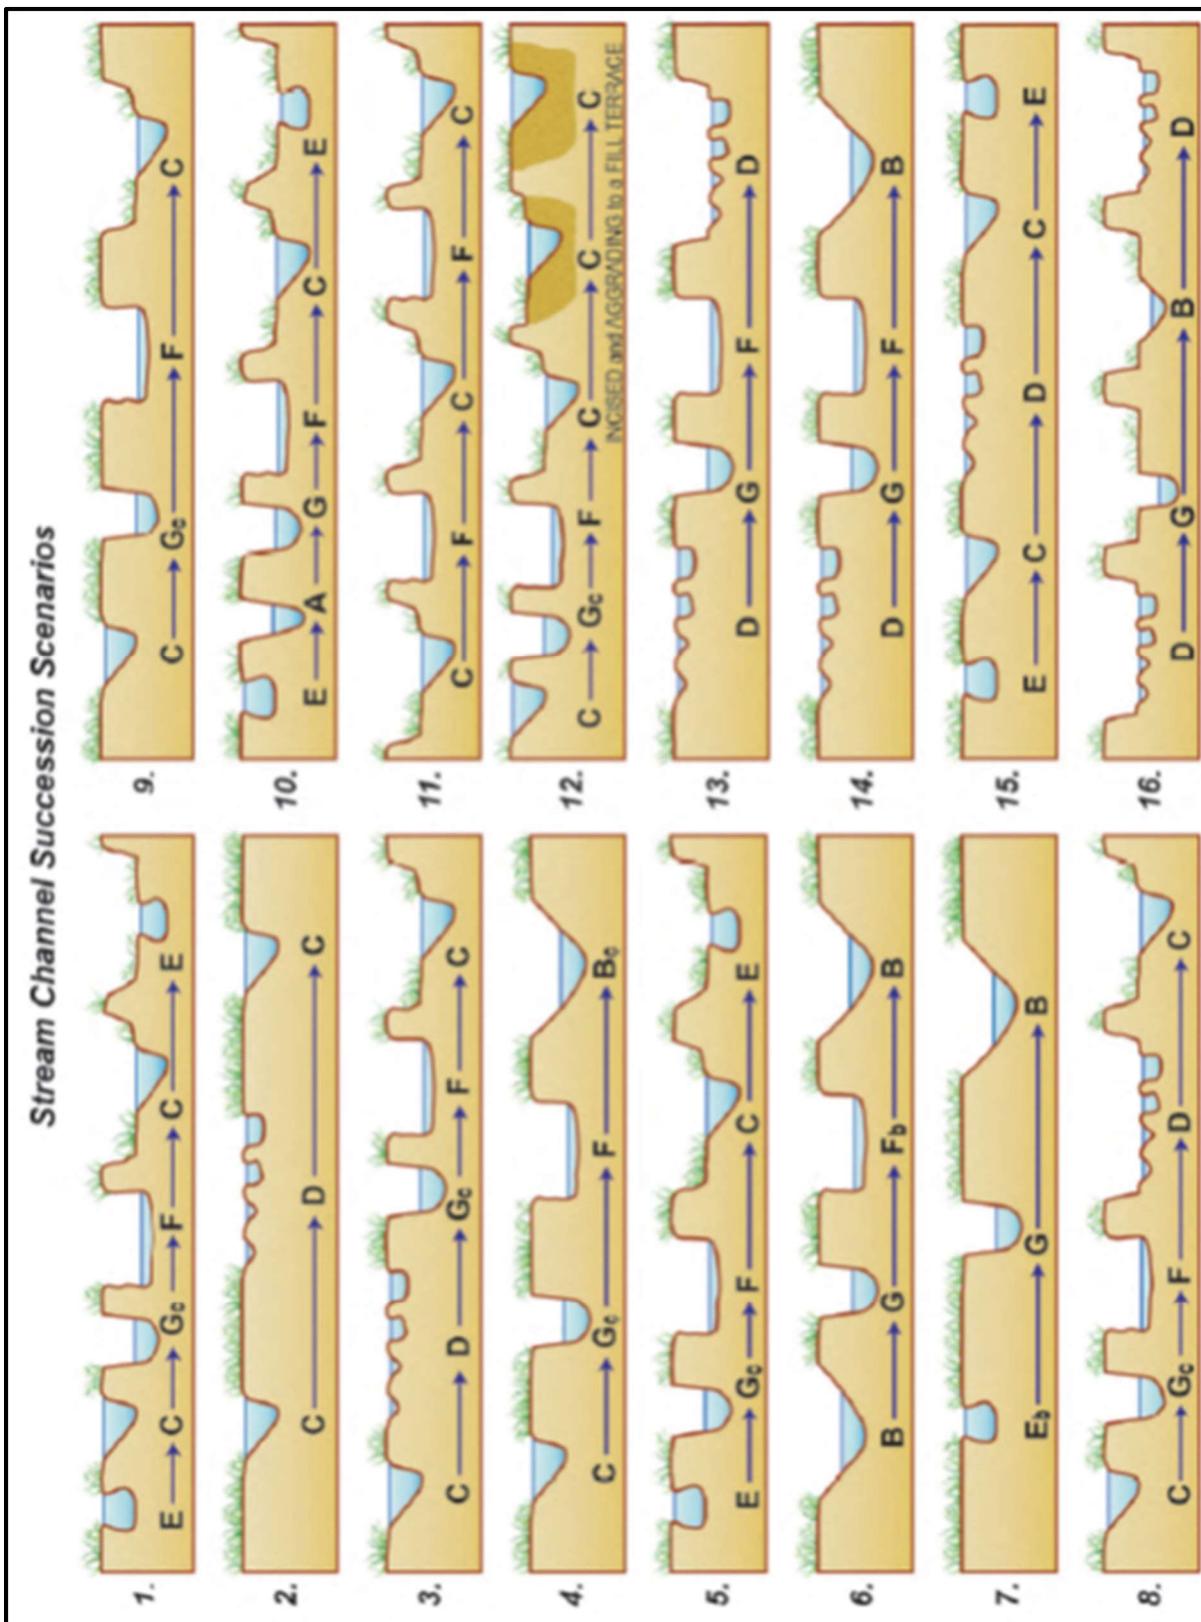
Figure 3.24. Various stream succession scenarios and corresponding stages of adjustment (Rosgen 2006, 2009).

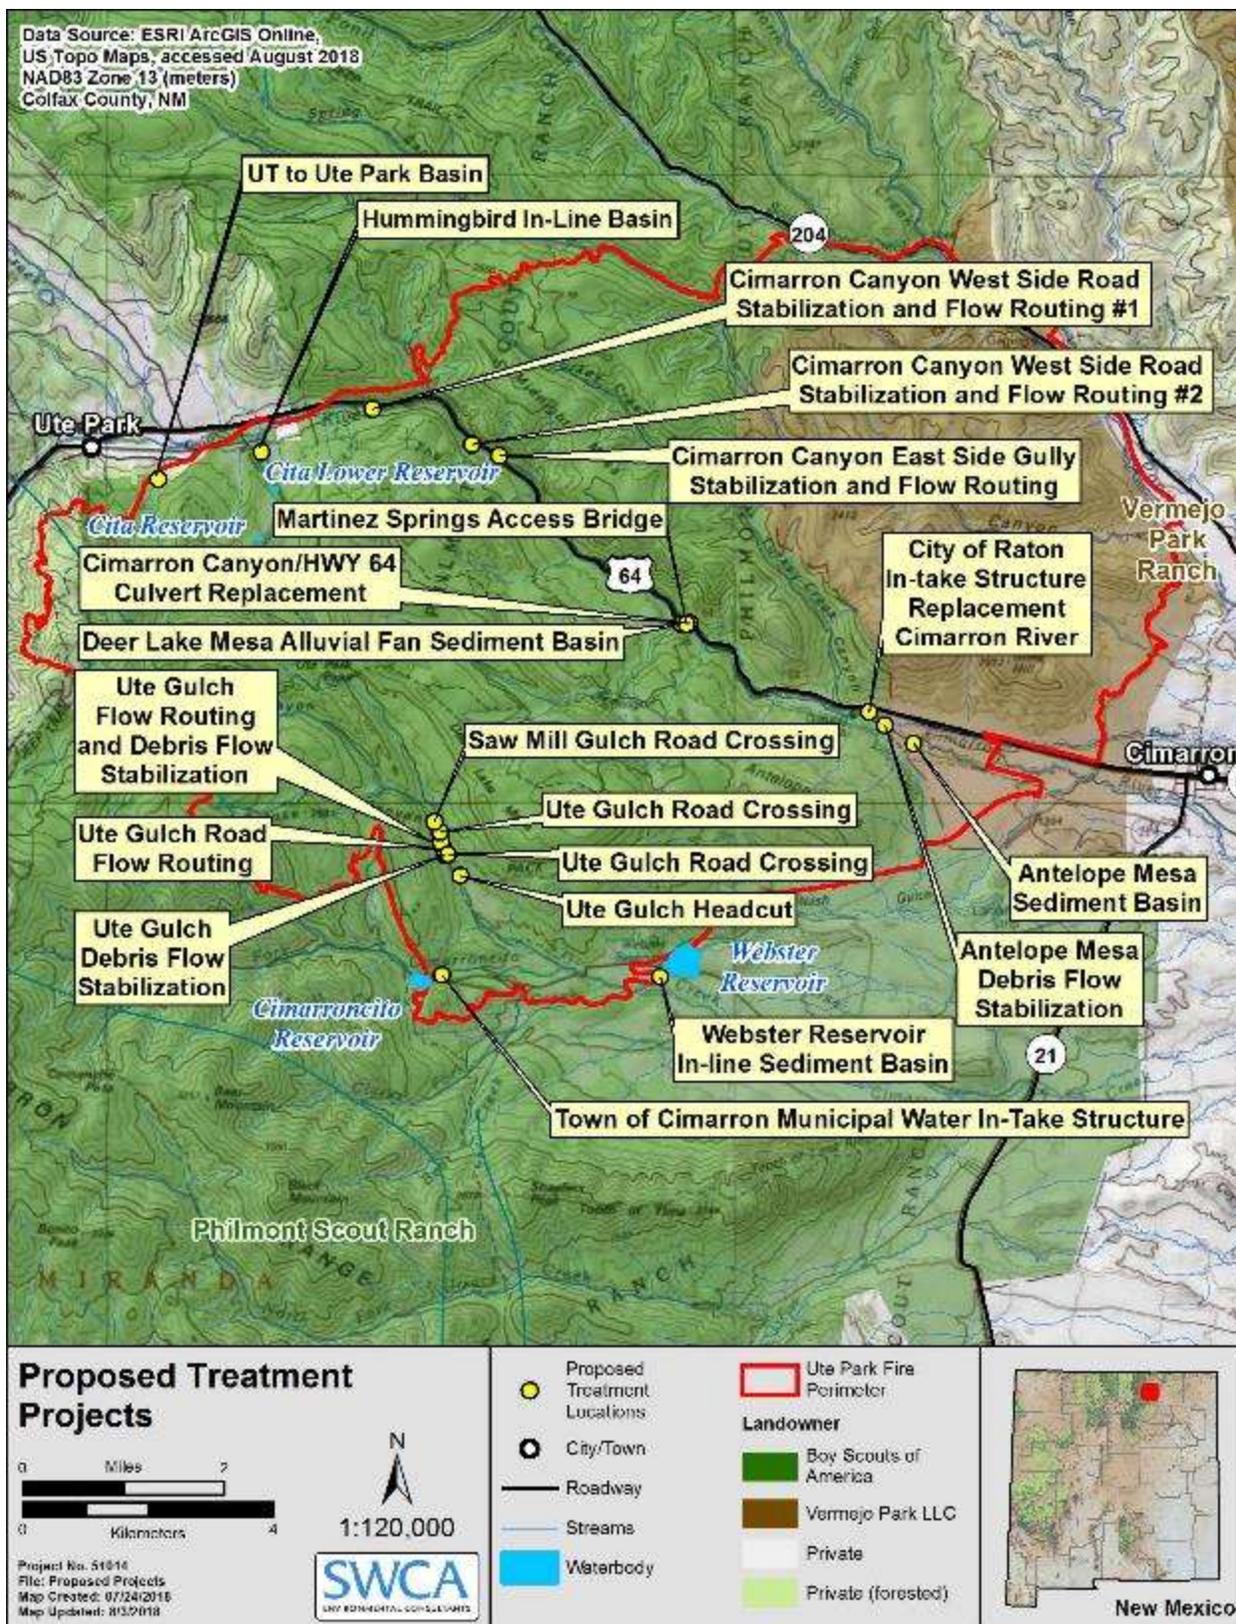
Figure 3.25. Approximate locations for the reconnaissance-level treatment opportunities proposed.

Figure 3.25 below shows the approximate locations for the reconnaissance-level treatment opportunities that are described in Table 1.5.

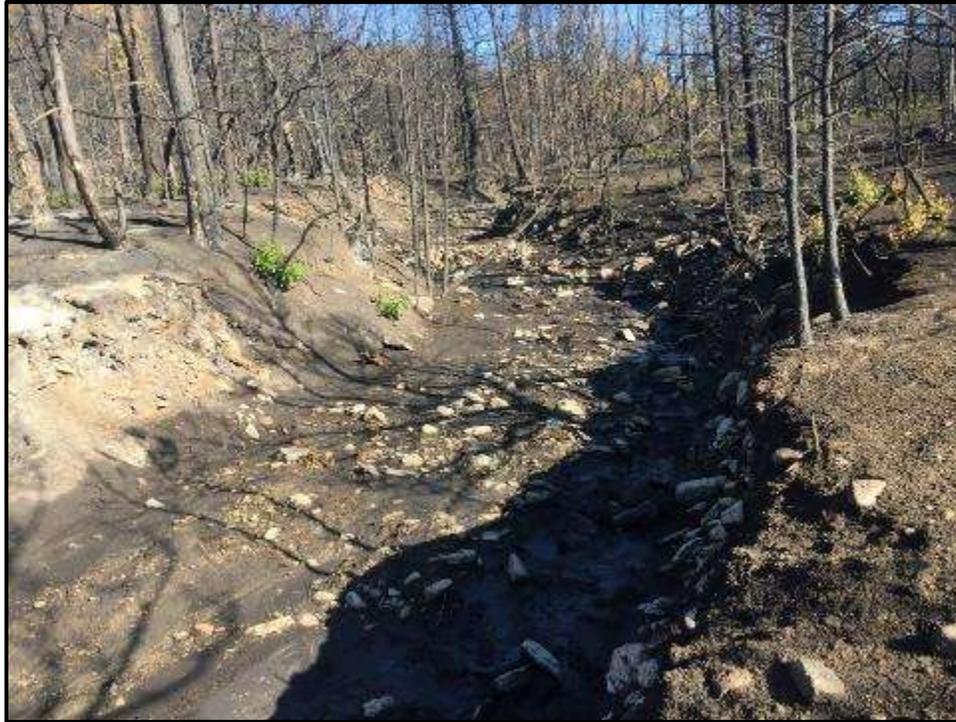
Figure 3.26. Ute Gulch intermittent channel near the recommended in-line sediment basin location.

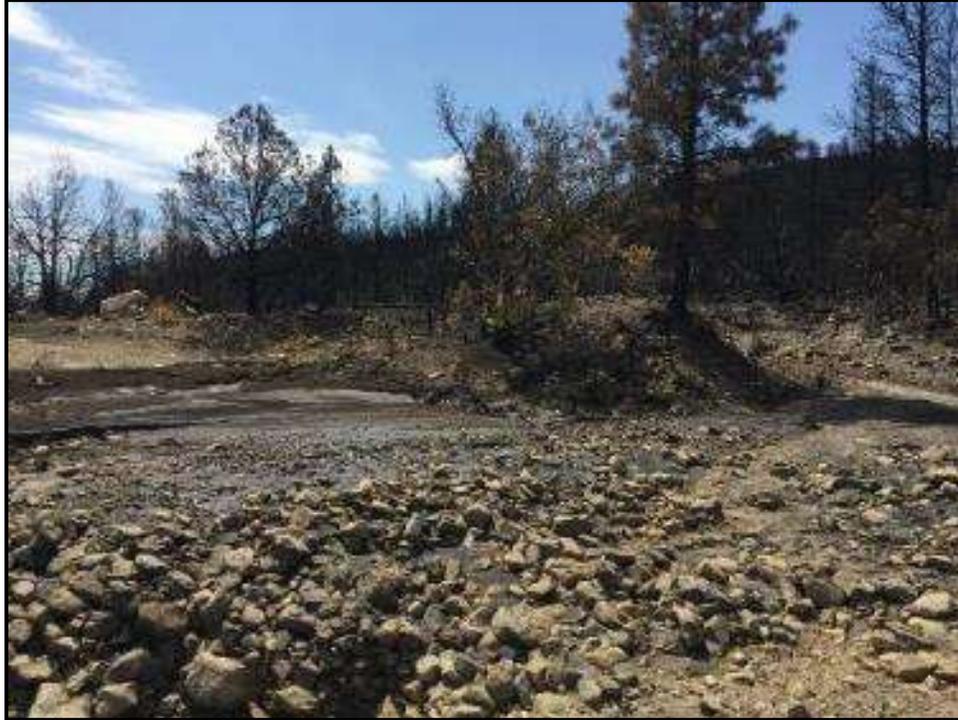
Figure 3.27. View looking west towards historic alluvial fan delta and the new delta forming.

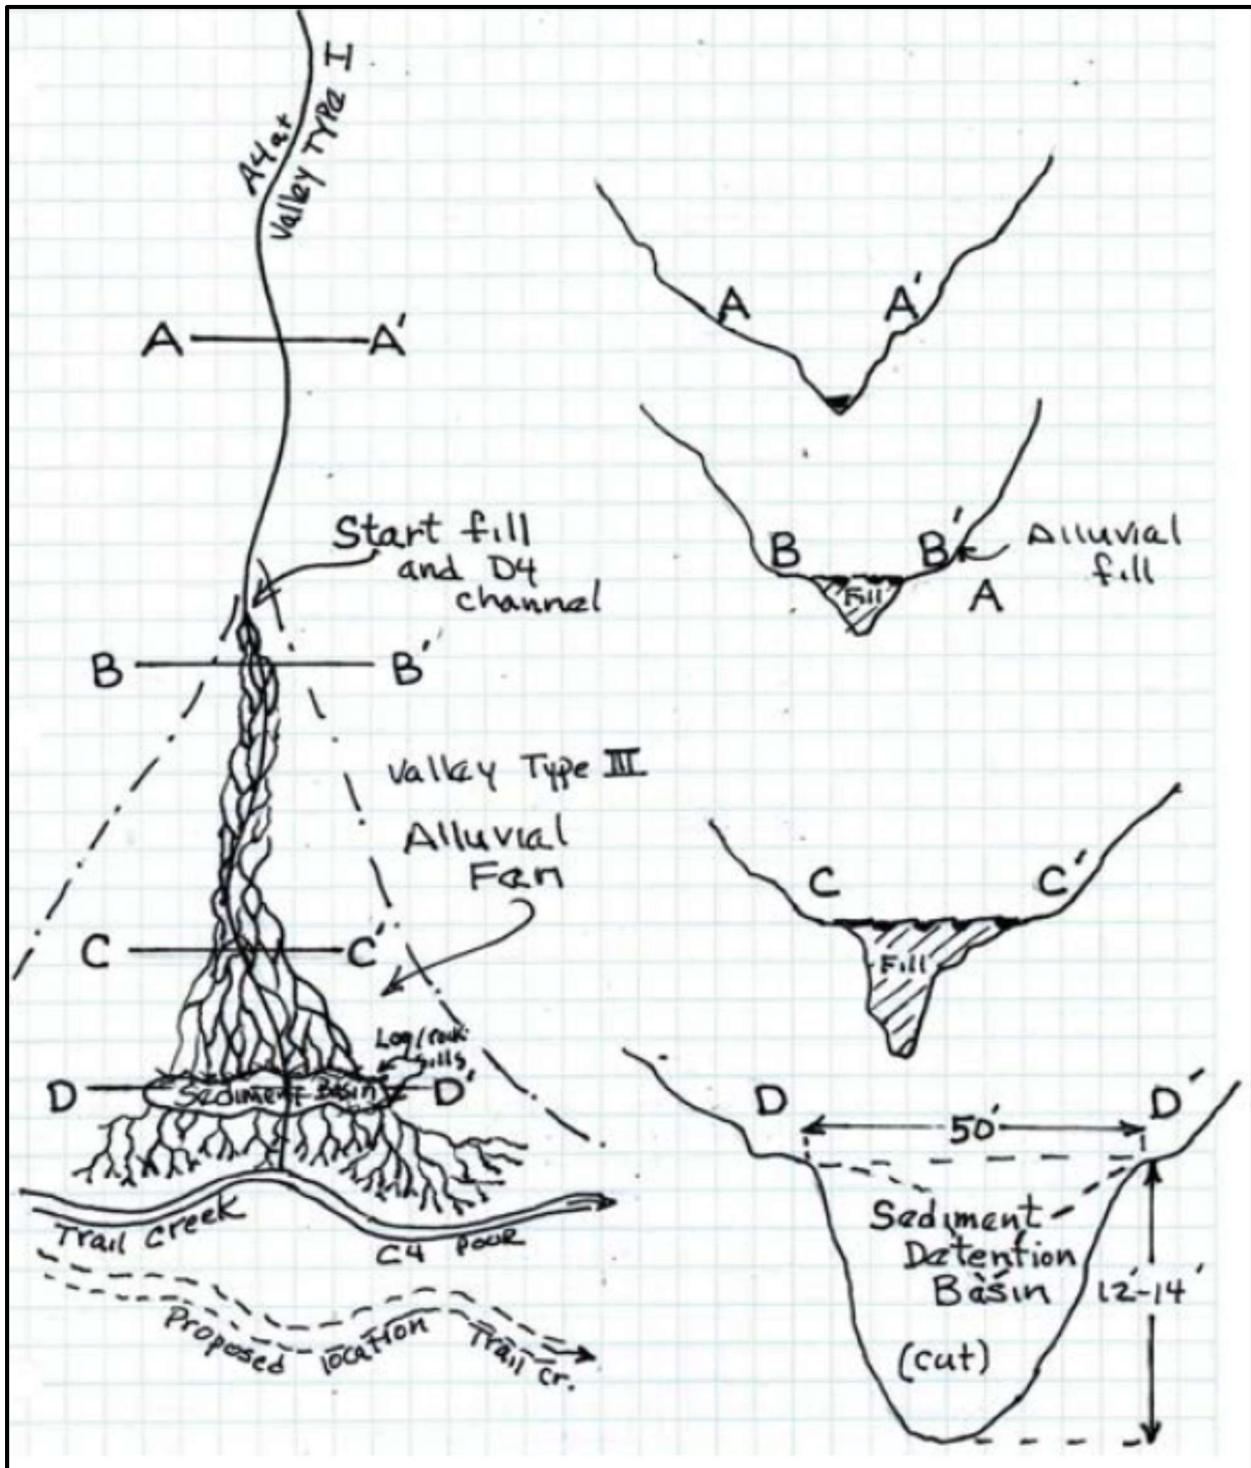
Figure 3.28. Example preliminary design of sediment basin and alluvial fan (Source: Wildland Hydrology 2011).

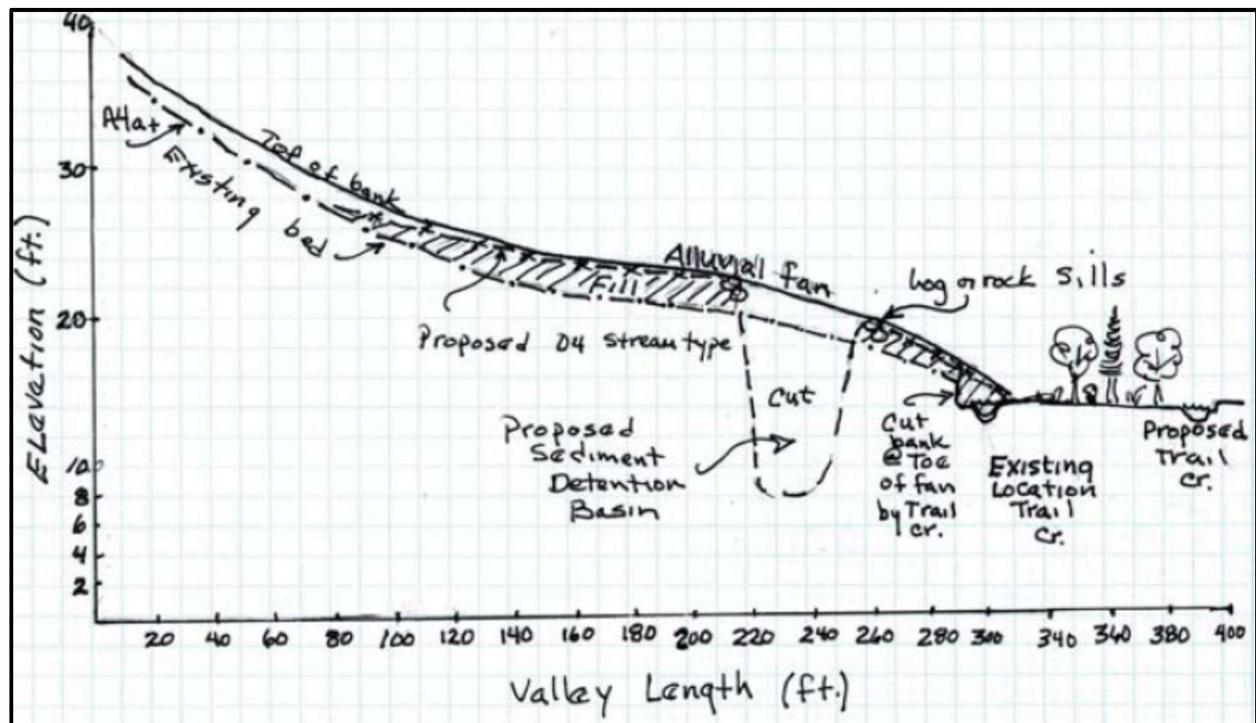
Figure 3.29. Example preliminary design of sediment basin and alluvial fan (Source: Wildland Hydrology 2011).

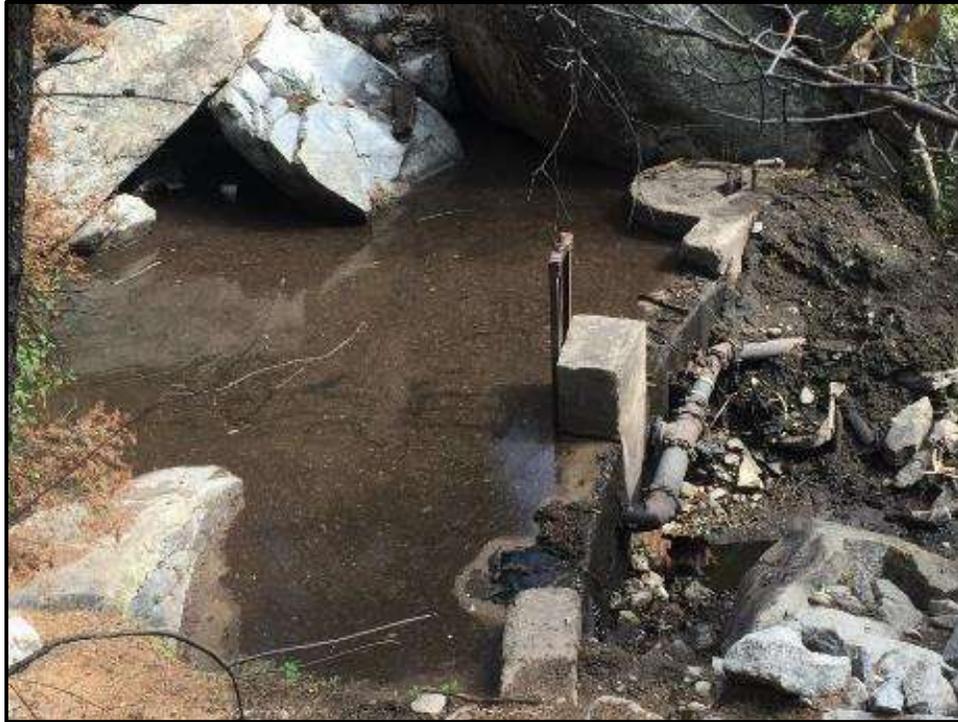
Figure 3.31. View of existing Town of Cimarron intake structure. Notice the pool is black and filled with ash/debris from the adjacent hillslope that received high severity burn.

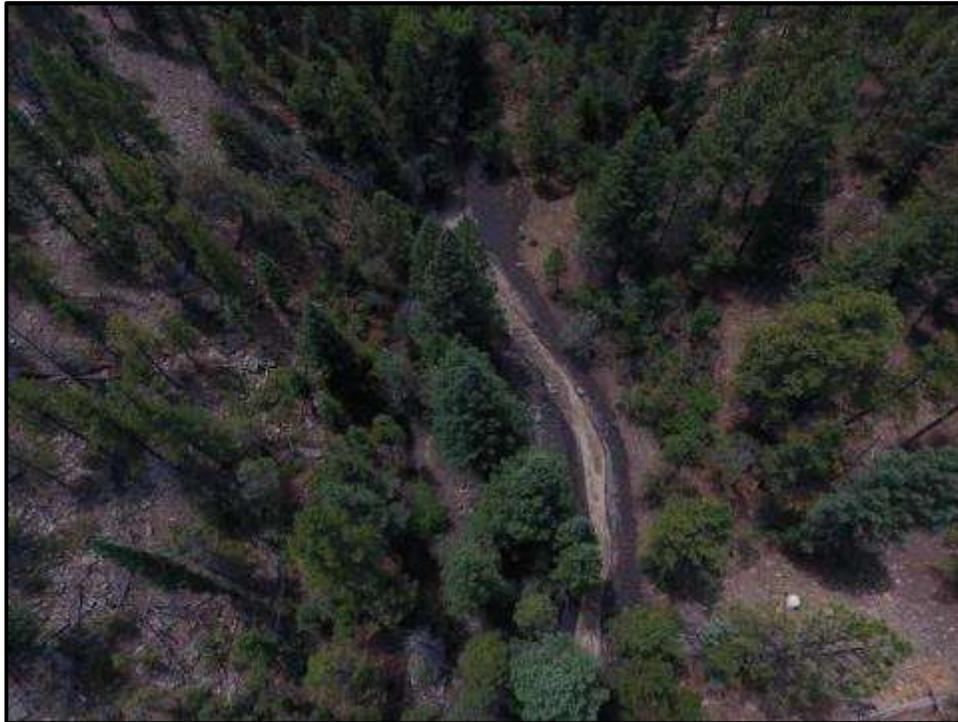
Figure 3.32. View of an unnamed intermittent stream, titled Hummingbird Lane for the purposes of this study.
