Ute Park Fire

Damage Assessment and Burned Area Emergency Rehabilitation Plan

SWCA ENVIRONMENTAL CONSULTANTS

AUGUST 2018

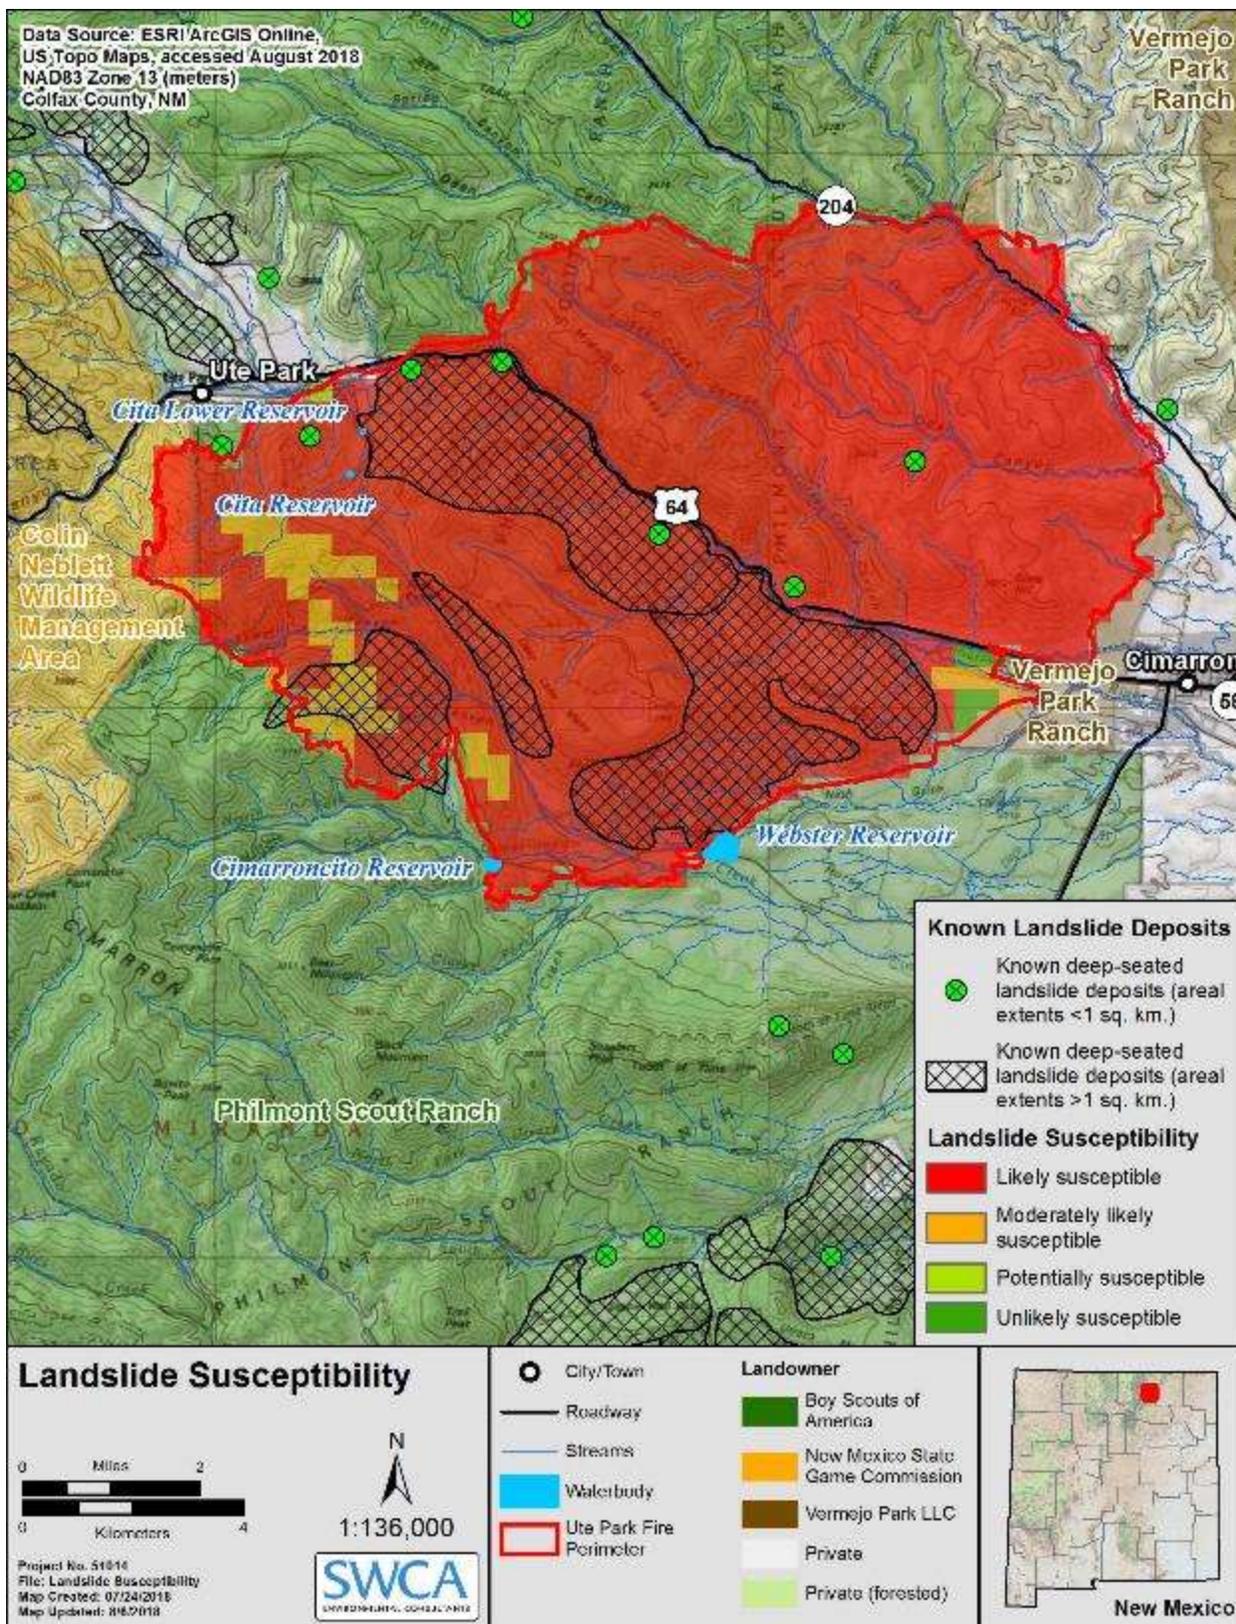
Figure 3.33. Landslide susceptibility within the Ute Park Fire perimeter (developed by Cikoski and Koning 2017).

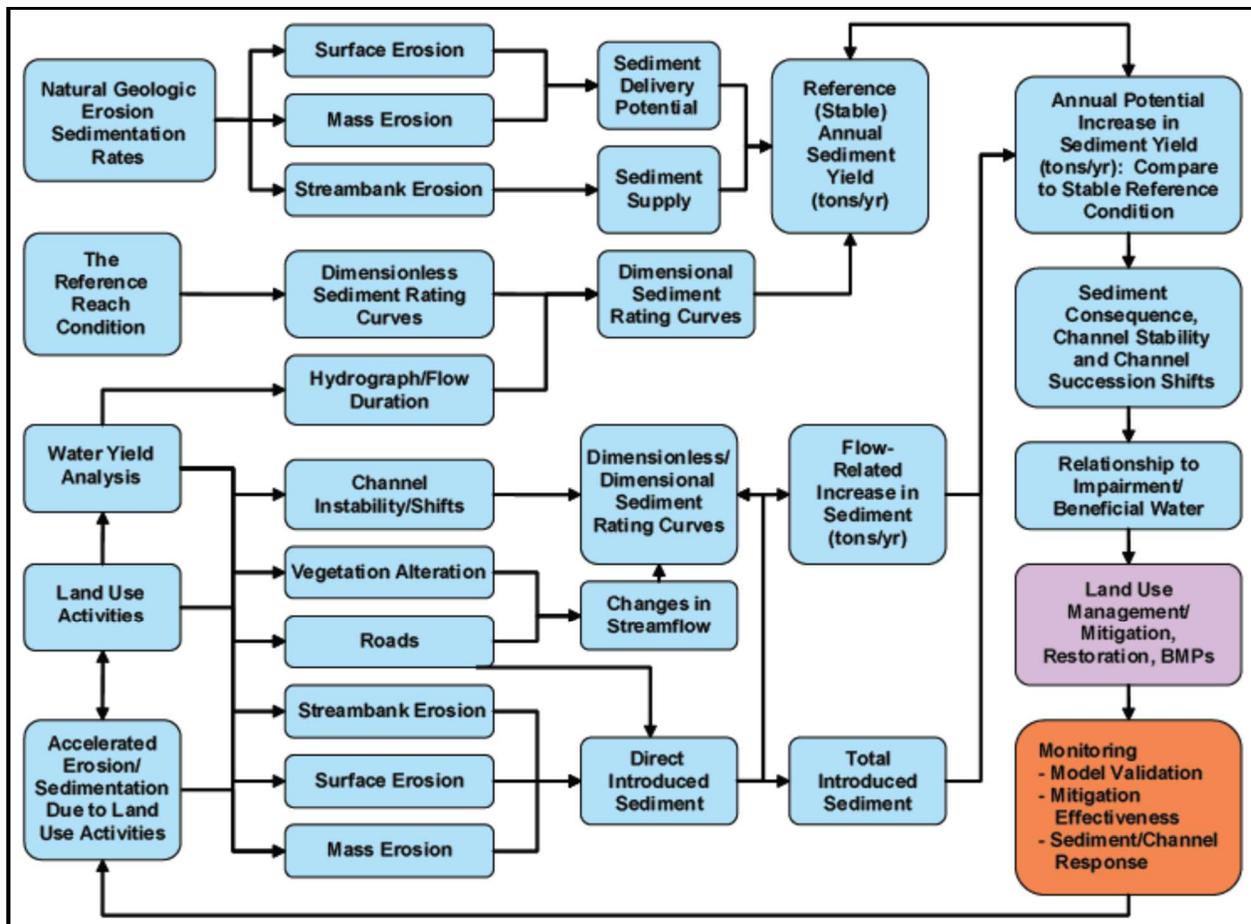
Figure 3.34. The general organization of the procedural sequence for the PLA (Rosgen 2006, 2009).

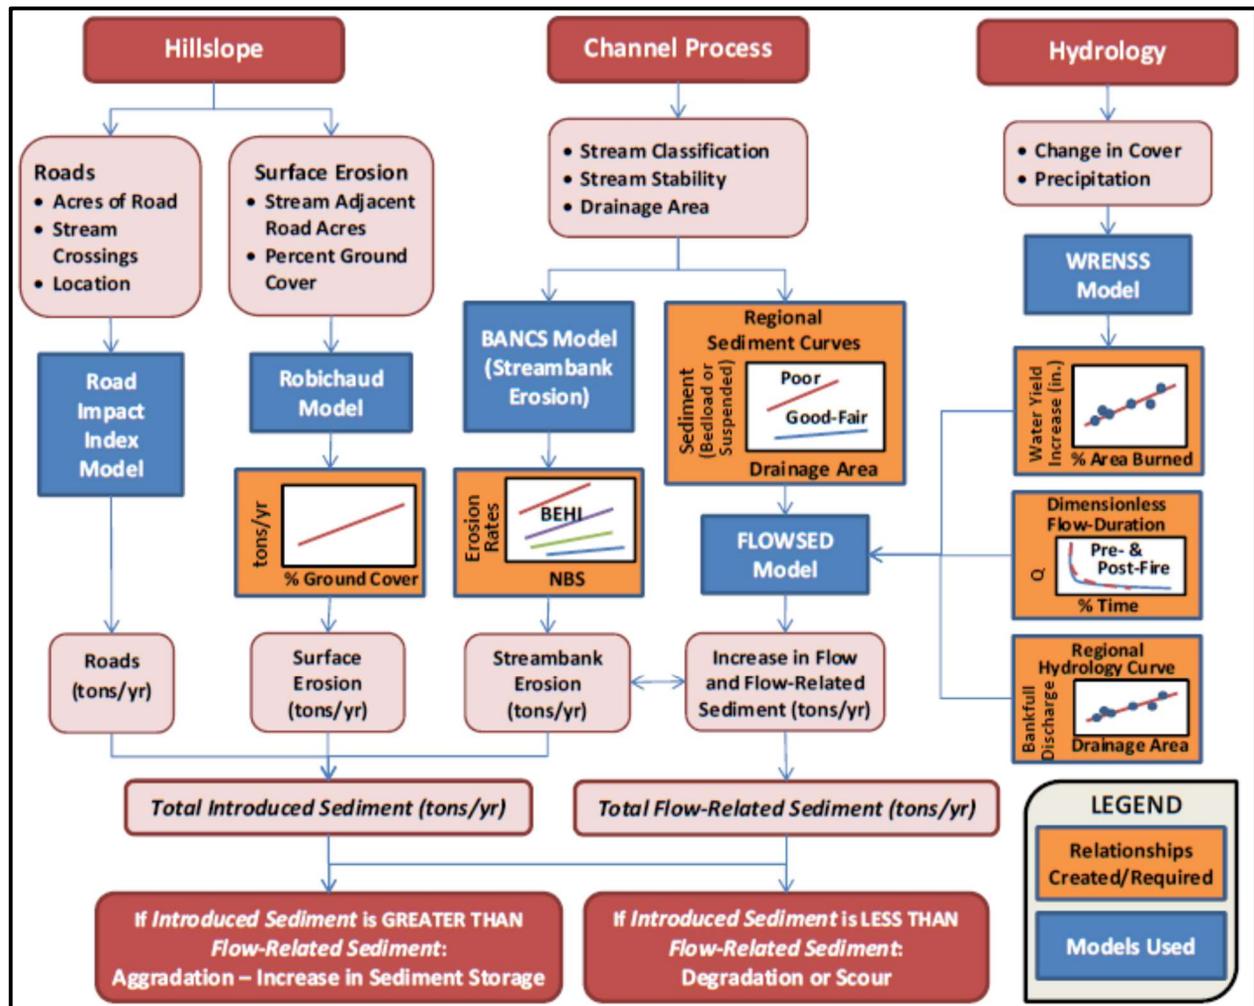
Figure 3.35. Procedural flowchart of the quantification of sediment sources and channel response utilizing a variety of models (Wildland Hydrology 2011).

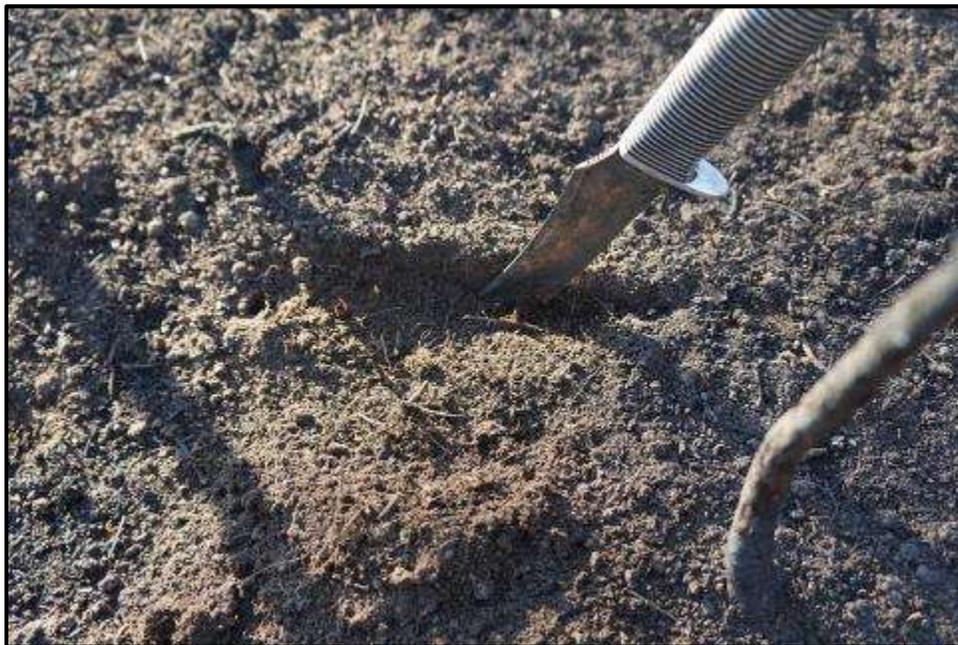
Figure 3.36. Presence of fine roots showing the soil structure is still intact.

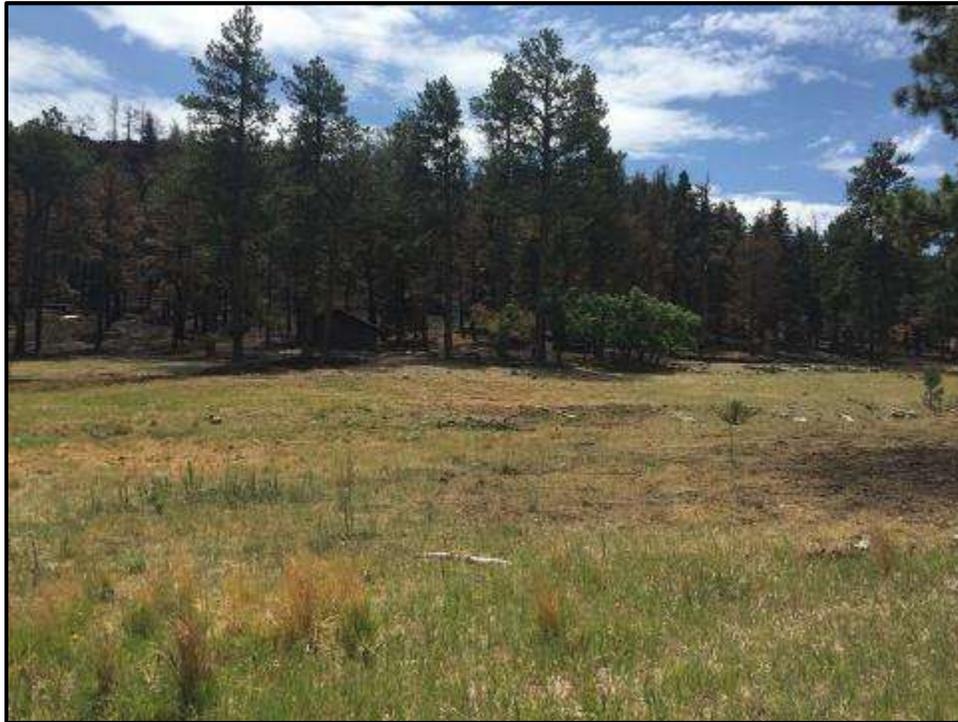
Figure 3.37. Low severity burn showing recovery as grasses and forbs are visibly sprouting.

Low soil burn severity: About 13% of forest and rangeland soils (4,745 acres) were determined to be in the low soil burn severity category. These burned over soils exhibited good surface structure, contain intact fine roots and organic matter, partially intact litter and duff layers, and are often already exhibiting recovery as grasses and forbs are visibly sprouting (Figure 3.37).

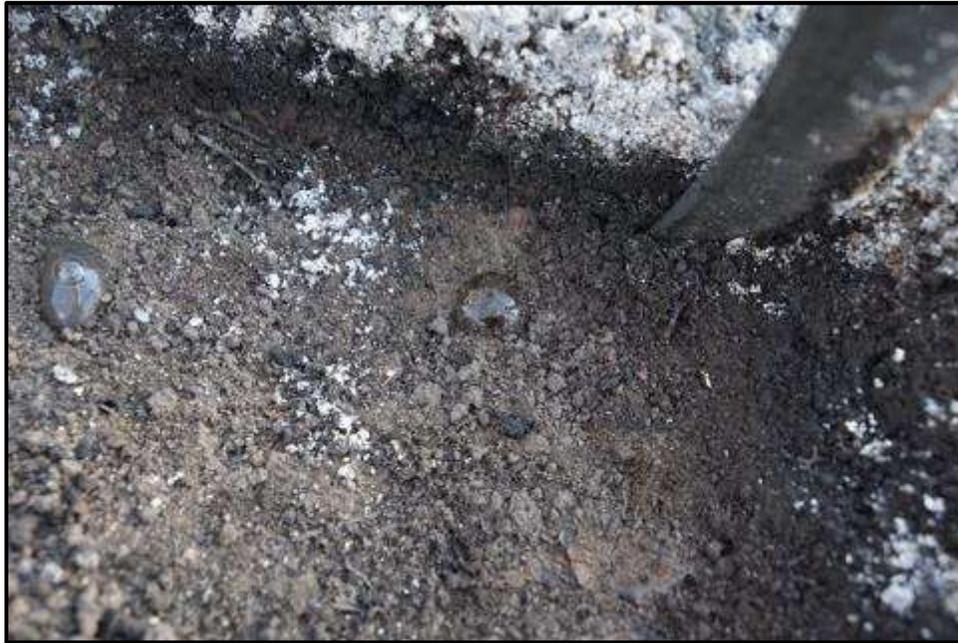
Figure 3.38. Strong water repellency observed in a high severity burn area.

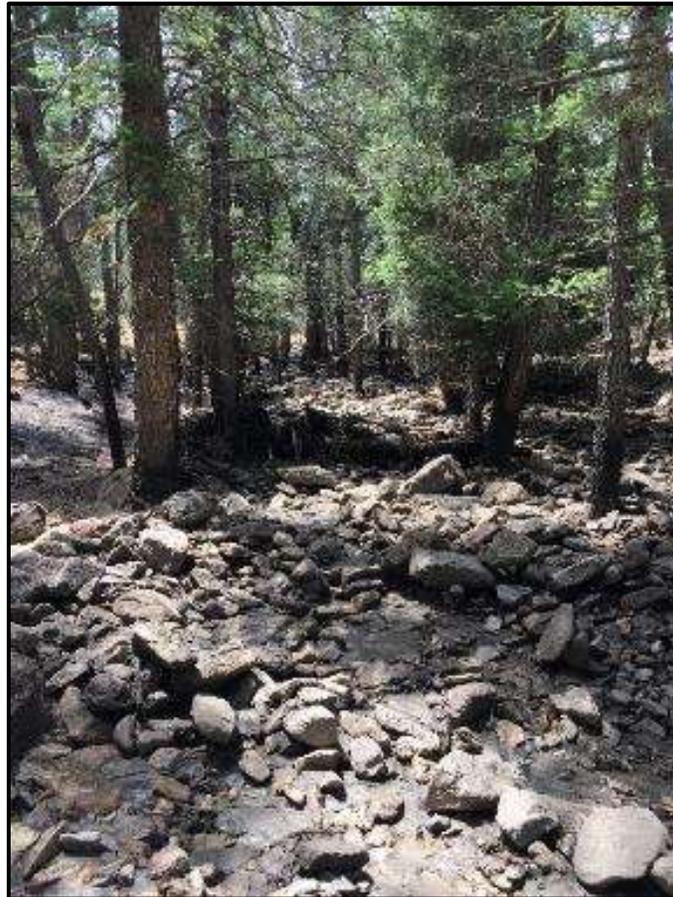
Figure 3.39. Photograph of debris flow that impacted Ute Park on July 13–14, 2018.

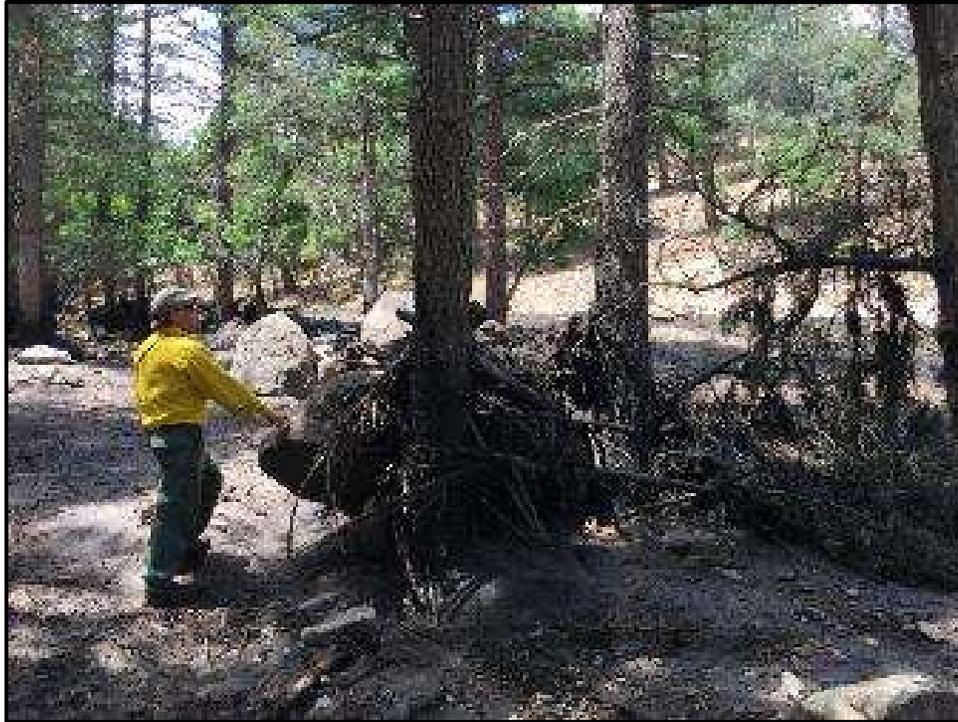
Figure 3.40. Photograph of large material that was mobilized during the debris flow that impacted Ute Park on July 13–14, 2018.

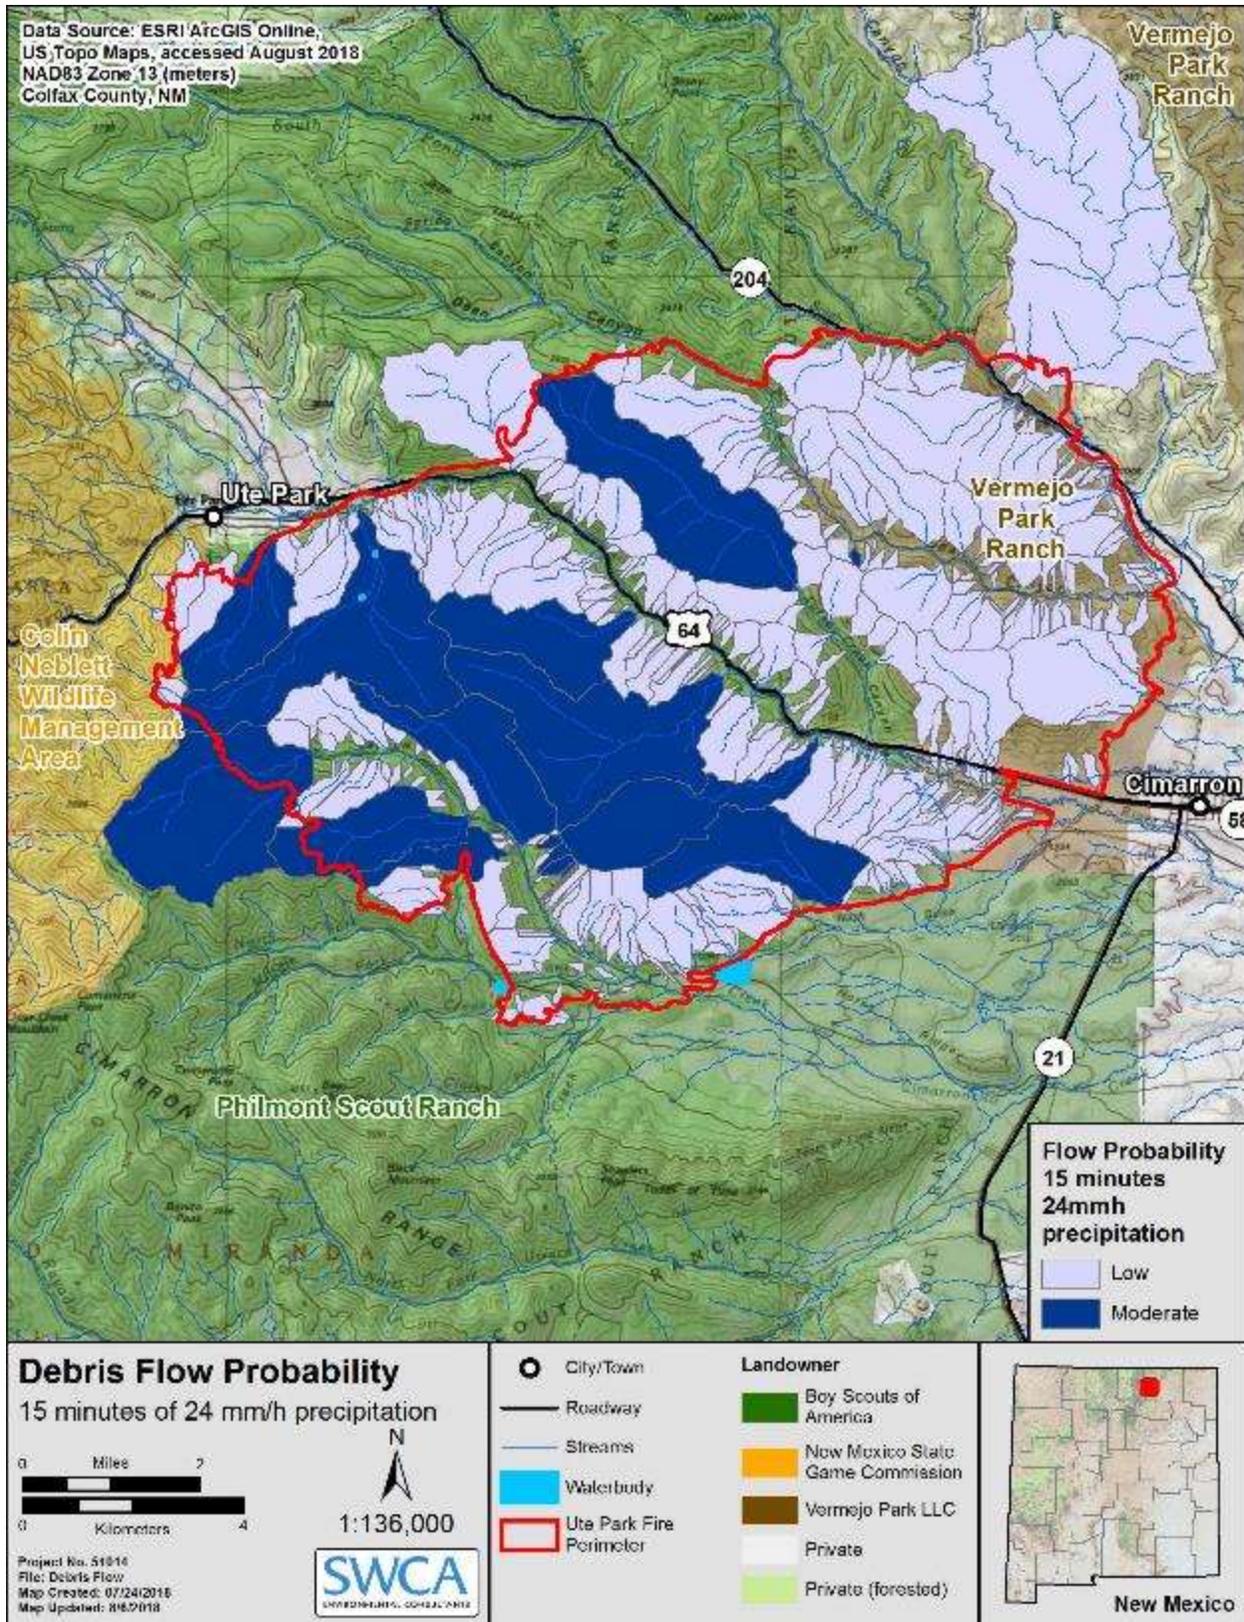
Figure 3.41. Map showing areas of greatest risk to debris flows from USGS modeling.

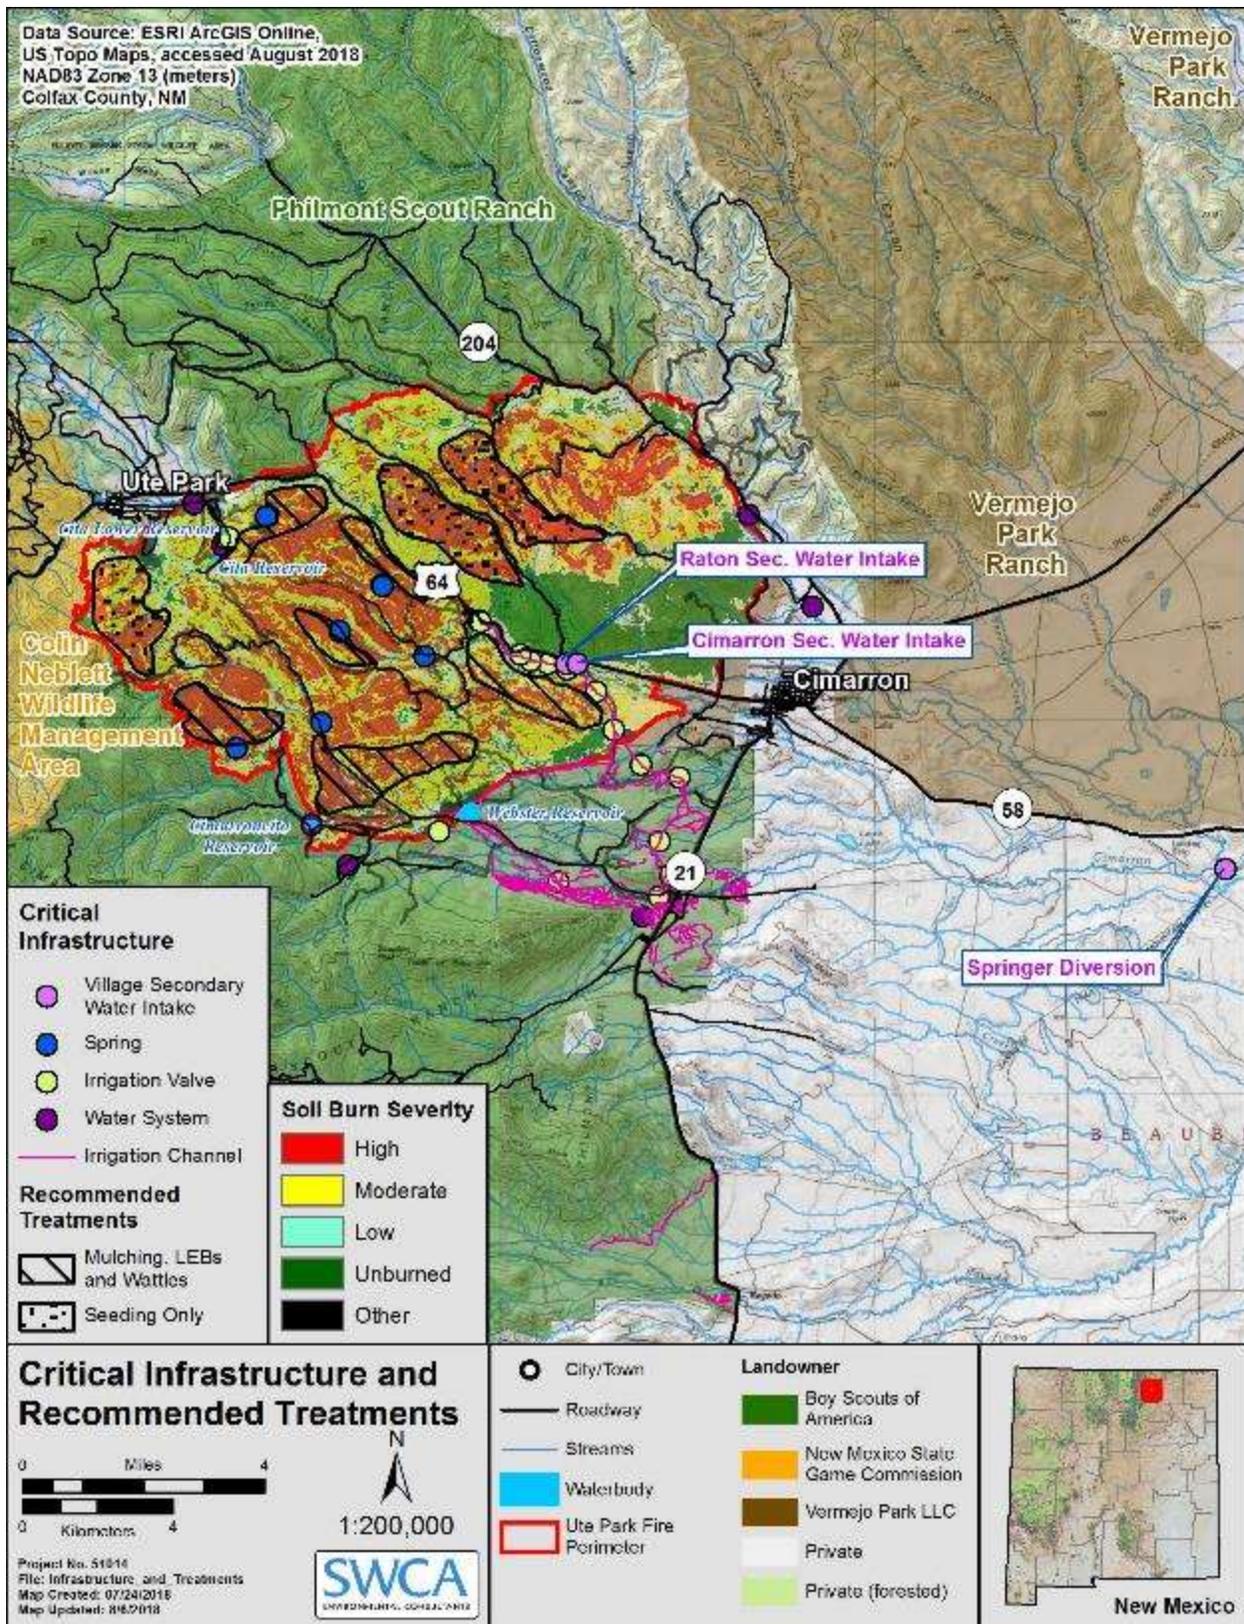
Figure 3.42. Recommended treatment locations for stabilizing hillslope soils.

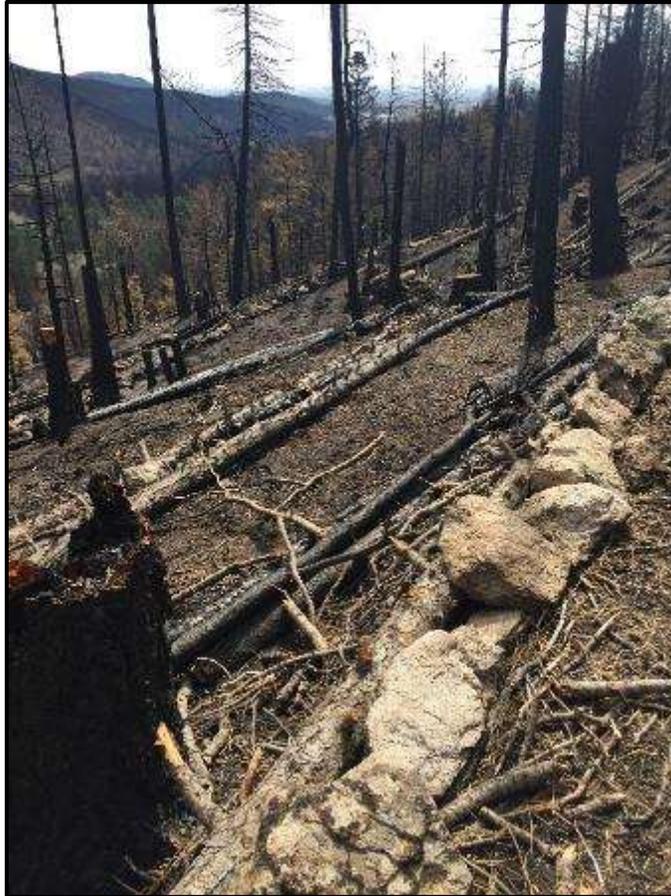
Figure 3.43. Log erosion barriers installed above Cimarroncito intake structure on Philmont Scout Ranch.

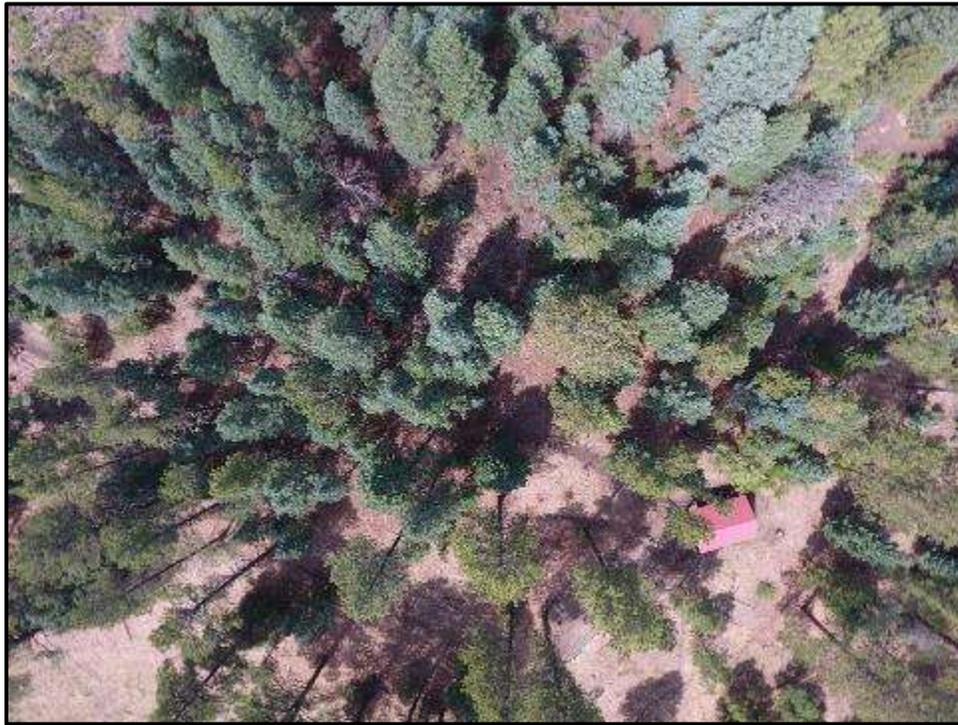
Figure 3.44. Aerial photograph of low severity burn area taken using drone reconnaissance, showing intact green tree canopy.

Given the patchy nature of burn severity, with intermixing of high, moderate, low and unburned (Figure 3.44 through Figure 3.48), natural understory vegetation recovery should proceed with new growth (Figure 3.49). The soil seed bank appeared to be largely intact based on the presence of scorched but not completely burned plant leaf litter and duff on soil surfaces, even in high- and moderate-severity burn areas. Additionally, unburned plants from adjacent and upslope unburned patches should provide additional natural seed dispersal to adjacent high- and moderate-severity burn areas.

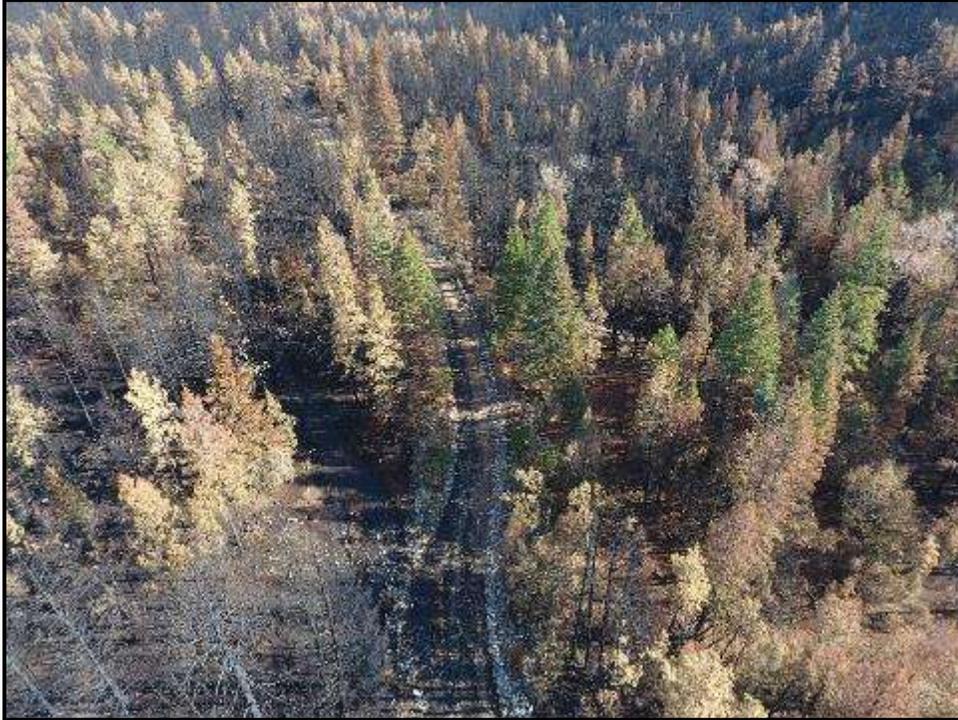
Figure 3.45. Aerial photograph of moderate severity burn taken using drone reconnaissance, showing extensive scorch to overstory trees.

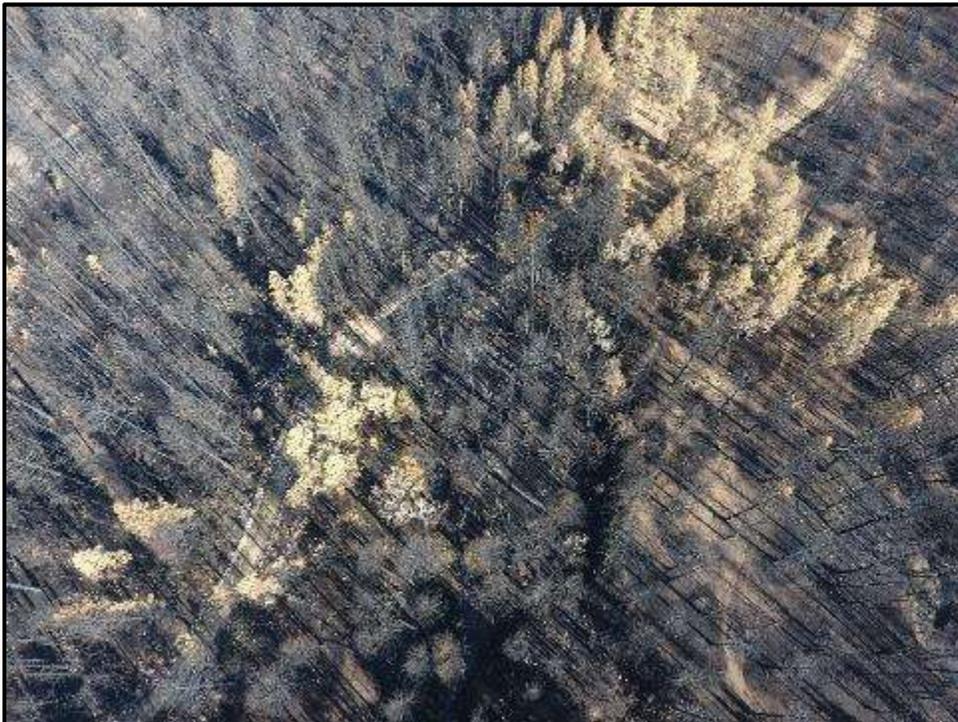
Figure 3.46. Aerial photograph of moderate to high severity burn taken using drone reconnaissance, showing the majority of the tree canopies were entirely consumed, but some trees have retained scorched needles.

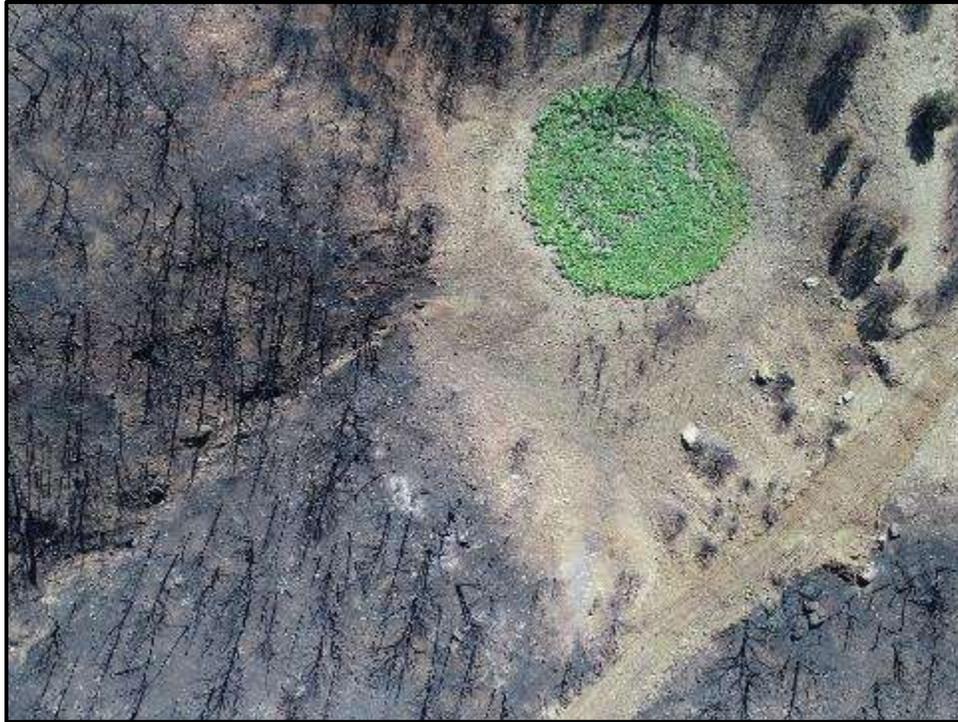
Figure 3.47. Aerial photograph of stock pond in high severity, stand replacement portion of the burn that has been colonized by sunflowers.

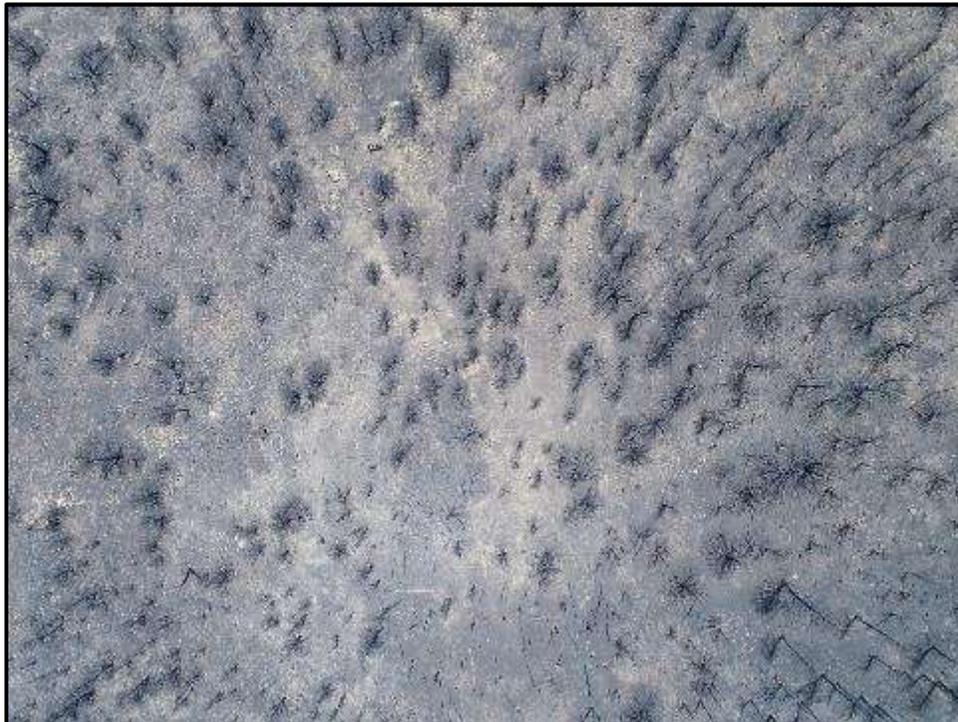
Figure 3.48. Aerial photograph of high severity burn area taken by drone reconnaissance over Turkey Creek; light ash on the ground surface suggests intense heating of soils, litter, and duff.

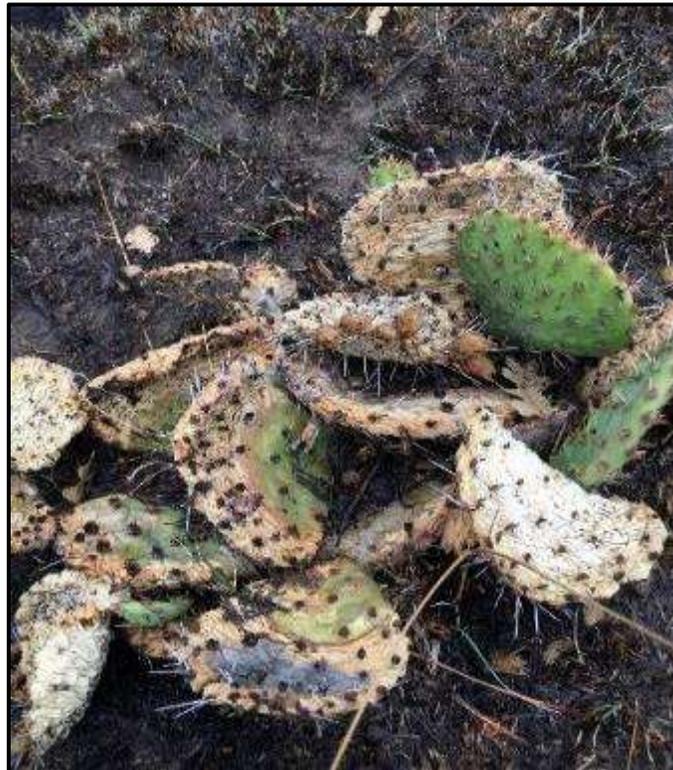
Figure 3.49. New growth of cactus pad in a low severity burned grassland area.

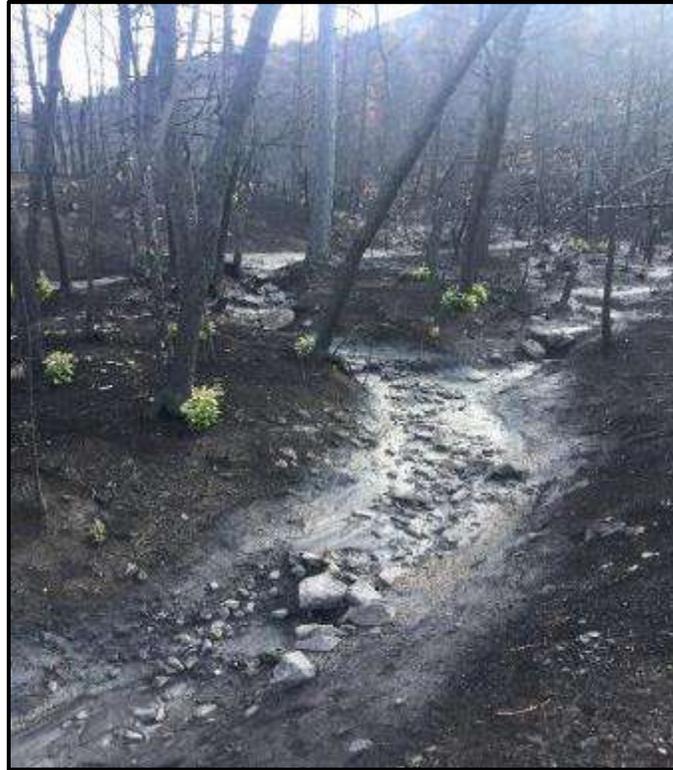
Figure 3.50. Vegetation recovery already observed along many riparian areas.

Riparian areas also experienced variable burn severity, but vegetation immediately along the Cimarron River appeared to be less damaged than in adjacent conifer woodlands on slopes. While surrounding slopes experienced moderate to high-severity fire, the immediate riparian zone appeared to have experienced more moderate-severity burn. Willows including coyote or arroyo willow and peachleaf willow were still alive in many places (Figure 3.50), even if the leaves had been scorched. Larger cottonwood, ash, alder and Gambel oak trees were scorched, but many riparian oaks were re-sprouting from roots, and cottonwood and ash trees may resprout as well. The greatest post-fire threat to the riparian vegetation is likely to be flooding and sedimentation resulting from runoff and soil erosion on steep burned slopes above the Cimarron River and other streams and drainages.

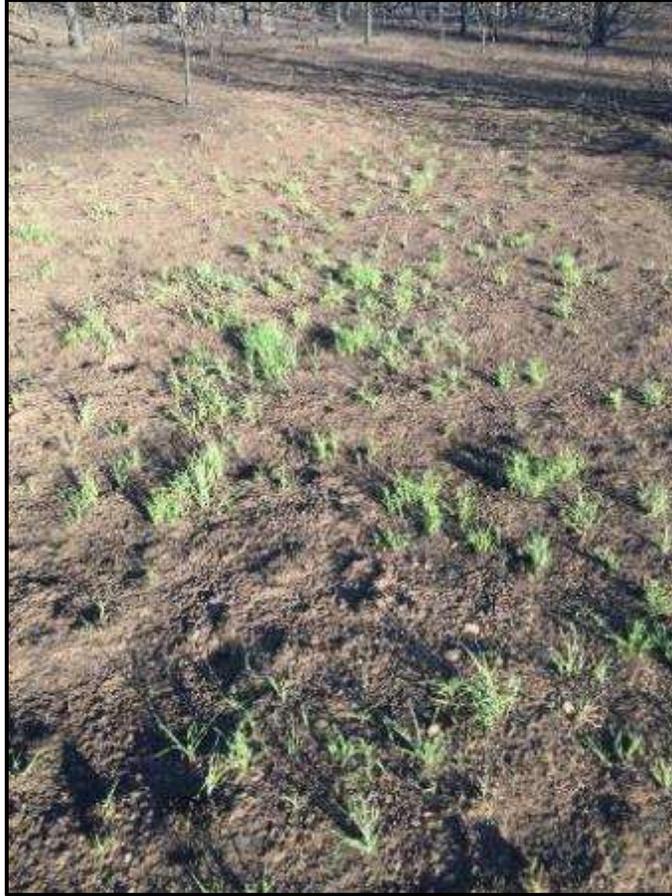
Figure 3.51. Grass recovery in basin burned with high severity.

As of July 12–14, 2018, perennial grasses such as western wheatgrass, blue grama, galleta, and big bluestem had already started producing new leaves from their rootcrowns in many of the moderate and some high-severity burn areas (Figure 3.51). Gambel oak had begun to produce stems and leaves from root crowns in high- and moderate-severity burn areas (Figure 3.52). Earthstar fungus fruiting bodies had recently developed on burned soil surfaces of a high-severity burn, indicating that lethal fire heat did not penetrate deep into the soils (Figure 3.53).

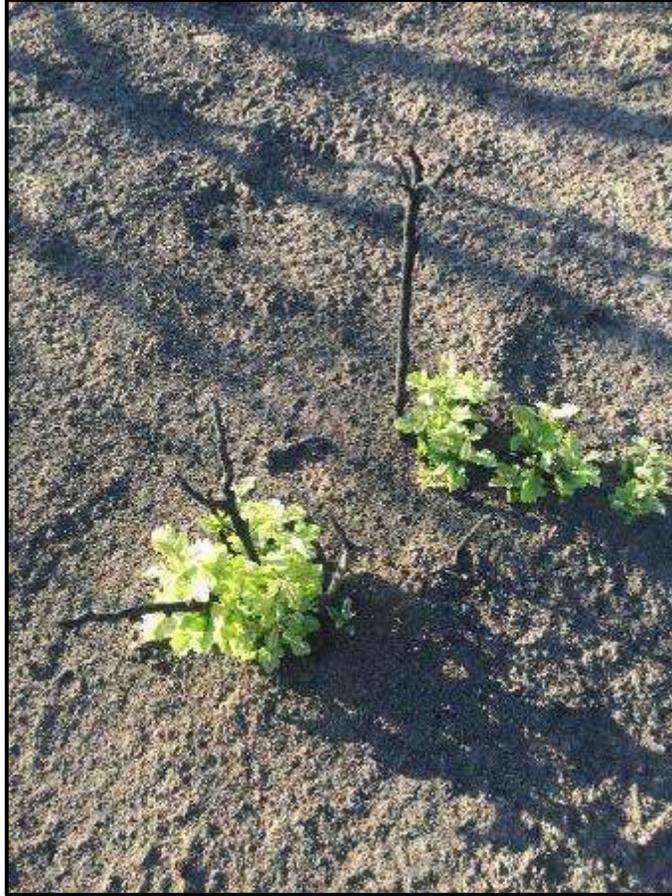
Figure 3.52. Basal sprouting of Gambel oak.

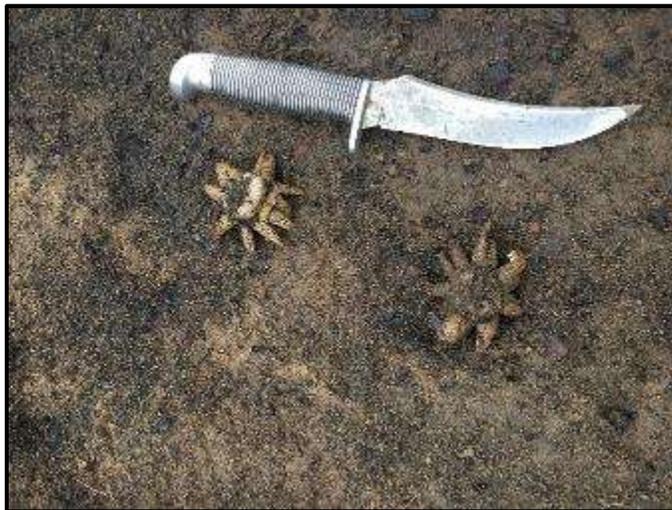
Figure 3.53. Earthstar fungus fruiting bodies.

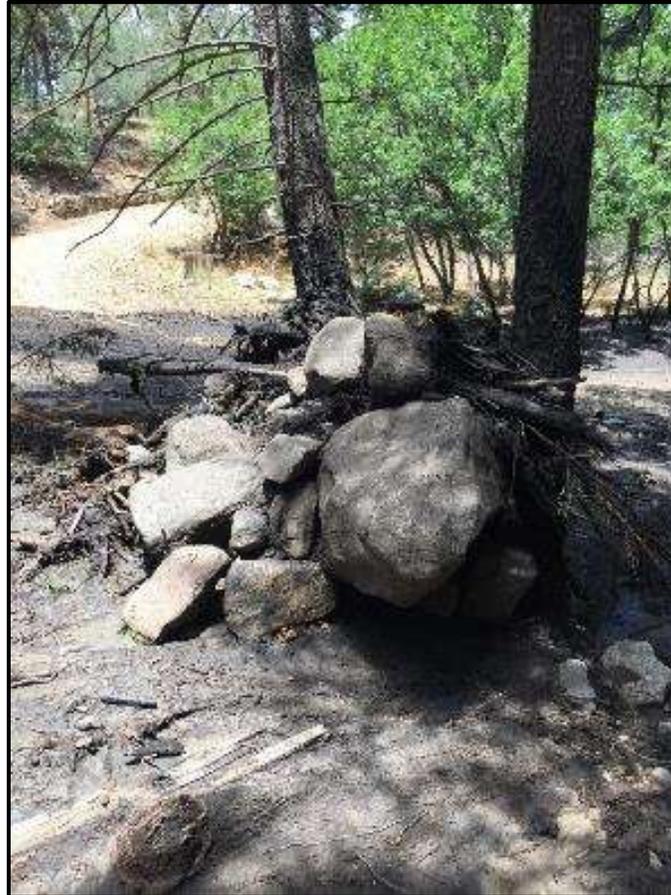
Figure 3.54. Photograph showing the size of material mobilized during the debris flow above Ute Park. Slope stabilization is a priority for the drainage and slopes in that area.

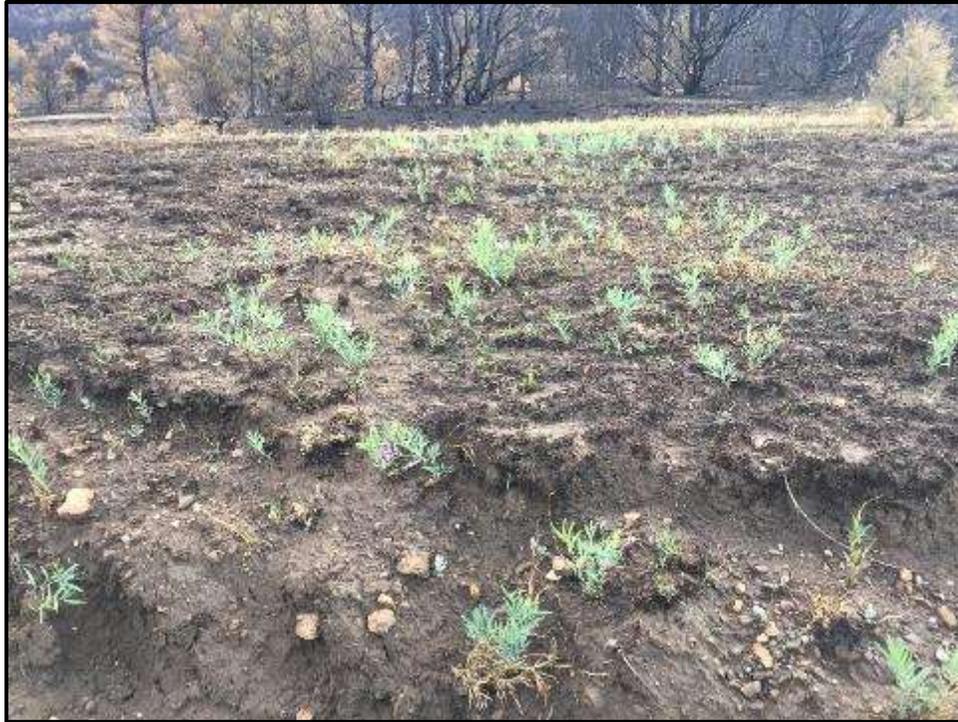
Figure 3.55. Native perennial herbaceous species recovery in moderate severity portion of the burn area.

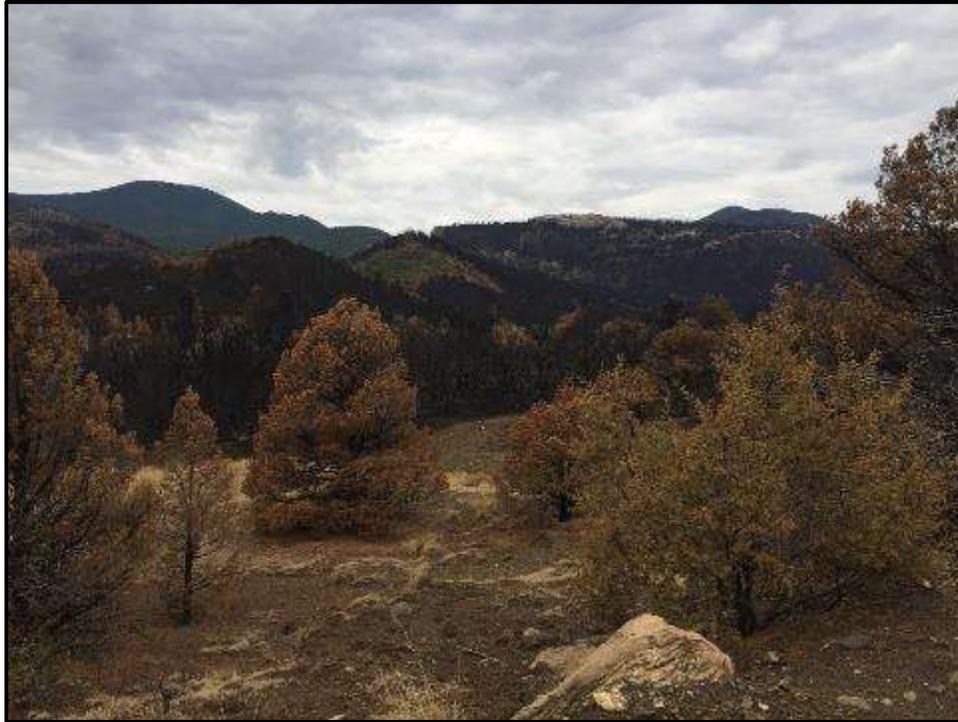
Figure 3.57. Patchy burn severity left many areas of intact overstory and understory species.

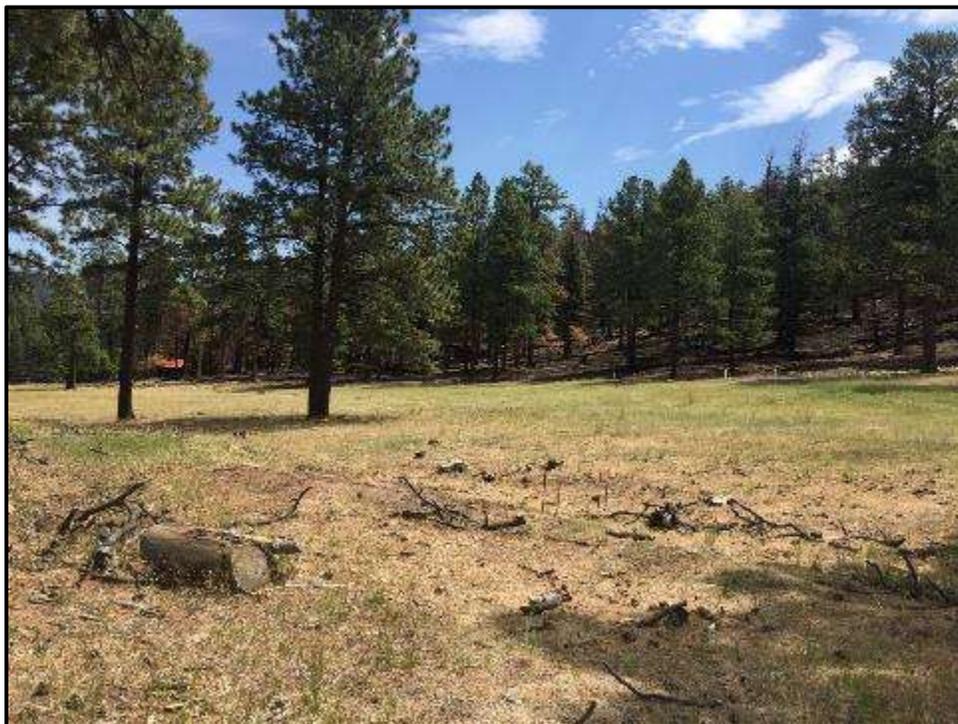
- Where bunch grasses were present before the fire, more than 50% crown roots are alive and grasses should grow back.
- Shrubs leaves will be dead but remain on the plants.
- Between 0 and 50% of coniferous tree crowns will be scorched, but long-term survival will be relatively high.
- Ground cover will have a mixture of live vegetation, litter, duff, and bare ground present (Figure 3.58).

Figure 3.58. Low severity surface burn on Philmont Scout Ranch.
