Ute Park Fire

Damage Assessment and Burned Area Emergency Rehabilitation Plan

SWCA ENVIRONMENTAL CONSULTANTS

AUGUST 2018

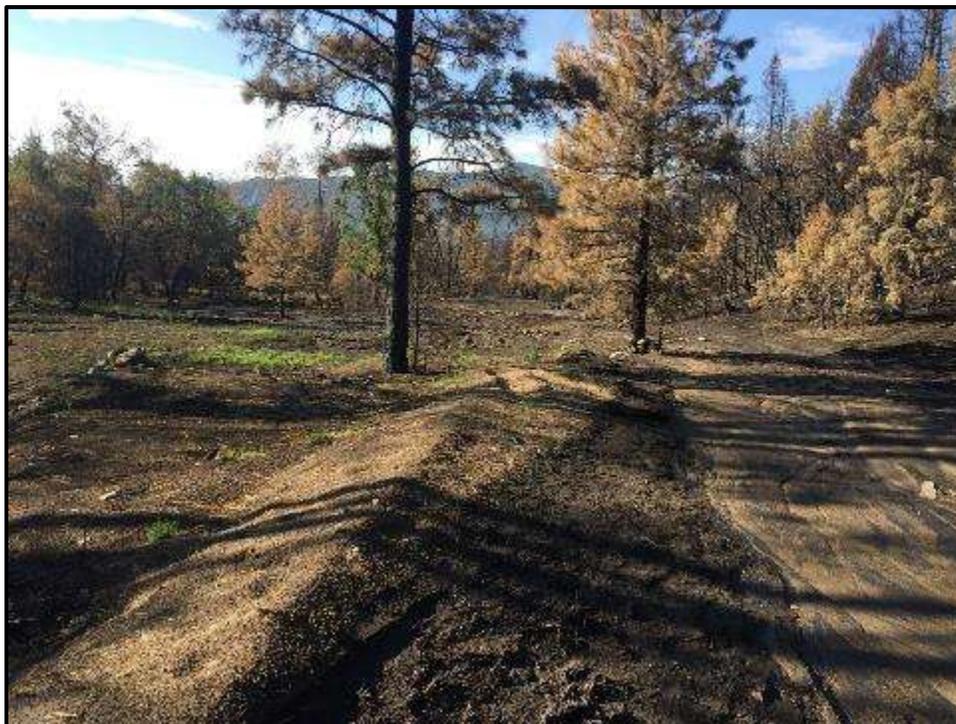
- Where bunch grasses were present before the fire, less than 50% crown roots are alive and grasses will grow back.
- Shrubs will be missing leaves and small twigs or just stems remaining.
- Conifer tree crowns will have scorch between 50% and 100%, but typically the needles will be brown and still attached to the trees (Figure 3.59)
- Ground cover will be a mixture of litter, duff, and bare ground. Some live vegetation may be present.

Figure 3.59. Moderate severity burn area showing some green leaves among fully scorched trees. Some grass recovery is evident.

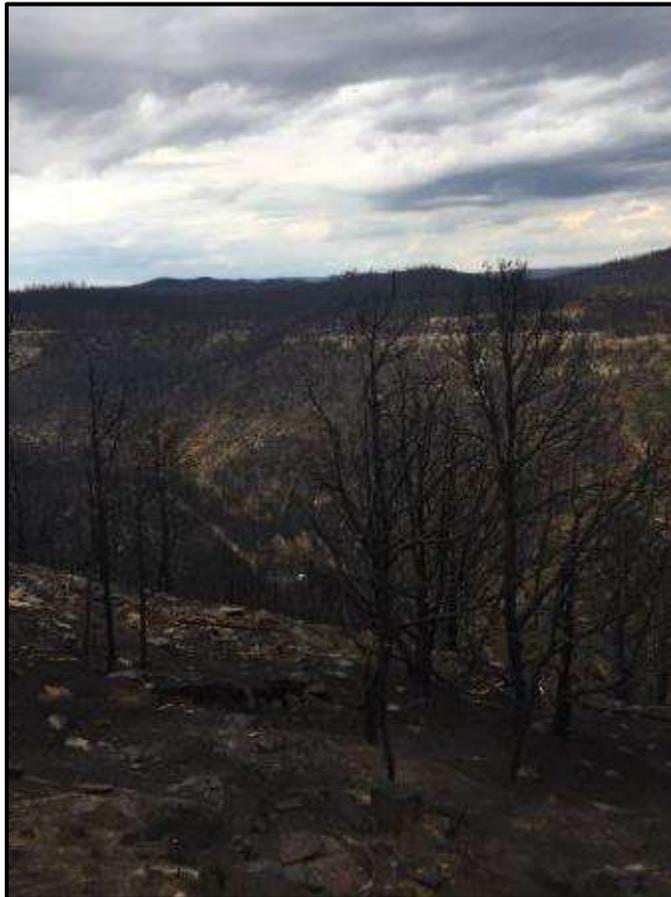
- Shrubs will just have the stubs remaining, but root systems still intact.
- Conifer tree crowns will generally be black, with no to little needles present (Figure 3.60).
- Ground cover will include some blackened litter and duff, but most of the area will be bare ground.

Figure 3.60. High severity burn area above Turkey Creek.

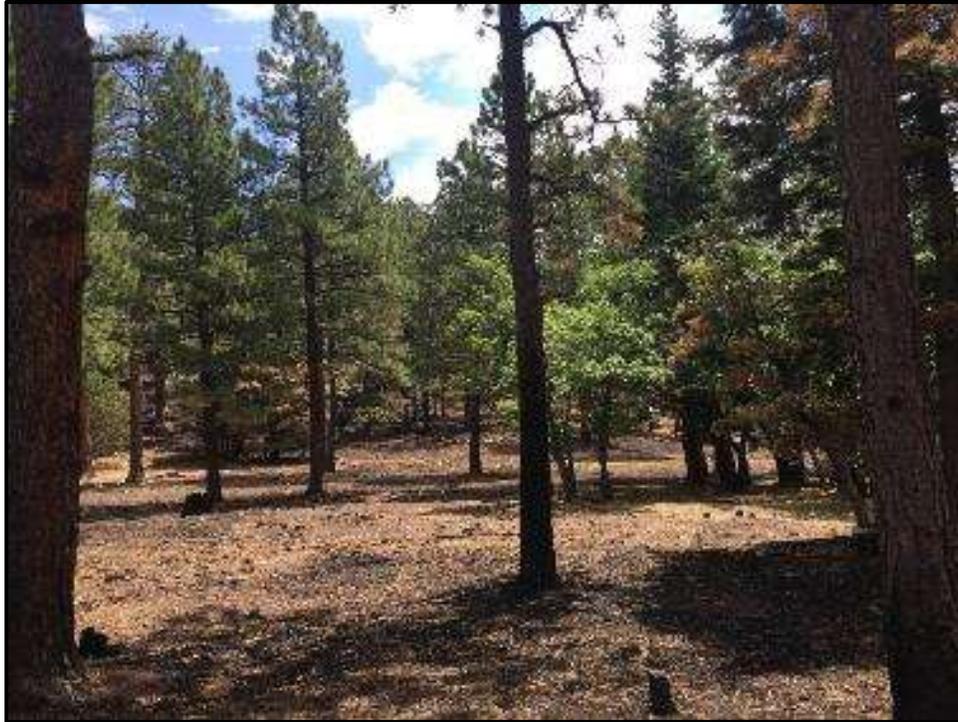
The Ute Park Fire burned with mixed severity, with many areas lightly burned in the understory with intact overstory vegetation (Figure 3.61). In some places low severity burn was found immediately adjacent to areas that experienced high severity stand replacing fire effects. This results in a mosaic of stand structures with areas of intact seedbanks that will over time help in the recovery and regeneration of forest species in adjacent high severity burned areas. Even in some high severity areas, initial recovery of understory shrub species like Gambel oak has already begun (Figure 3.62).

Figure 3.61. Low severity, understory burn in open ponderosa pine stand.

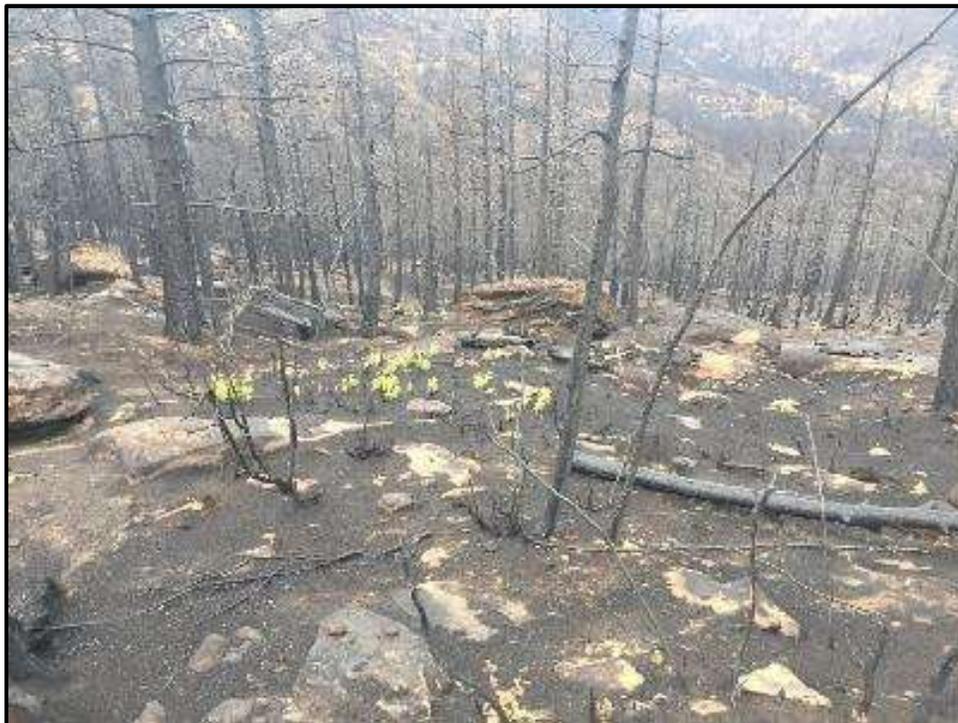
Figure 3.62. Gambel oak resprouts in an area of high severity stand replacement.

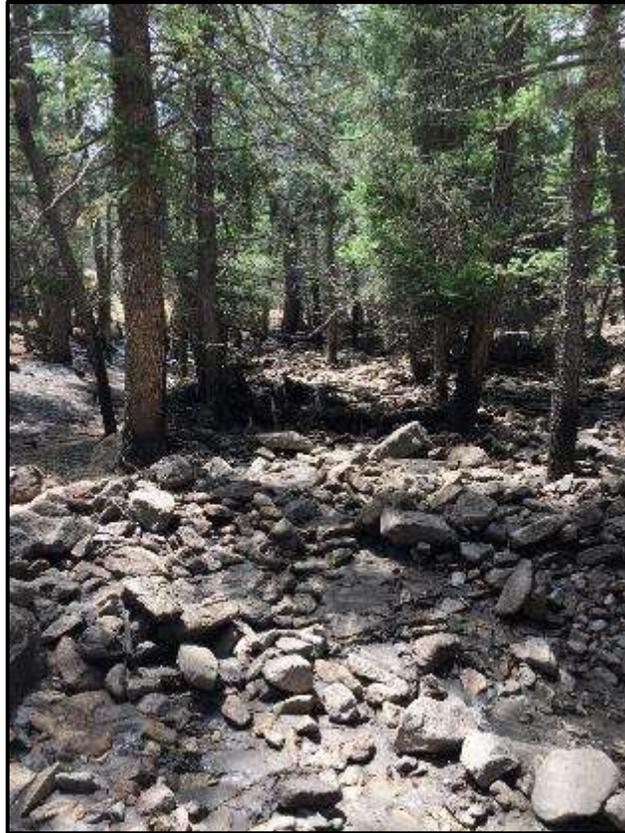
County roads within the community of Ute Park have been severely impacted by post-fire flooding and debris flows, particularly during the rain event that impacted the community on June 13–14, 2018 (Figure 3.63 through Figure 3.66). The County Emergency Manager has been working with NMDOT to remove sediment and debris from roads to allow residents to access their homes. Culverts are undersized for the anticipated flow increases, and culvert size will need to be increased or culverts will need to be removed, and replaced after peak flows recover toward pre-burn conditions. Some roads may need to be closed until watershed conditions recover.

Figure 3.63. Large rocks and debris deposited along Hummingbird Lane in Ute Park.

Many of the rehabilitation measures described in the sections above will serve to reduce the risk of flooding and sediment flows that would adversely impact these transportation systems and threaten the health and safety of motorists and residents.

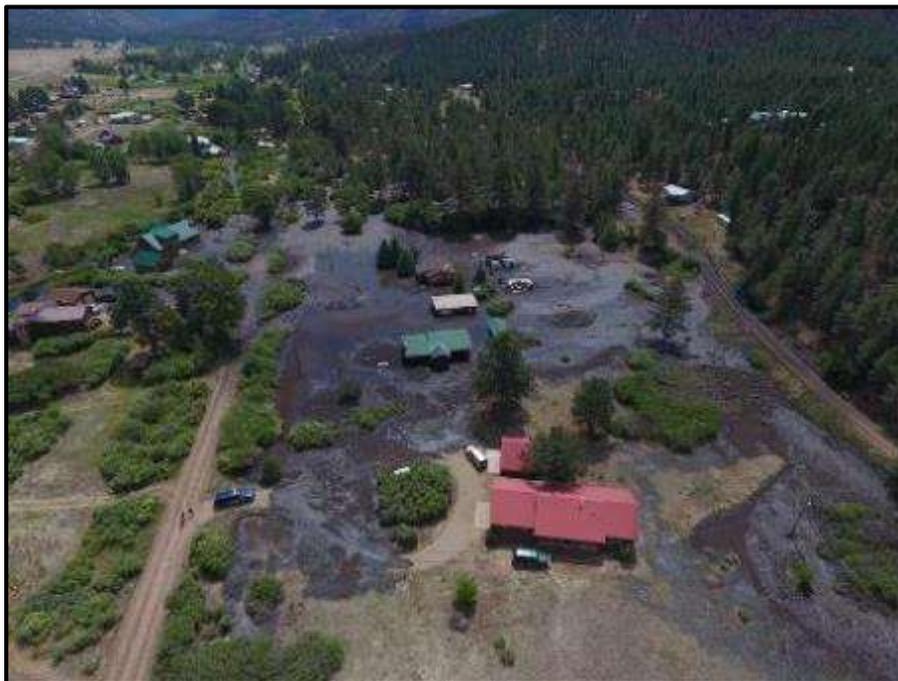
Figure 3.64. Ute Park post flooding, June 13, 2018, showing debris flow crossing two roads within the community.

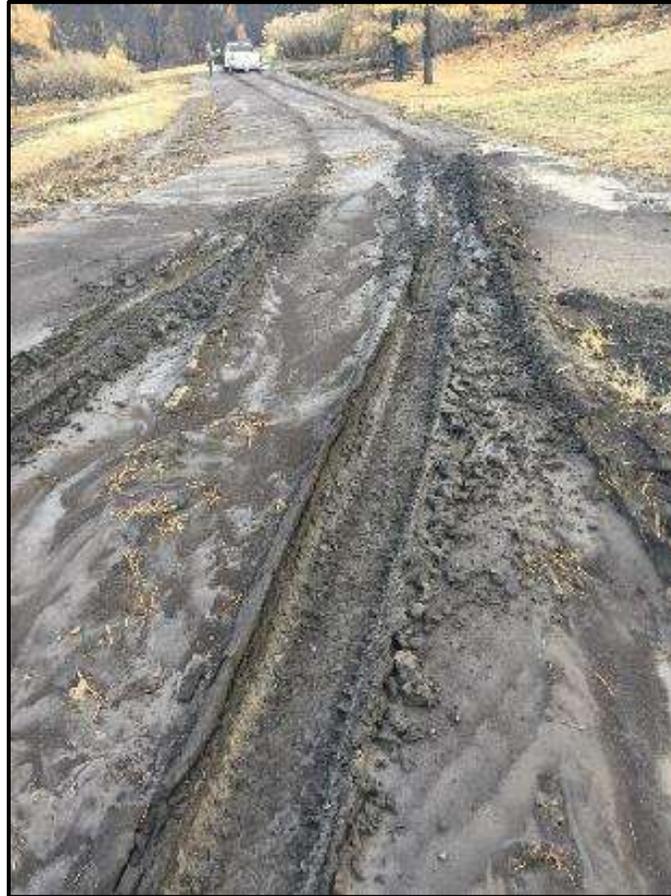
Many of the roads observed on Philmont Scout Ranch have been heavily impacted by secondary fire effects of post-fire flooding and debris flows. Some roads are impassable (see Figure 3.65). Some bridges were heavily damaged during the fire (see Figure 3.66) and/or are threatened by post-fire debris flows.

Figure 3.65. Post-fire flooding and sediment flow impacts to road surface in Philmont Scout Ranch.

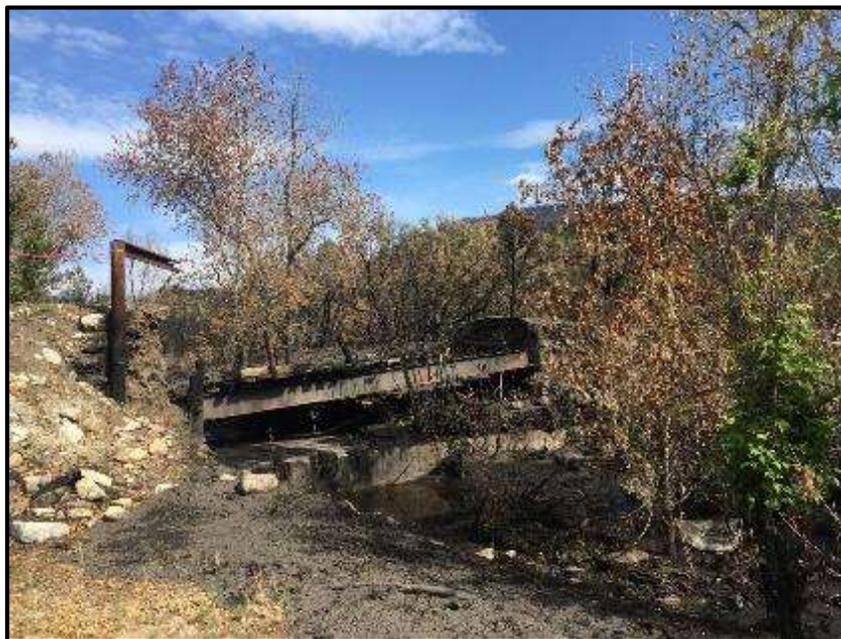
Figure 3.66. Burned-out bridge on Philmont Scout Ranch.

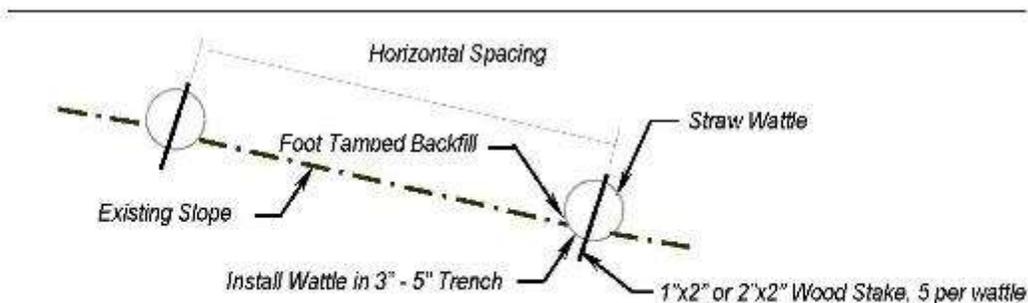
The horizontal spacing of wattles on the slope is based on normal rainfall intensity, slope steepness, soil characteristics, and the extent of surface cover remaining after the fire. Figure 1 depicts the placement straw wattles on the slope. Table 1 shows recommended wattle spacing.

FIGURE 1 - Typical straw wattle installation

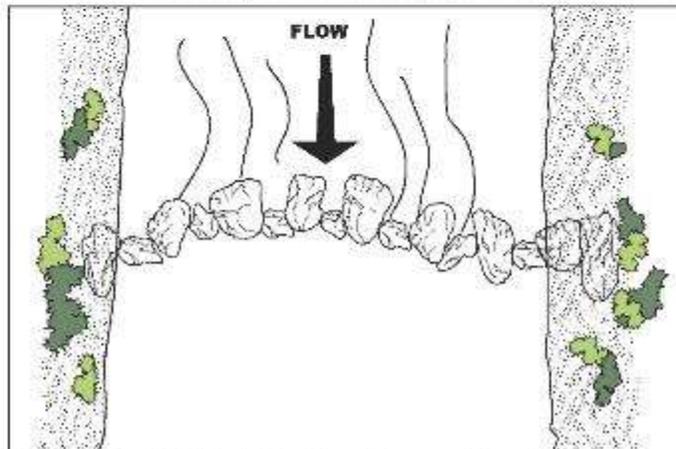
Figure 57—Grade stabilizer is placed at grade to prevent channel incision.

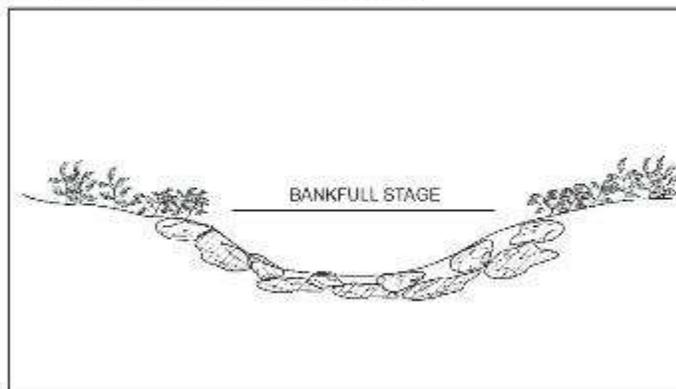
Figure 58—Bankfull view of grade stabilizer.

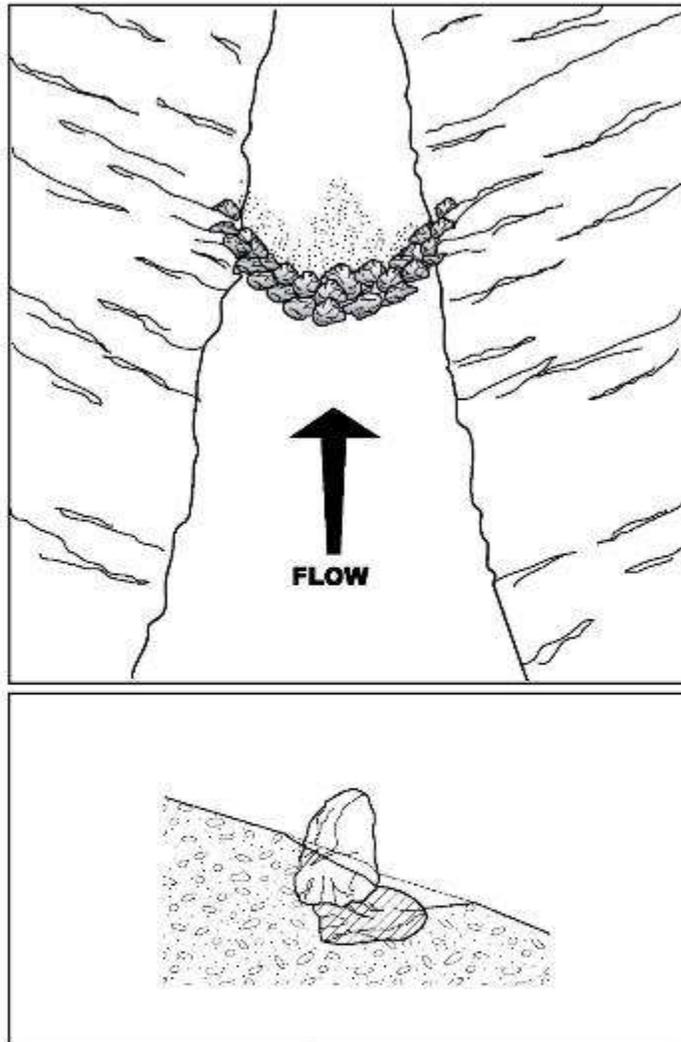
Figure 59—Stream grade can be adjusted and maintained by careful placement of boulders.

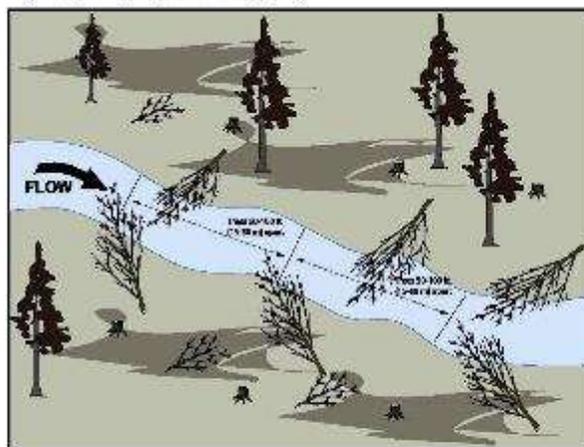
- Fell the primary tree across the channel to "plug" the channel.
- Buck the primary tree so the log touches the channel bottom.
- Fell secondary trees to support the primary tree.
- Use trees large enough to hold the expected runoff and debris load (Fitzgerald, unpublished paper).

Figure 56—Directional tree felling.

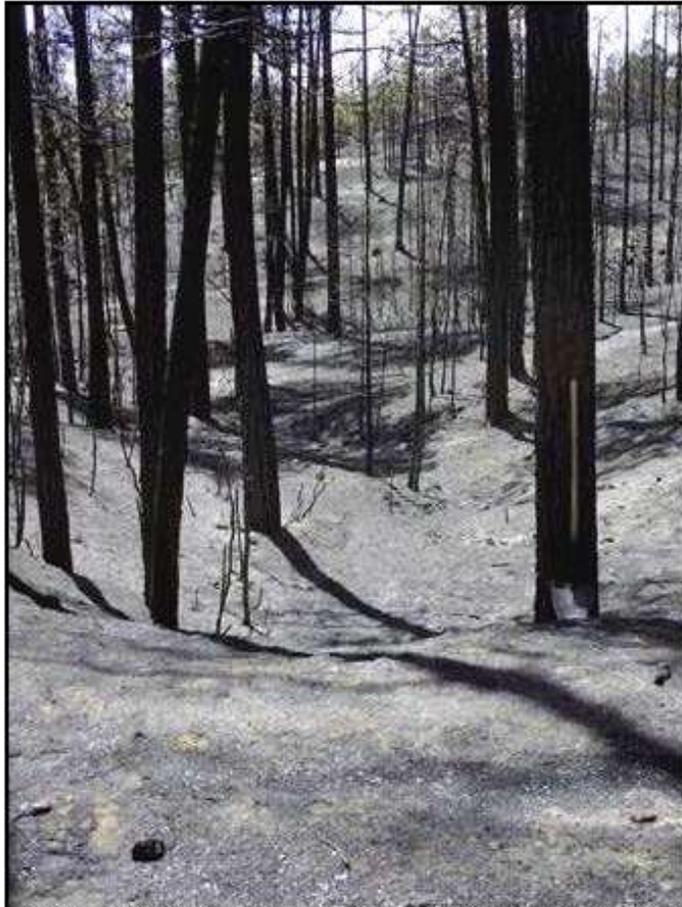
Figure 21—High-burn severity areas on the Santa Fe National Forest with available trees that are candidate sites for contour felled LEBs.

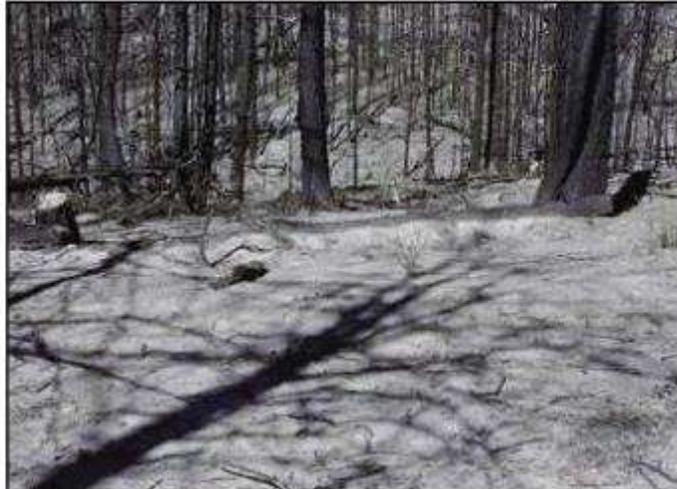
Figure 22—Contour felled LEB held in place with existing tree and stump.

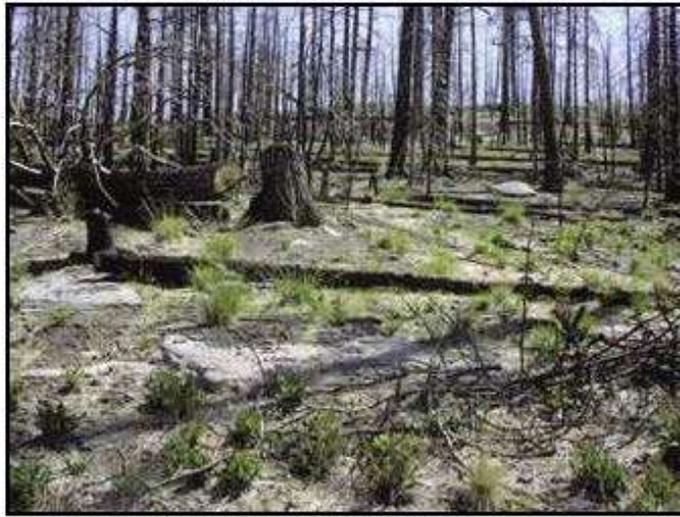
Figure 23—Contour felled LEBs 2 years after treatment.

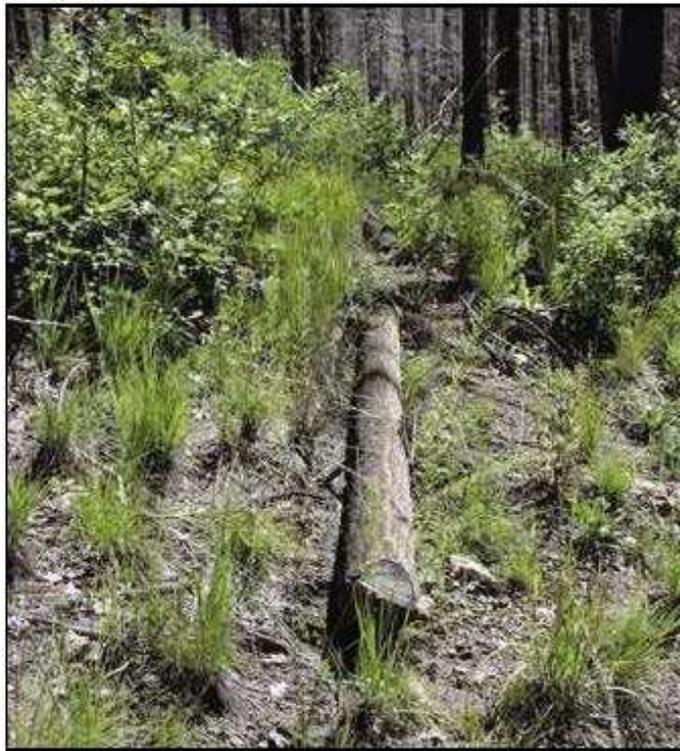
Figure 24—Contour felled LEB 2 years later that has not trapped any sediment.

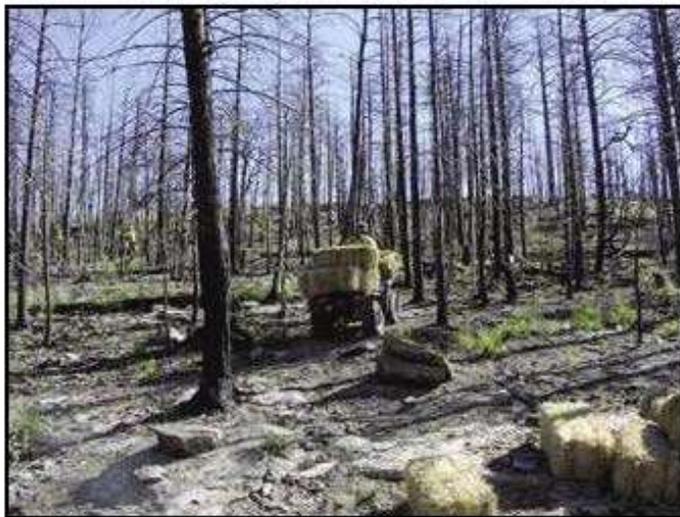
Figure 25—Area initially treated with LEBs, but secondary treatment of straw mulch is added to reduce erosion.

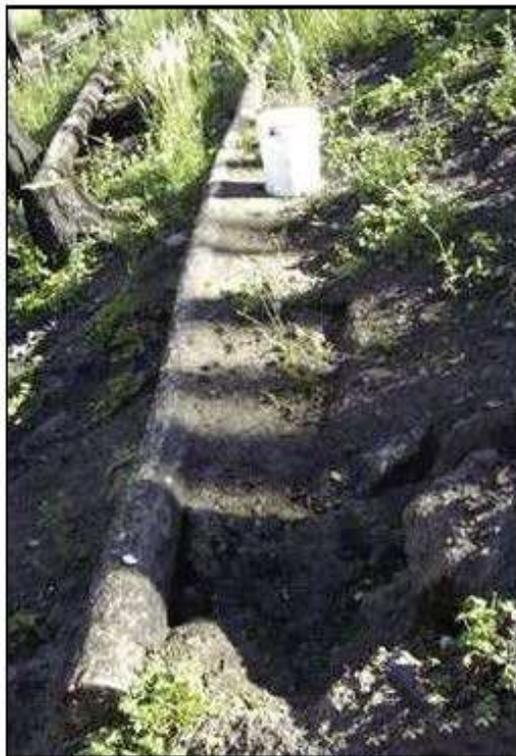
Figure 20—Contour-felled LEB which has filled with sediment and then failed. Sediment trapping ability of LEBs on steep slopes is limited.

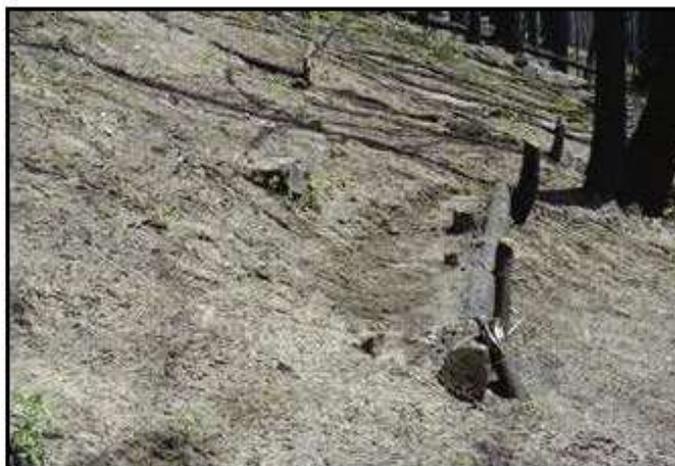
Figure 27—Once the LEB fills, sediment will move over or around the log. Soil berms on the sides of LEBs help hold more material behind the log.

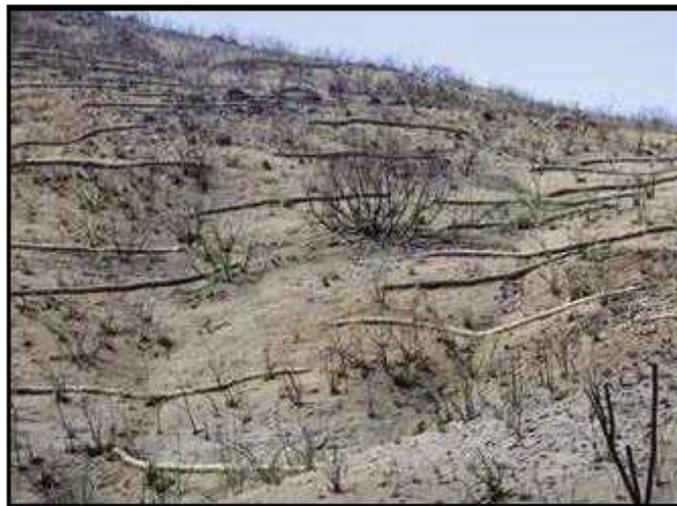
Figure 2B—Fiber roll placed across the hillslope. Not all the fiber rolls are on the contour which can accelerate erosion.

Fiber rolls, commonly called wattles, are prefabricated rolls manufactured from rice straw and wrapped in ultraviolet degradable plastic or jute netting. Fiber rolls are approximately 9 inches in diameter and up to 25 feet long. A 25-foot-long fiber roll weighs 35 pounds. Fiber rolls are designed for low-surface flows not to exceed 1 cubic foot per second. They are not for stream channels or gullies (Morris 2004).

Fiber rolls reduce erosion by shortening the slope length to slow overland flow velocity. Fiber rolls trap sediment and provide a seedbed for vegetative recovery. If water repellent soils are present, the installation of the fiber rolls may break through the water repellent layer and can improve infiltration.

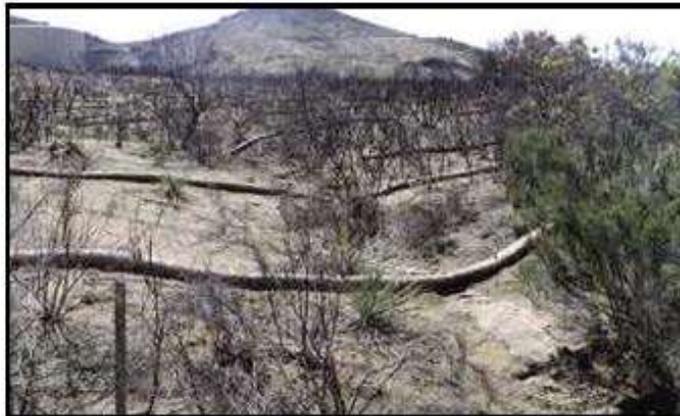
Figure 29—Avoid placing the fiber rolls in drainages.

Findings indicate the need for implementation monitoring to ensure proper location, spacing, and placement of the fiber roll. Do not place fiber rolls in drainages or turn the ends down. Fiber rolls in drainages failed and fiber rolls with the end turned down contributed to rill formation (Hubbert, unpublished paper).

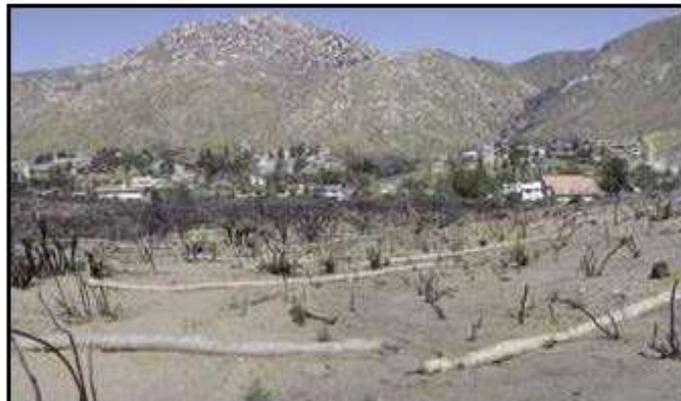
Figure 20—Fiber rolls do not reduce erosion but trap sediment on the slope. Where high values are at risk identify the emergency objective and select the treatment which best meets that objective.

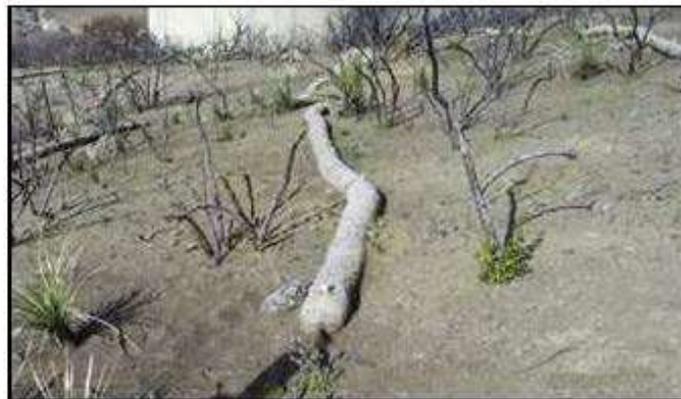
Figure 31—To ensure proper installation, work with experienced crews and inspect as the fiber rolls are installed. Improper installation negates the effectiveness of this treatment.

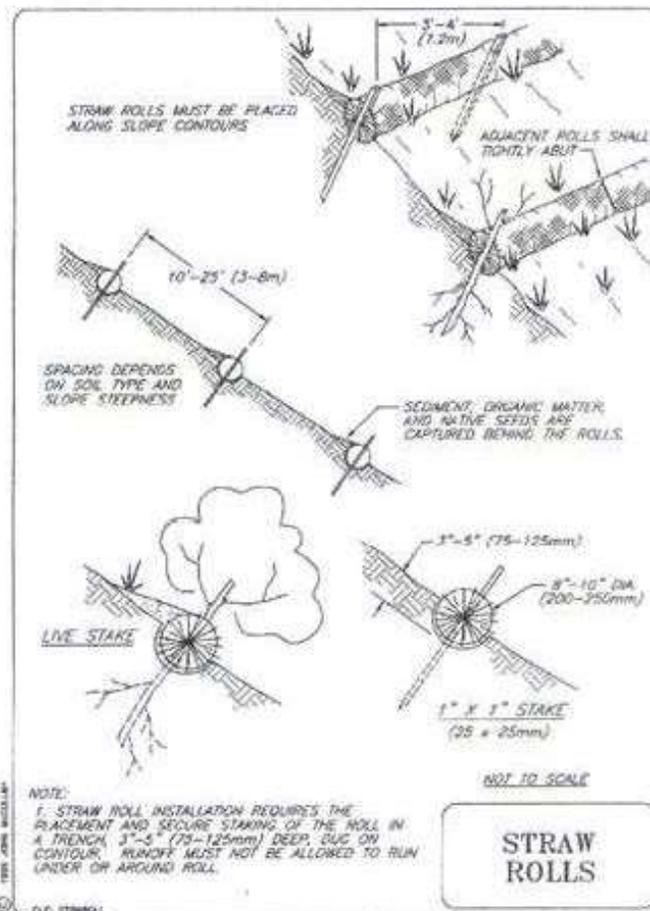
Figure 22—Fiber roll installation guide.

9. Place wattles 50 feet apart (872 per acre) on moderate-burn severity on slopes of 20 to 50 percent. Place wattles 20 feet apart (2,178 per acre) on high-burn severity slopes. (Natural Resource Conservation Service Web site).

10. Stagger the layout on the slope in a bricklayer pattern starting at the top of the slope with a 12- to 16-inch overlap.

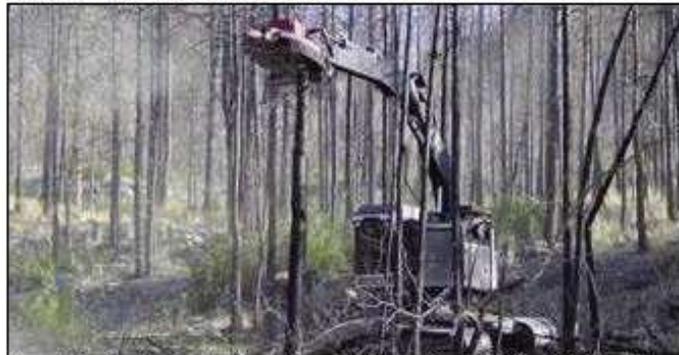
Figure 15—Mechanized equipment can quickly produce slash for effective soil cover.

Slash spreading involves felling, limbing, and scattering submerchantable trees and brush to provide soil cover.

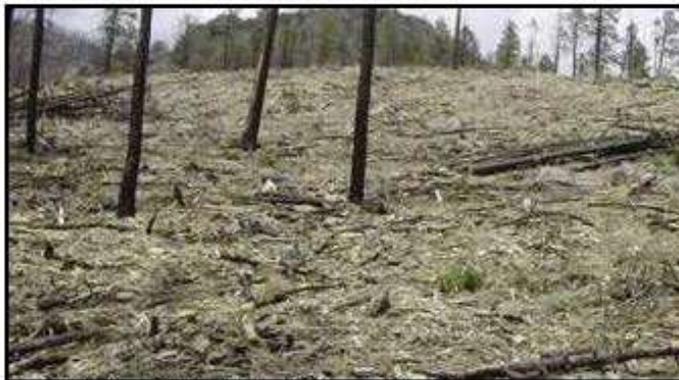
Figure 16—Completed unit with slash spread uniformly.

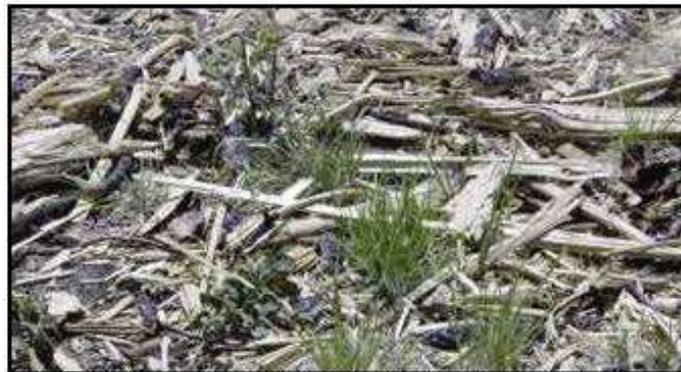
Figure 17—Closeup of the slash material generated with heavy equipment.

Use of track-mounted shredders on the Borrego fire and the Clearwater National Forest demonstrate opportunities for shredding to reduce erosion. Track-mounted machines can shred trees 6 to 8 inches in diameter and provide "weed free" erosion control (Groenier, 2004). Equipment varies but generally enables an operator to treat an area within a 20-foot radius from a single position. Track-mounted machines tested in New Mexico exerted less than 4 pounds per square inch of ground pressure (Armstrong, unpublished paper).
